Report for
UK Civil Aviation Authority
on
Class A Terrain Awareness Warning System (TAWS) for Offshore
Helicopter Operations

Prepared by Peter Clapp (flightdatapeople.com) and David Howson (UK CAA)

Proposal Reference:
FDP-CAA-Report 150922

Date:
April 2017

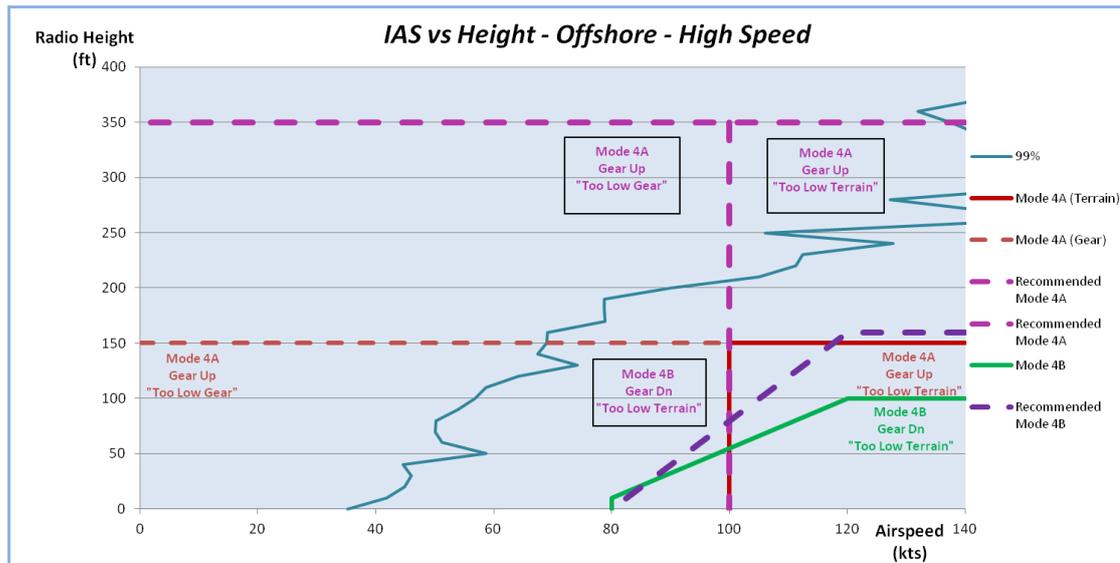
Although solving the nuisance alert rate on the AW139, the modification significantly reduces the warning times for G-BEON and G-REDU which is undesirable and might preclude the deletion of Mode 6A were this version of Mode 4B to be applied generally. Alternatively, this envelope might be implemented on the AW139 only. Analysis of FDM data for further helicopter types (e.g. Airbus Helicopters H175 and Leonardo AW189) will help to identify the best solution.
