Appendix 14.5 Review of Existing Structures

Shetland Space Centre

Review of Existing Structures

Project Number : 60617516

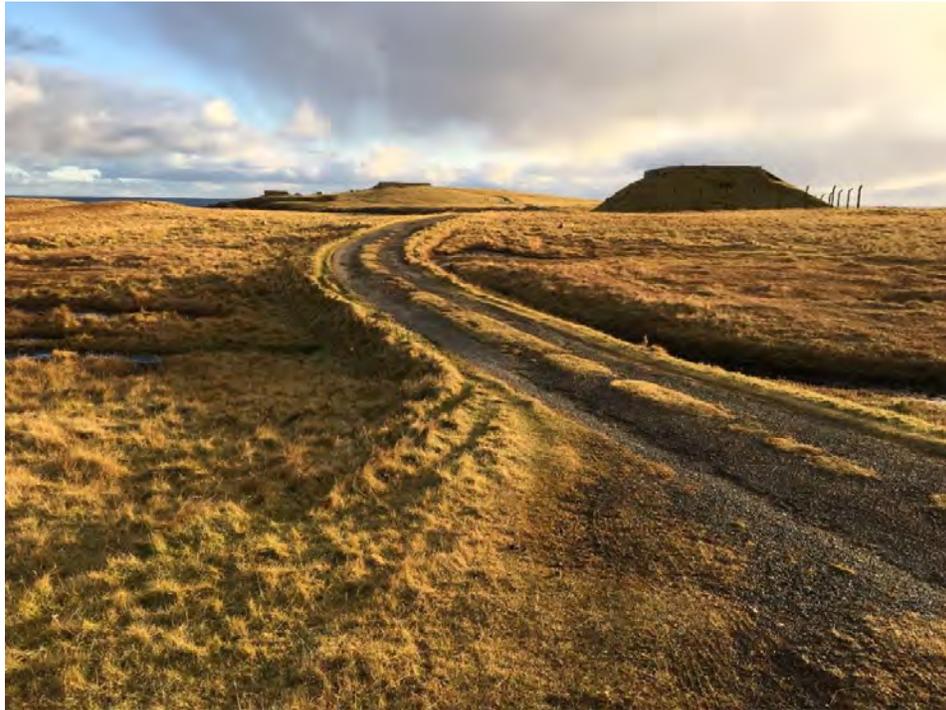
- 1.2.1 A former road extends from the site entrance in the west to the Lamba Ness area of the site to the east. This road is used for general access by the landowner, common grazing users and for public access to Lamba Ness for whale and bird watching.
- 1.2.2 The roads generally have a bituminous surface and are narrow and in poor surface condition in many areas.

Typical existing road condition

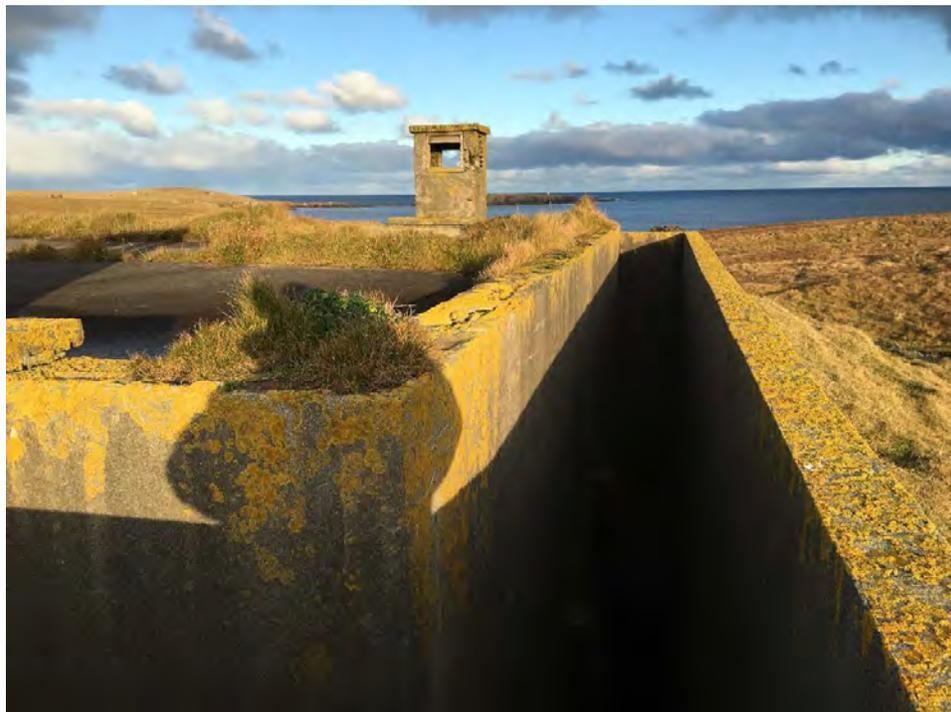
The roof consists of a flat concrete slab spanning between external walls and internal walls which has been waterproofed. Water proofing has deteriorated exposing roof slab in some areas, impacting the surface of roof and deteriorating concrete which will, in turn, impact the reinforcement of the roof slab.

Large Bunker roof and external walls (typical)

- 2.1.2 The condition of spanning concrete roof slabs, present in the bunkered buildings, show significant deterioration of the surfaces and material conditions. The condition of integral reinforcement within reinforced concrete slabs cannot be verified but can be seen to have deteriorated in many locations. The structural integrity of these elements cannot therefore be confirmed.

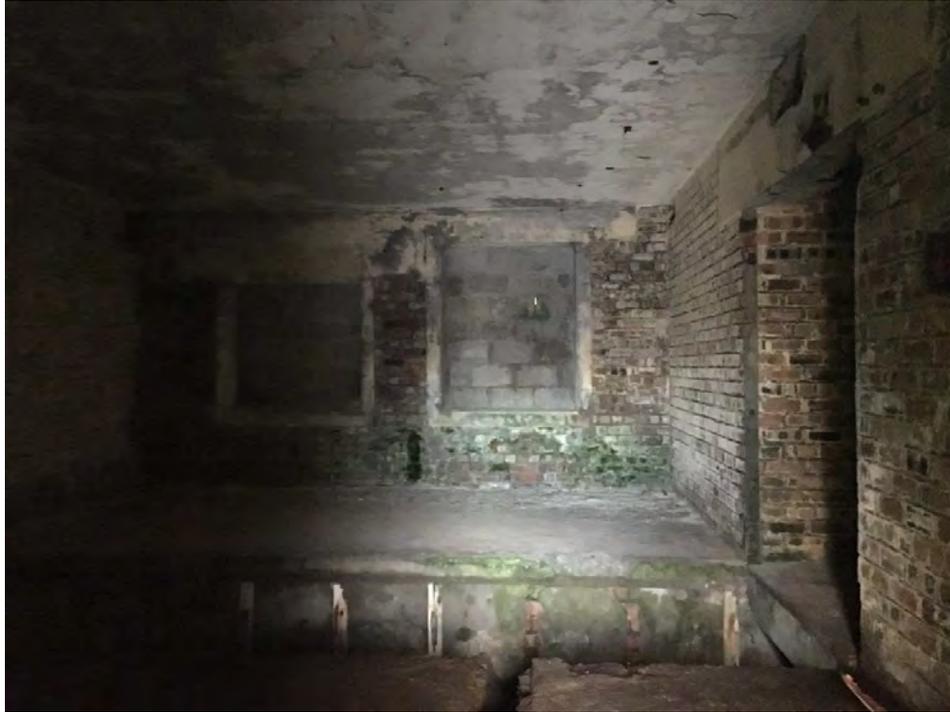
Internal and external remains are in generally good condition except at some locations where opening have been cut.

Large bunker internal (typical)

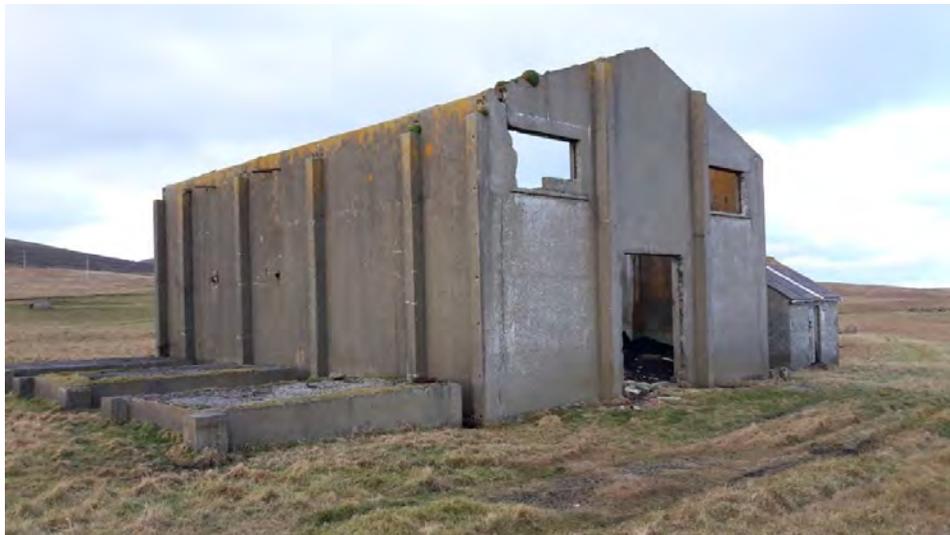
Large vertical cracks from ground to eaves level are evident on the south west elevation wall.

Due to the collapse or removal of the roof, the external walls are no longer supported at roof level to enable loads to be transferred to the side walls. The structure is therefore at risk of collapse during high winds.

Former Power House

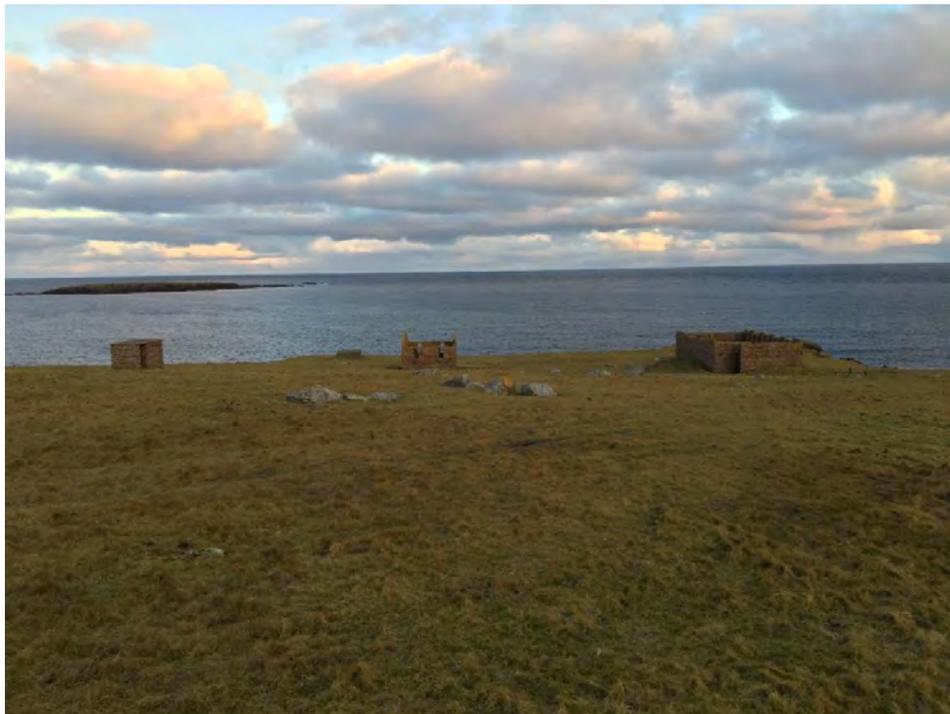
Deterioration of the brickwork and concrete is evident due to carbonation of concrete elements and weathering

The integrity of small enclosed buildings with concrete roofs does not appear to have been compromised however buildings with former timber roofs have high level walls which are no longer supported and will be at risk of collapse in high winds

Typical Small Buildings

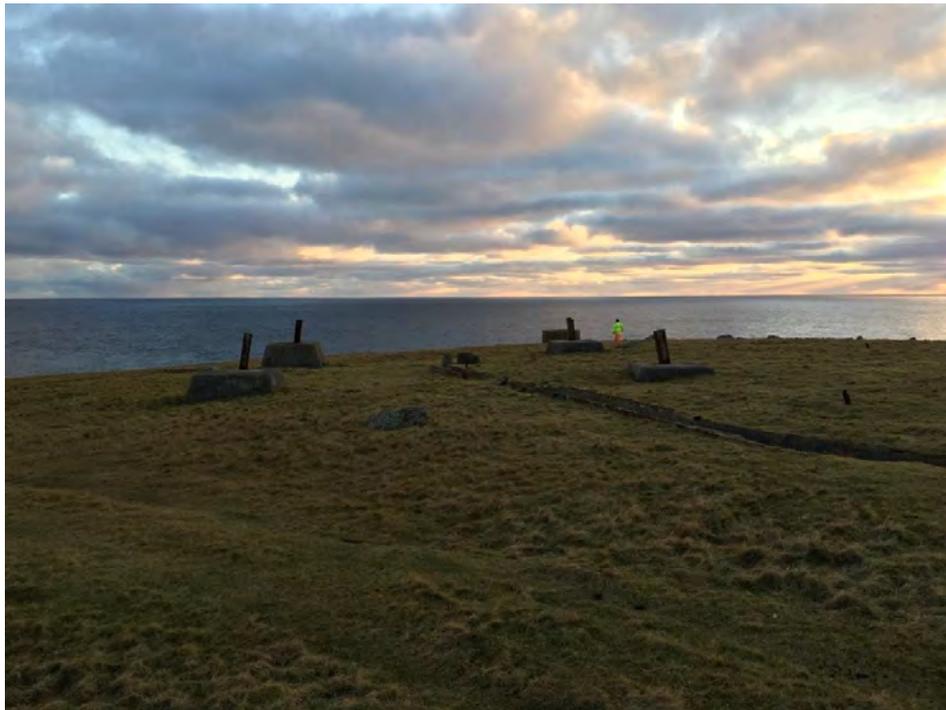
There are 4 large concrete bases on each tower, which are generally exposed at ground level.

Concrete is exposed and surfaces are deteriorating due to carbonation, and weathering.

Typical remains of Mast Bases

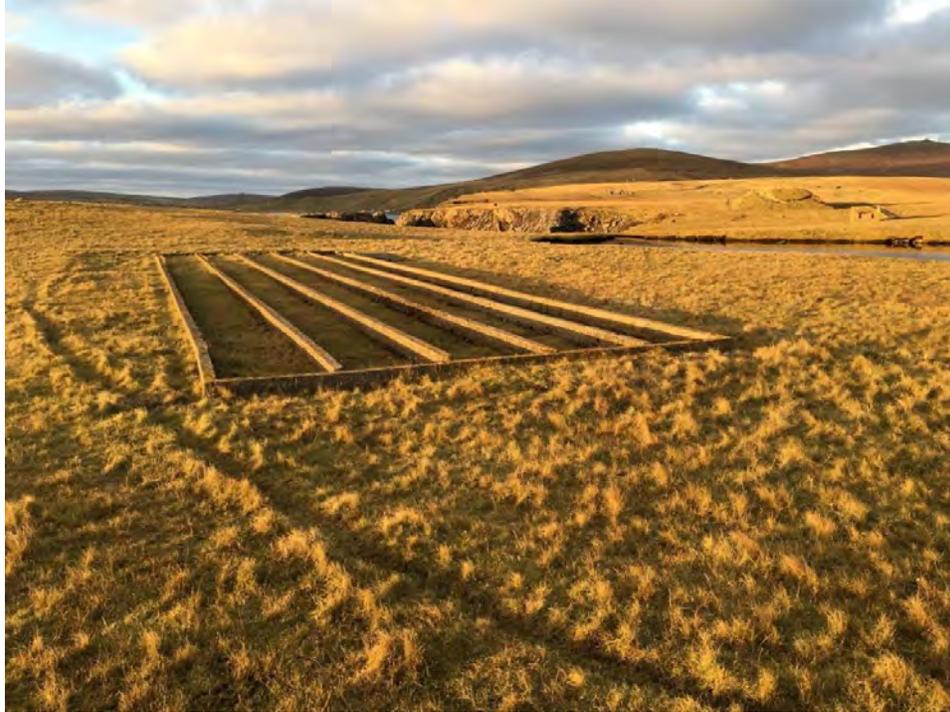
A number of small concrete slabs and bases are present which formed the foundations for wooden hut structures. These mainly consist of exposed concrete slabs with lines of brickwork. Brickwork and concrete surfaces are deteriorating due to carbonation and weathering.

Small building foundations for former huts

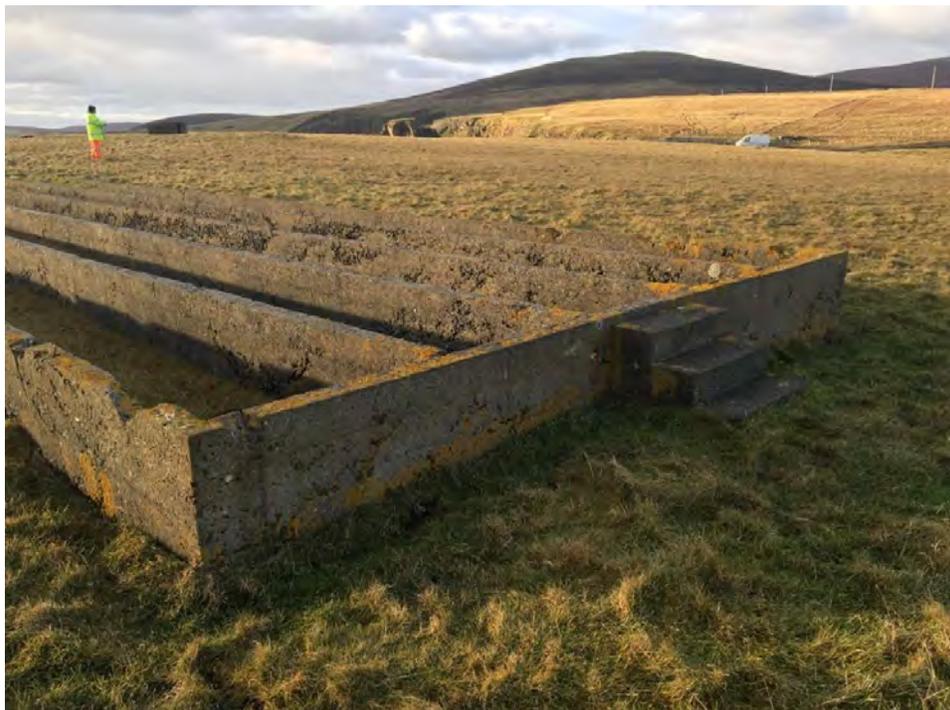
Former building foundations

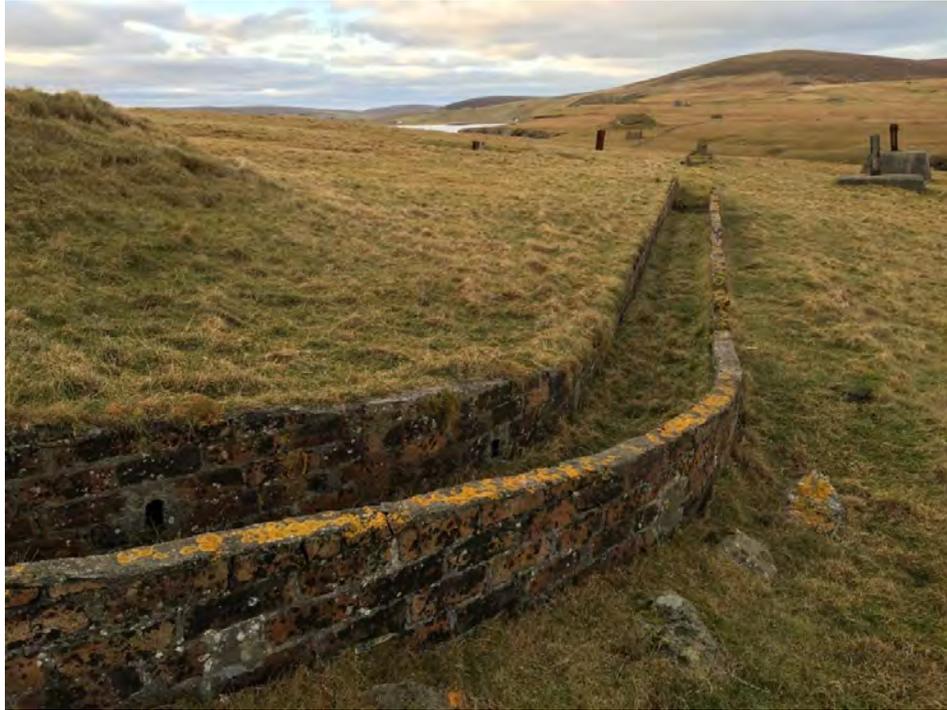
External service trenches and ducts are known to be present at shallow cover below ground in various locations. The condition of these is not known and the structural integrity of covers cannot be confirmed.

Typical external service trench

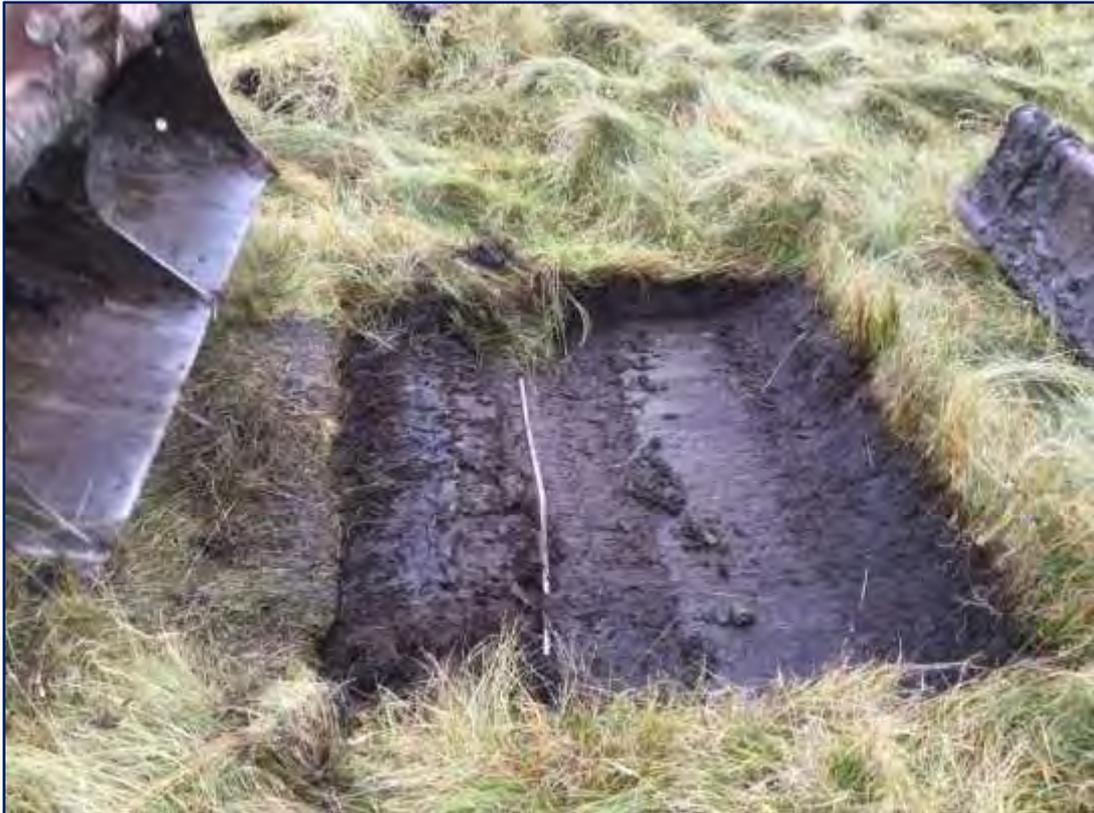
- 6.12 Service cables of unknown date were identified during the opening of TP015 and TP028. As such the ground was immediately reinstated and a second location (recorded as "a") was chosen for each. Figures 6 & 9) show the original and secondary location of TP015 and TP028. Mr Charlie Clark (2020, per comms), the machine driver and a shareholder on the Garth Estate stated that to his knowledge none of the service cables within the Site were live but had been in use in his memory, following the abandonment of RAF Skaw.

Plate 3: East facing view of TP015 showing the cable found upon opening.

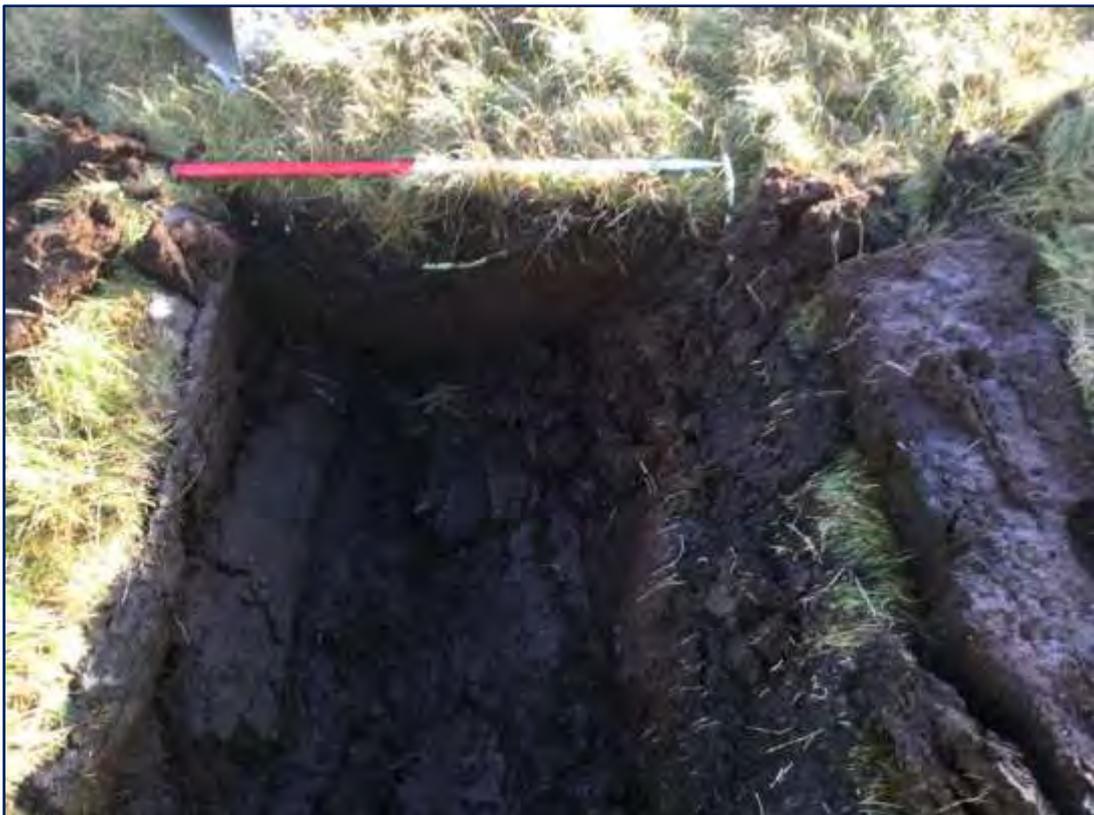
Plate 4: South facing view of TP028, showing the cable disturbed in the north facing section.

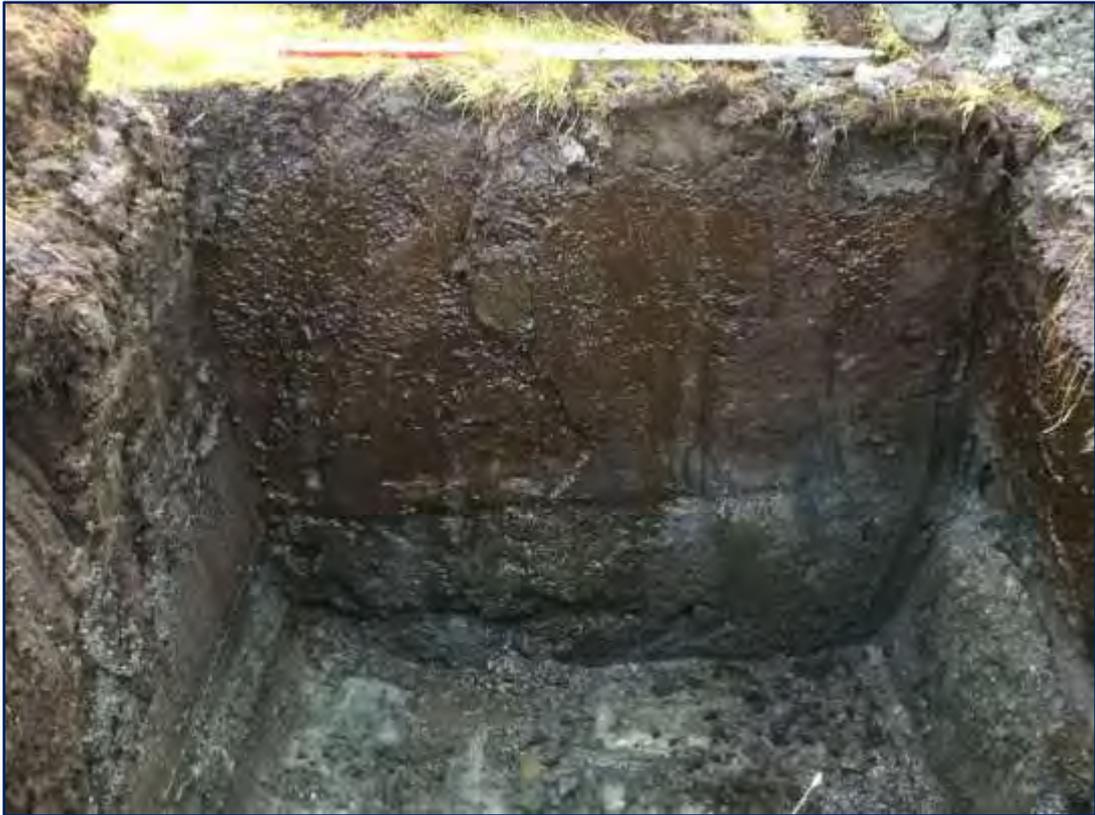
- 6.24 A band of dark material, approximately 0.05m in thickness was visible in the sections of TP012, TP013 and TP016. This band of material was only visible after the depth of the Test Pits had extended past a depth where access to the Test Pits was deemed unsafe and was therefore not intensively investigated. The band of material was located in TP012 and TP016 at the juncture of the layer of peat and a layer of light bluish grey clayey sand which was identified in a large number of the Test Pits across the Site. The band of material may be an area of saturated peat, which cannot percolate through the underlying clayey sand. The deposit may also be evidence of initial peat development, or a buried land surface.

Plate 8: West facing section of TP012. A thin dark deposit is visible between the 1.03m deep layer of peat and the underlying light bluish grey clayey sand. TP012 was terminated on presumed bedrock.

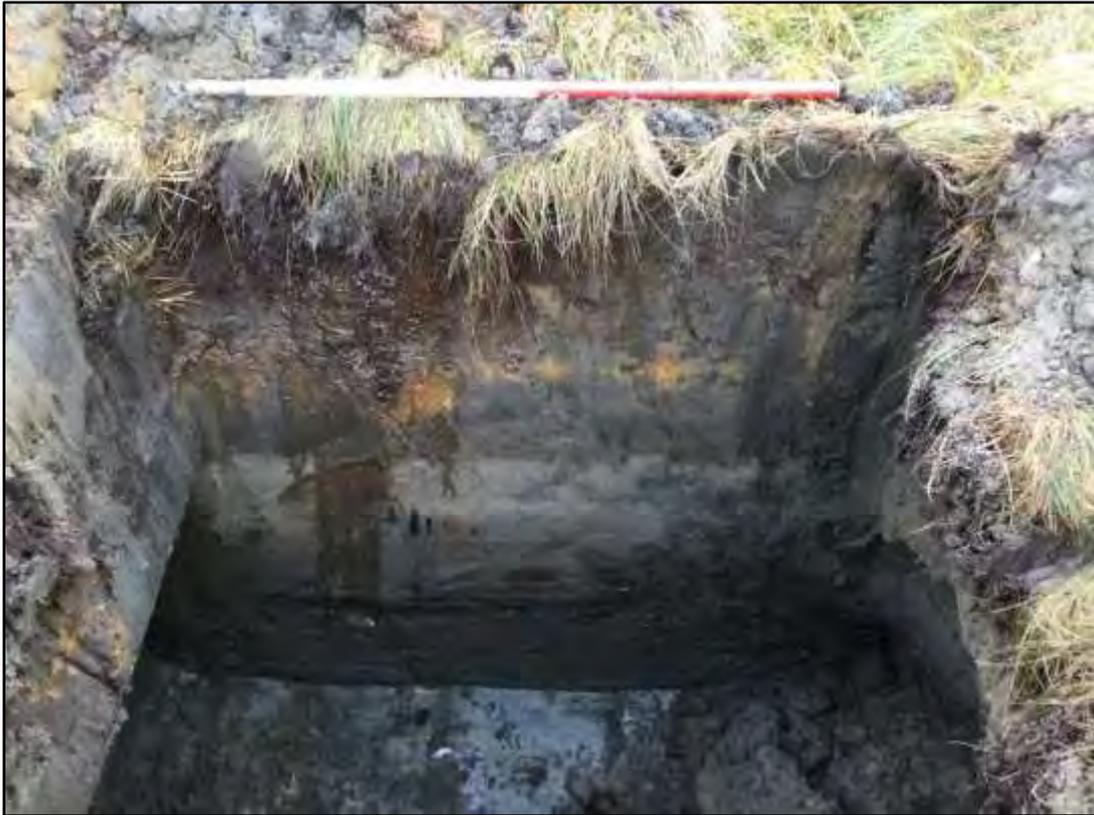
- 6.26 A deposit (1005) was recorded in TP015a beneath the peat. Peat was found to extend from the ground surface to 0.3m in depth. Beneath which (1005) was identified. (1005) is characterised as a firm to friable light grey, mottled brown sand c. 0.67m in thickness. Underlying (1005) was a layer of light bluish grey clayey sand which lay on the presumed bedrock. It is possible that (1005) is evidence of exposure prior to peat development at the location of TP015, however the deposit may also be a mixing of peat and the light bluish grey clayey sand deposit.

Plate 11: North facing section of TP015a.

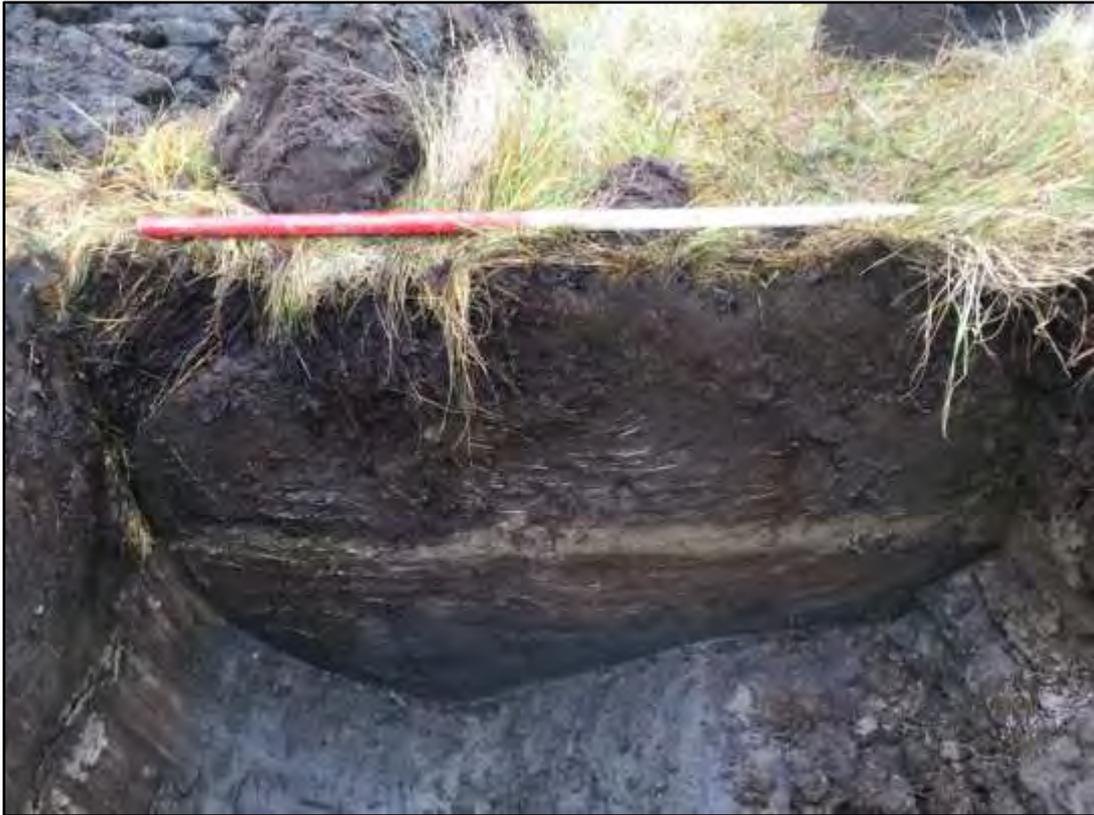
- 6.27 Evidence of a period of hiatus in peat development was identified in TP017. No topsoil was recorded in TP017, with peat being recorded from the ground surface to 0.45m in depth. A context recorded as (1006) was identified beneath the peat. (1006) is a dark yellow firm sand approximately 0.05m in thickness. Another layer of peat, 0.10m in thickness was found to overly (1006) and light bluish grey clayey sand was identified between 0.6m in depth to 1.87m when TP017 was terminated at presumed bedrock. (1006) must have been formed when there was a pause in peat development and is potentially evidence of a buried land surface. The composition of (1006) suggests that the area was exposed, most likely to windblown sands or inundation of sand from coastal deposits as the Site is located on a peninsula.

Plate 12: South facing view of TP017 taken at 0.9m below the ground surface. Note (1006) between two areas of peat.

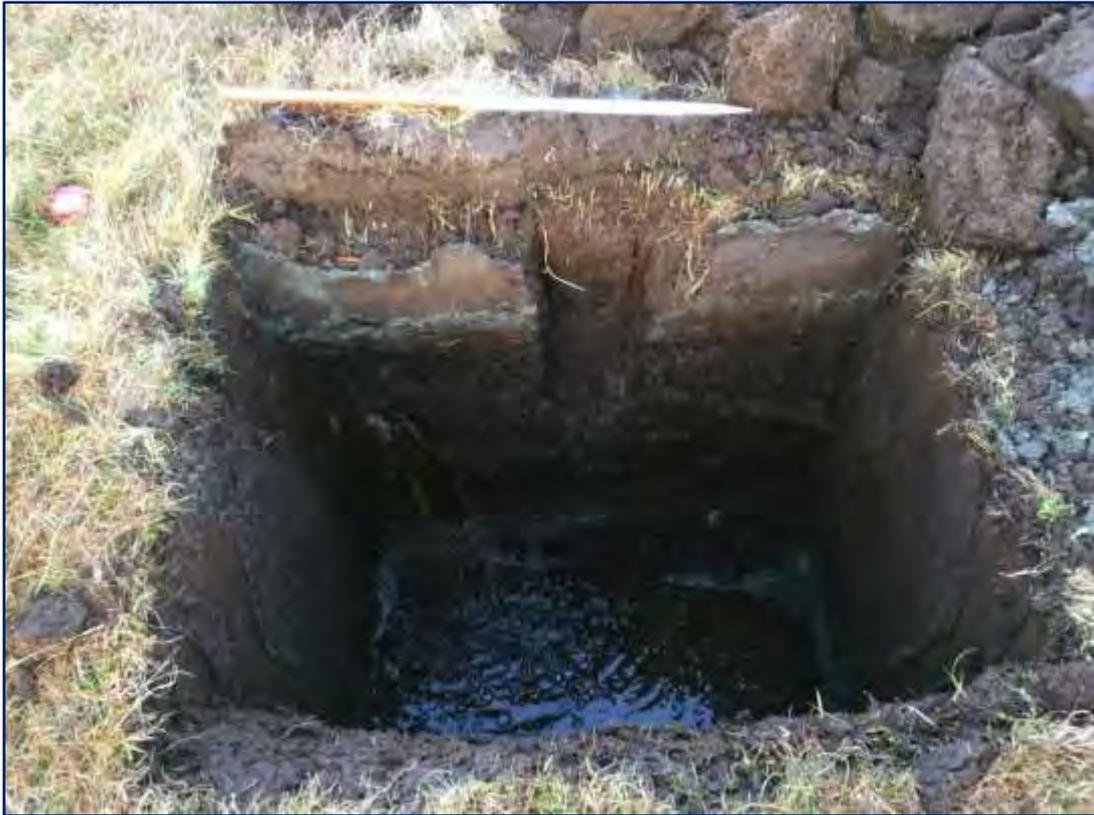
- 6.29 A plastic pipe was encountered in the northern section of TP029 by the machine bucket at a depth of 0.9m. The pipe was revealed in section only after a depth of 1.9m had already been reached. It was encountered as the machine tried to deepen TP029 beyond a depth of 1.9m and in doing so the machine bucket clipped the northern section of the TP029 and revealed the pipe. TP029 was abandoned immediately upon encountering the pipe. The pipe was made of plastic and appears to have been in active use as a drainage pipe. The pipe is most likely a post-WW2 feature, added to the Site to facilitate drainage.
- 6.30 No topsoil was recorded in TP029 and 1.4m of peat was identified overlying light bluish grey clay sand to a depth of 1.9m. The ground around the pipe is presumably composed of made ground although no cut for the pipe was visible.

Plate 13: North facing view of TP029. Note the pipe in the south facing section.

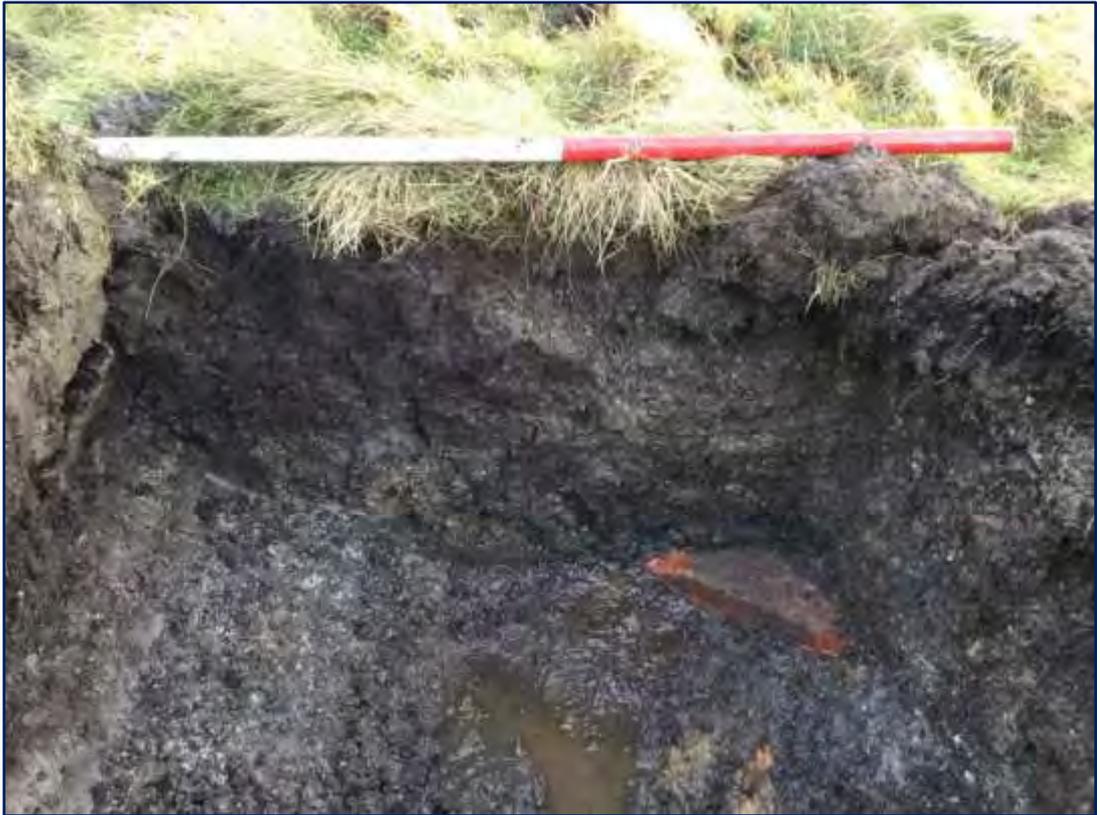
- 6.32 The cut for the brick was visible in the west facing section, with the ground above the brick being composed of mixed deposits and as such is made ground. The deposits in the south-western facing section of TP043 appear to be relatively less disturbed and 0.3m of peat was found overlying weathered bedrock.

Plate 14: West facing section of TP043 showing the brick found in the south-eastern corner and the disturbed, ground above the brick which is most likely made ground.

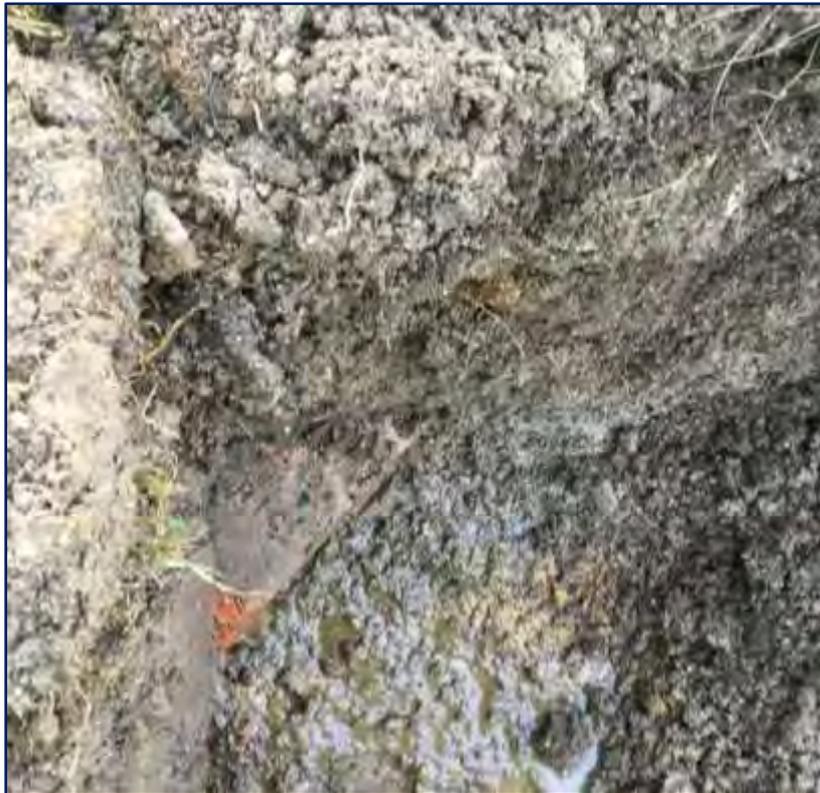
Plate 15: Detail of the brick found in TP043.
