AIRCRAFT ACCIDENT REPORT 1/2015

**Report on the accident to
Airbus A319-131, G-EUOE
London Heathrow Airport
24 May 2013**

Air Accidents Investigation Branch

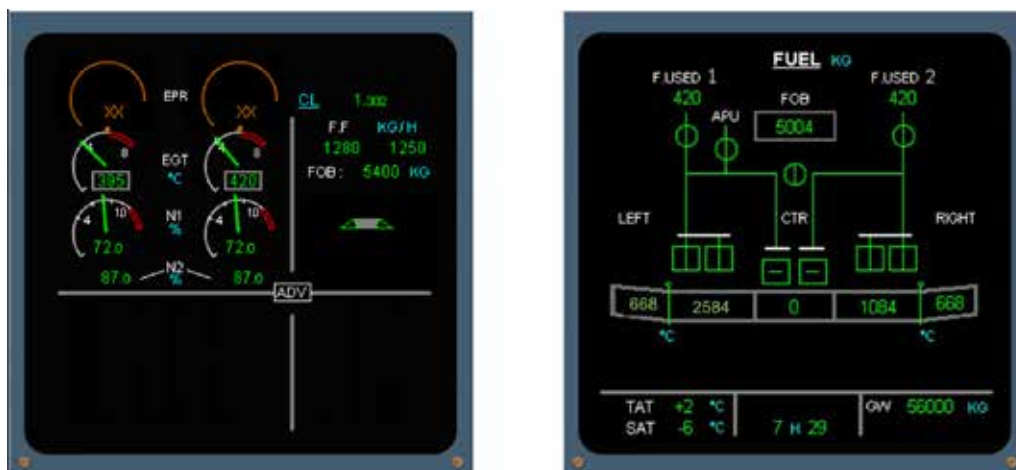
Figure 11

At the time of the accident, the aircraft did not have automatic fuel leak detection but did have a fuel imbalance monitor. This is triggered once a difference of more than 1,500 kg is detected between the left and right wing tank quantities. There is no ECAM warning message for this condition but a flashing white advisory (ADV) symbol appears on the E/WD and the Fuel System Data page is displayed on the lower ECAM page (Figure 11). The FUEL title on the screen flashes and the fuel quantity in the fullest wing tank will flash.

E/WD with ADV indication and Fuel Page

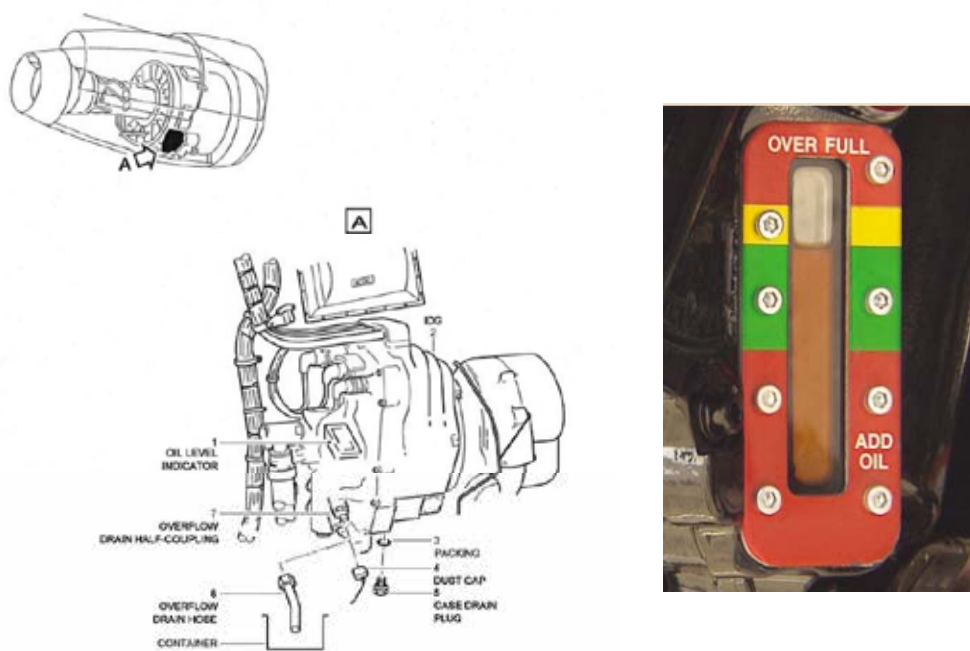
Figure 12

Each engine has an integrated drive generator (IDG) mounted on the lower right side of the engine (Figure 12). The IDG converts variable-speed shaft power from the engine's high pressure shaft into constant frequency 400 Hz AC electrical power. Each IDG has a self-contained oil system in which oil is used to cool and lubricate internal components of the IDG. A vertical sight glass is provided on the IDG to allow the oil level within the IDG to be determined. Servicing is performed according to the oil level position in zones demarked by red, green and yellow coloured bands adjacent to the sight glass.

Due to its location on the engine, the IDG cannot be viewed or accessed unless the fan cowl doors are opened and AMM task 24-21-51-200-010 requires, as an initial step, the fan cowls to be opened.

Location of the IDG on the V2500 engine

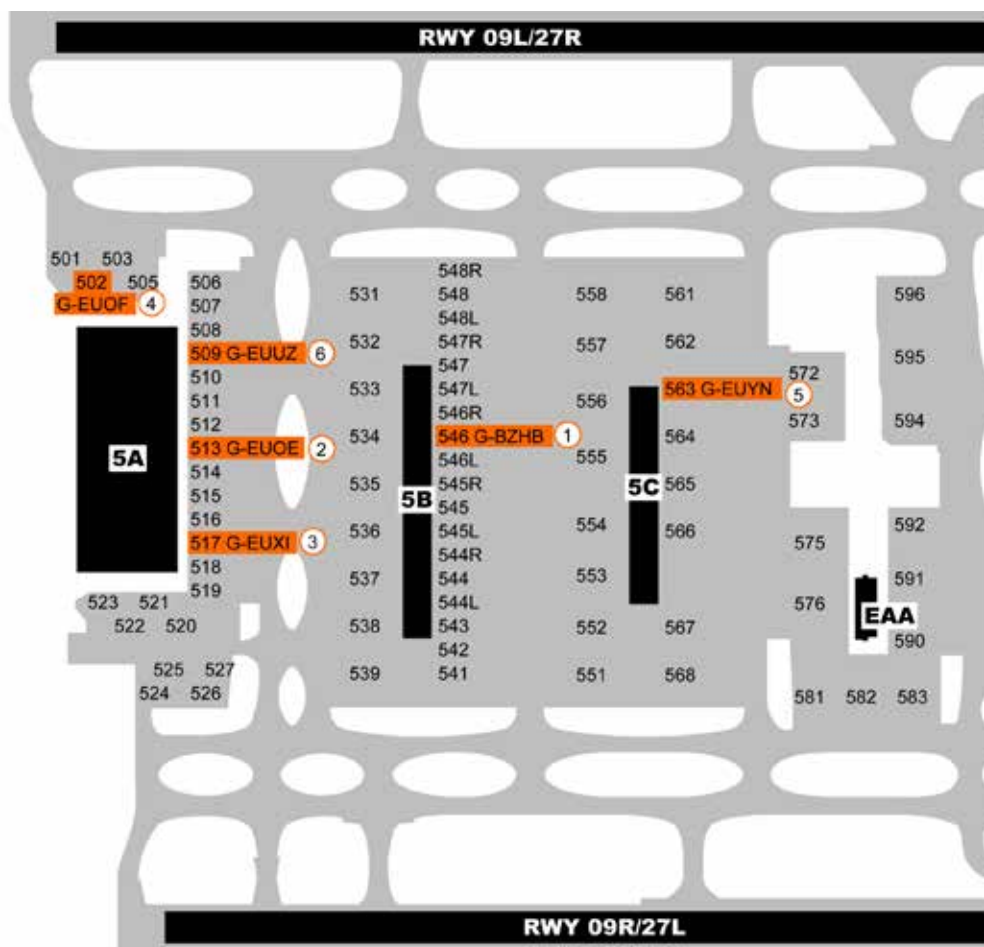
Figure 14

Technicians A and B began their work by travelling together, in a single vehicle, to a Boeing 767 on Stand 546 (Figure 14), where they completed a Daily Check. During this check Technician A noticed that the QAR datacard reader at the stand was missing and he logged a defect report via telephone with the operator’s IT department. Technician A made an entry for the Weekly Check in the aircraft technical log at 2100 hrs and both technicians then proceeded to Stand 513 to await the arrival of their second aircraft of the shift, G-EUOE, which arrived at 2138 hrs.

Location of the Technicians' aircraft during the nightshift;
circled numbers refer to the order in which aircraft were visited

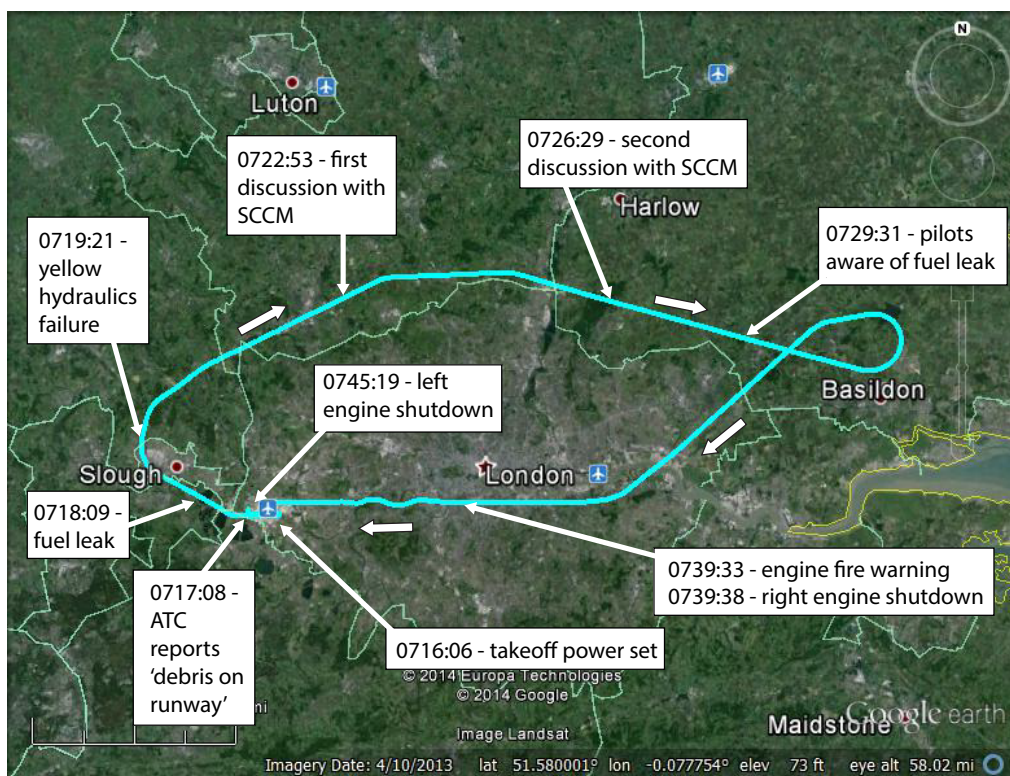
By combining the data sources, a timeline of the main aircraft-related events throughout the flight was generated (Figure 15). Cockpit effects and built-in test equipment (BITE) messages recorded in the PFR are only to the nearest minute; however, correlating the messages to the FDR data allows a more accurate timing to the nearest second to be established. A complete list of inoperative aircraft systems encountered during this accident is listed in Appendix 2.

Takeoff power was set at 0716:06 hrs, autothrust engaged, the aircraft accelerated and rotated at 0716:39 hrs. Three seconds later, EEC2 detected a P2/T2 probe heater disagreement; this was the first failure message corresponding to damage caused by the loss of the fan cowl doors.

Figure 15
G-EUOE flight routing and timeline

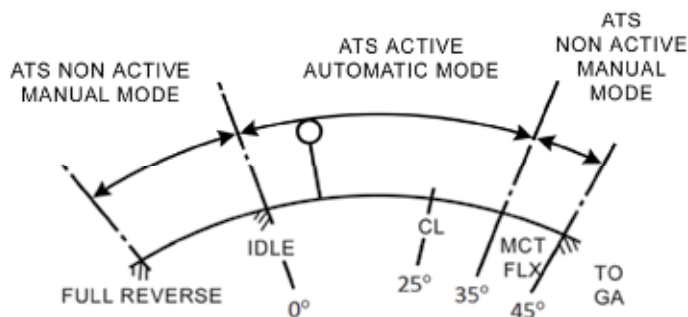
Figure 17

Just after the right engine thrust lever was retarded to idle, the left engine thrust lever was advanced up to 30°, which is between the CLIMB and FLX/MCT positions (Figure 17). The left engine responded, increasing to 79% N1. Just prior to the engine fire, both engines were at flight idle (26% N1); this thrust increase caused the aircraft to yaw to the right.

Thrust lever angular range

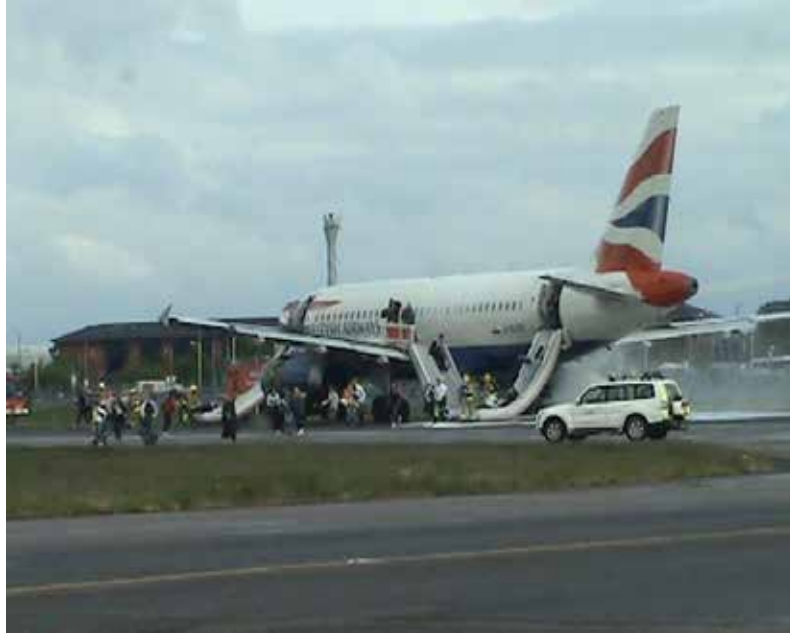
Figure 20

The post-landing events, including the fire-fighting and evacuation, were video recorded by various hand-held, vehicle-mounted and fixed-point cameras (Figure 20). These were compared with recorded radio transmissions, to create an approximate timeline of the evacuation (Table 3). Only the left exits were used during the evacuation.

Still image from evacuation video
(fire-fighting continues on right side of aircraft)

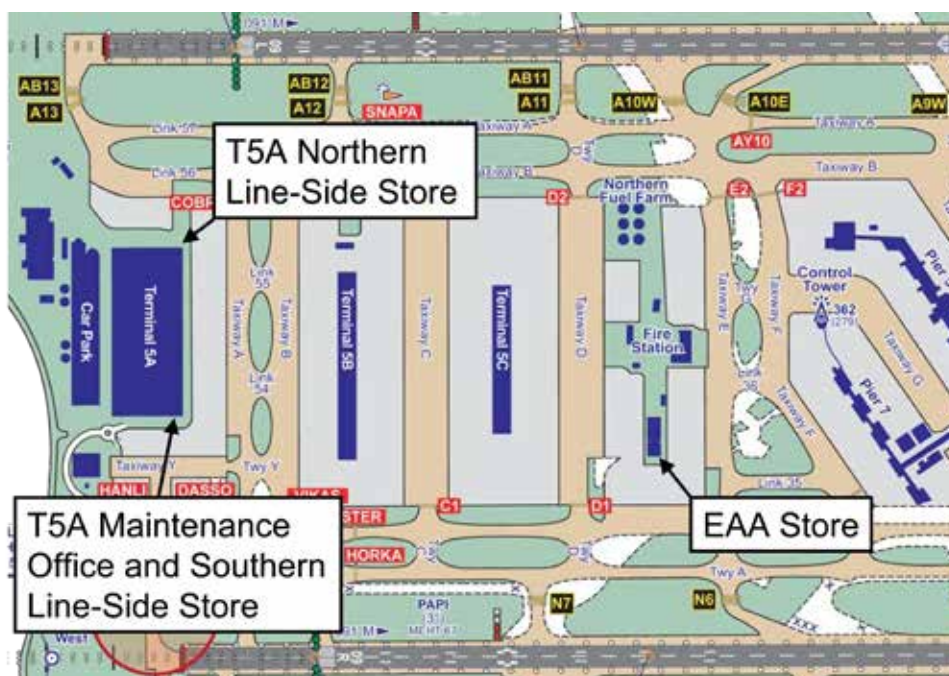
**Figure 22**

The technicians' normal operating base was in the northern end of Terminal 5A. This comprised a small technical office, a crew room and a line-side store containing consumables and tooling, including IDG guns. On the night before the accident, however, these facilities were closed for refurbishment and both technicians were temporarily operating from the main engineering facilities at the south end of Terminal 5A where the maintenance control office is located. The southern end of Terminal 5A also houses a line-side engineering store that stocks IDG guns suitable for use on the operator's A320-family aircraft. The number of guns available at this southern store on the night before the accident was not accurately determined, but was estimated at two. Neither of these was available when one was required by Technician B.

Location of stores

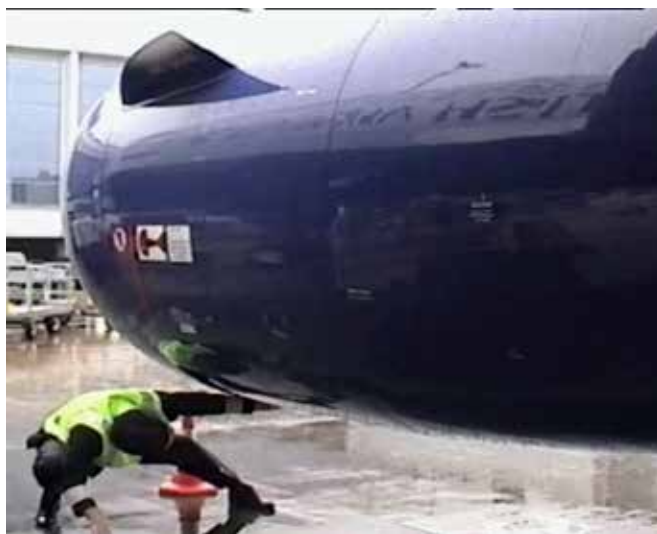
Figure 23

'Start with the left hand side. Remember you're always looking for skin damage, the access doors for the magnetic chip detector (IAE engines only) and the oil filler are here. Now check the fan cowl doors, it's the latches that need special attention here, [Figure 23]. They're weighted and painted red [Figure 24] so they'll hang down and should be easily seen if they're not properly closed. Make sure that you see that they are all flush. The cowls should be faired with

Pilot inspection of latch positions

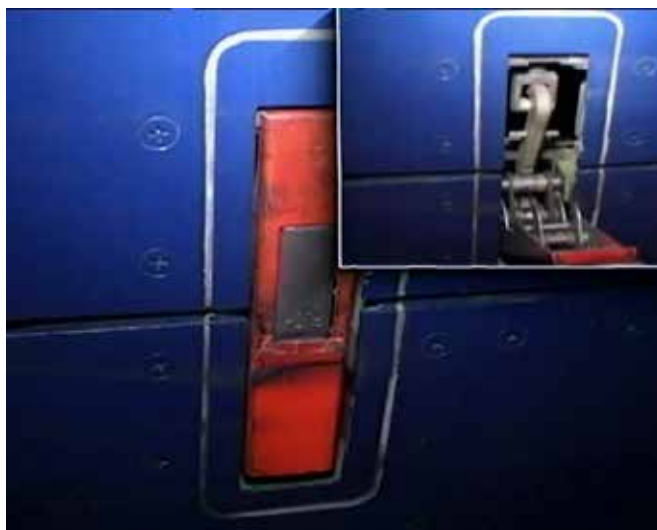
Figure 24

Latch colour and position from operator's video

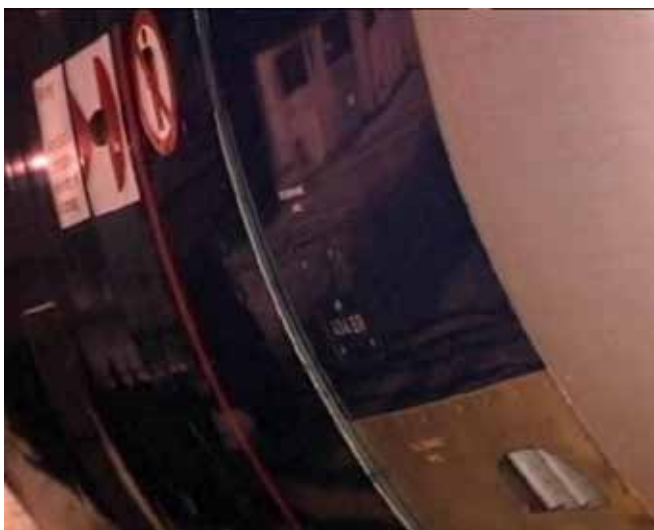
Figure 25
Door "flush" from video

the engine intake like this [Figure 25]...an embodied structure mod just forward of the cowl door will show this gap if the doors are not properly secured....'

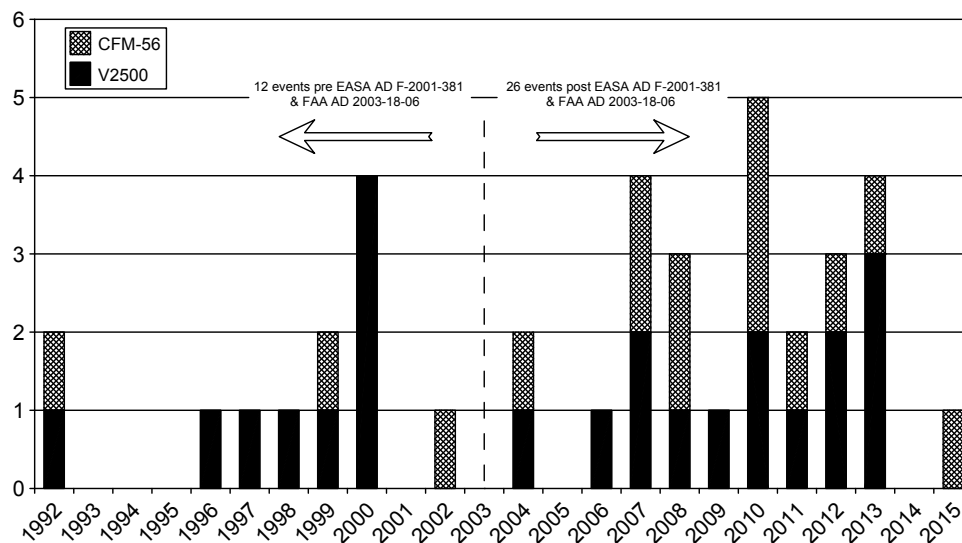
Figure 26

The aircraft manufacturer estimated that, up to the end of 2002, the in-service fleet of A320-family¹² aircraft had accumulated a total of 15.3 million flight cycles since 1992. There had been a total of 12 fan cowl door loss events during this period, equating to an occurrence rate of one event per 1.28 million flight cycles.

Airbus A320-family fan cowl door loss events, 1992-2015

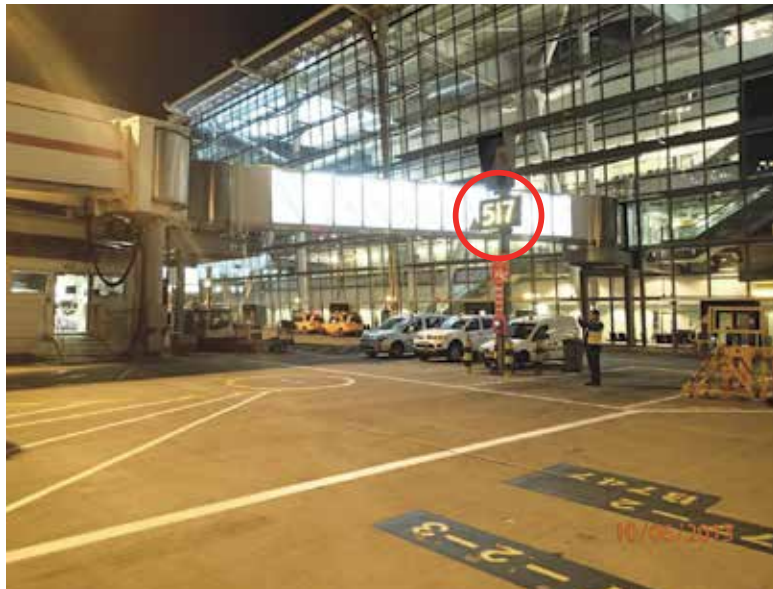
Figure 1

Yellow aircraft stand signage (Stand 517, circled)

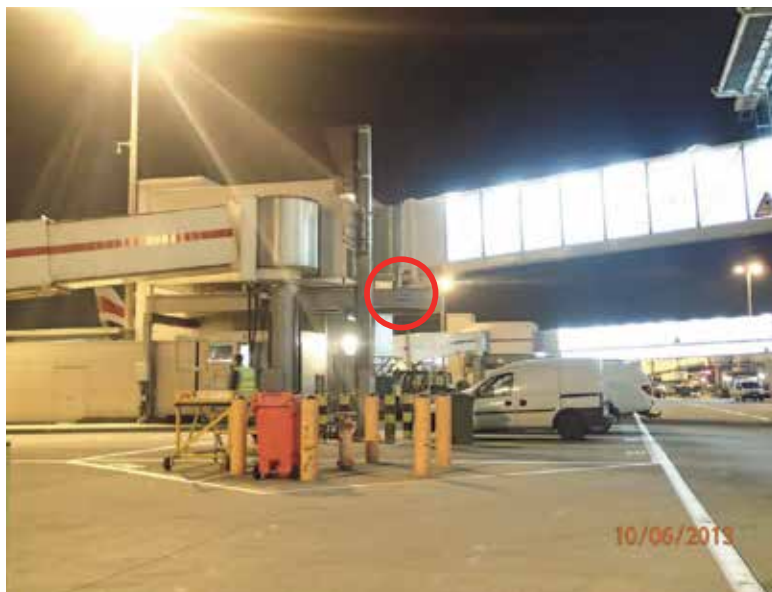
Figure 2

Blue road signage for aircraft stands (Stand 516/617, circled)

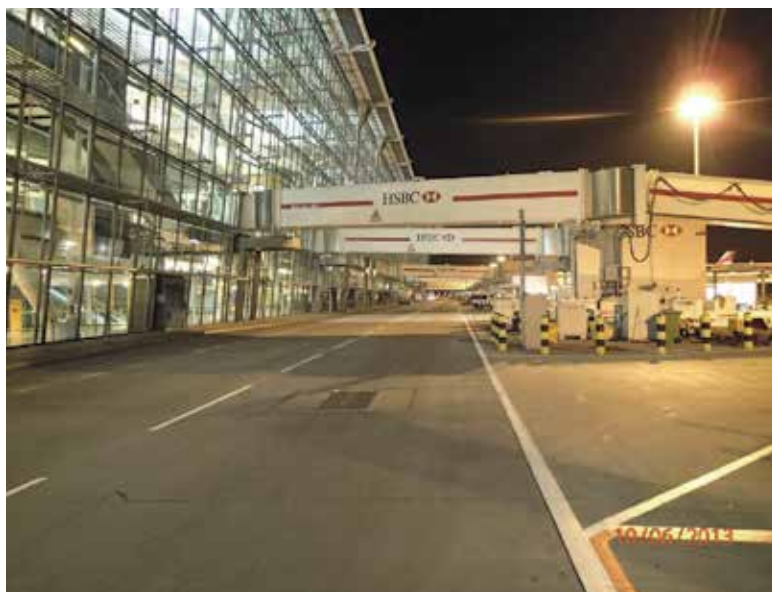
Figure 3

View along the terminal road

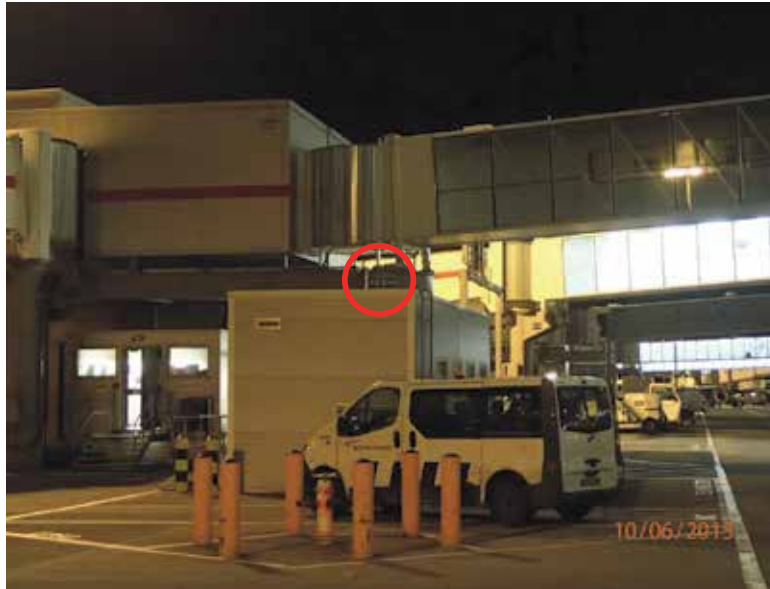
Figure 4

'Pod' service building at Stand 513 (signage circled)

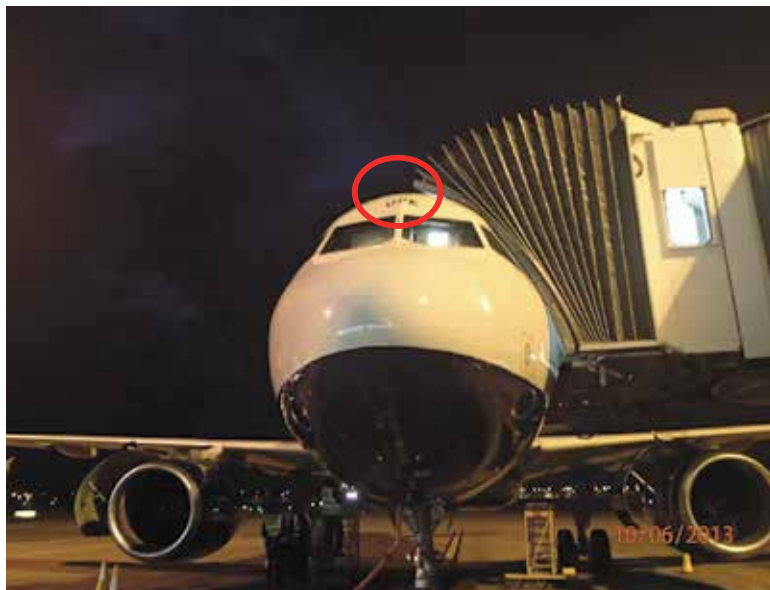
Figure 5

Nevertheless, there are identifiable differences between aircraft. The A321 (G-EUXI) is markedly longer than the A319 (G-EUOE), being as it is a stretched version of the aircraft. Moreover, each aircraft has its unique registration, which is marked in several places around the aircraft. For a road approach from the terminal, the nearest markings are above the flight deck windscreen (where the last three characters of the registration appear; Figure 5) and on the nose gear door (the last two characters are marked; Figure 6).

Aircraft registration markings above the flight deck (circled)

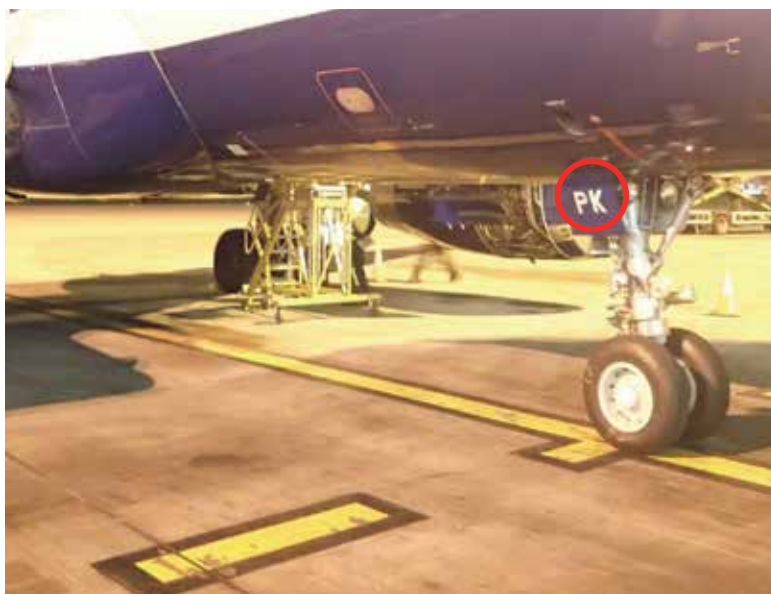
**Figure 6**

Aircraft registration markings on the nose gear door (circled)
