**FRICTION CHARACTERISTICS  
OF HELIDECKS ON OFFSHORE  
FIXED-MANNED INSTALLATIONS**

I Beaty, Cranfield University

REPORT PREPARED BY COLLEGE OF AERONAUTICS  
FLIGHT SYSTEMS AND MEASUREMENT LABORATORIES,  
AIRCRAFT GROUND OPERATIONS GROUP  
AND PUBLISHED BY  
**CIVIL AVIATION AUTHORITY, LONDON, MARCH 1998**

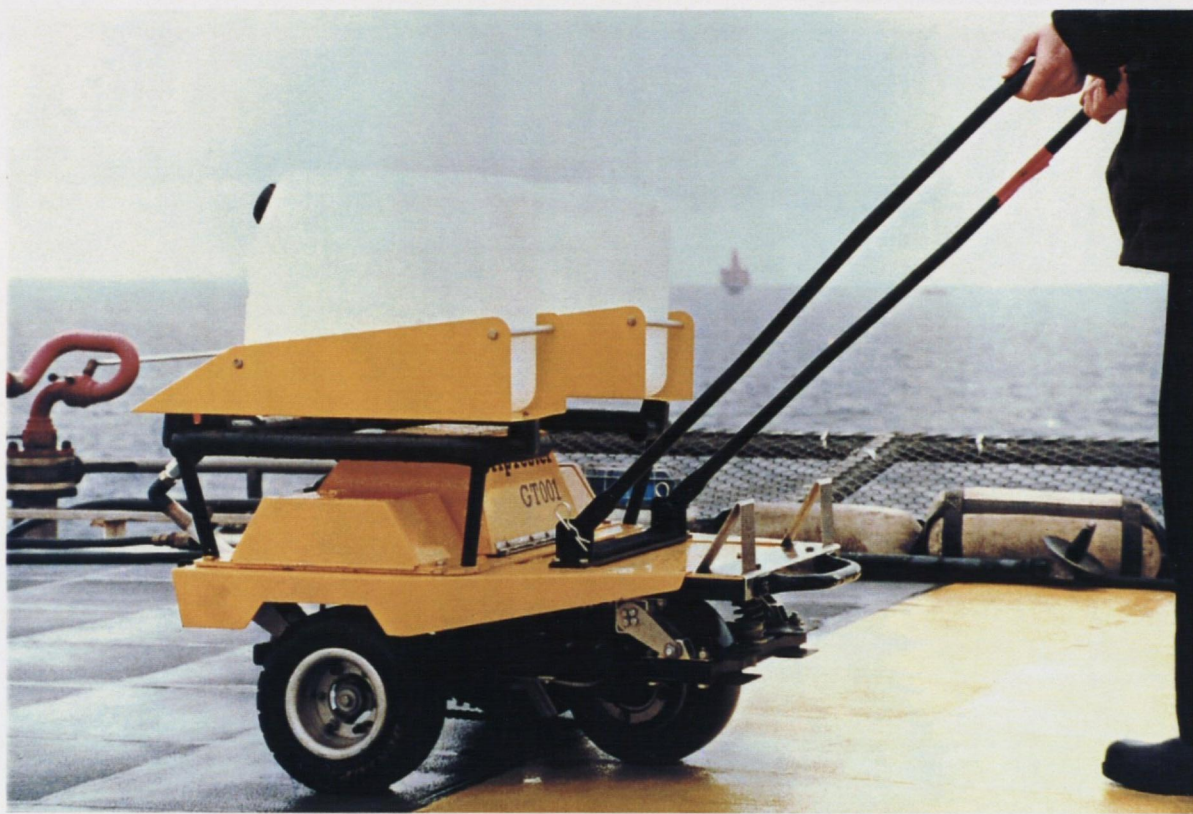
Figure 1 Grip Tester

- 1.3.6 The GripTester (Figure 1) was designed and developed in response to the specification. The machine is a relatively small (80kg) three wheeled trolley whose measuring wheel travels at 85% of the forward speed with the consequent drag measured and related to the friction measurement. It is described in greater detail in para 2.5 of this report. The GT was conceived to be air transportable, but required the removal of passenger seats from the helicopter. Subsequent increases in seat costs and changes in operating procedures have meant that the GT is now shipped to platforms in a container, which can result in long delays. The current level of testing (approximately 17 decks in 1995) is approaching the maximum for a single GT when delays due to weather and transport are considered.

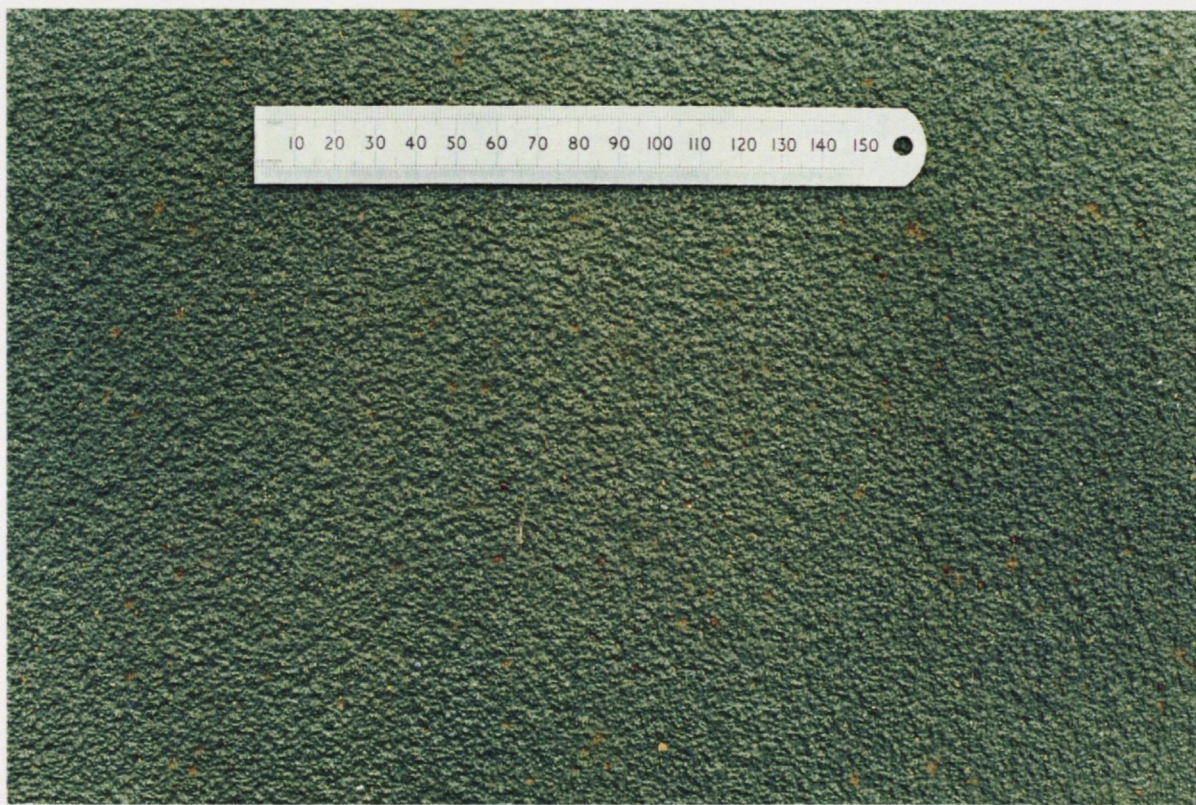
Figure 2 Sealcoat Green Deck Surface

2.3.2 The experimental epoxy surfaces were manufactured and laid by Safeway Traffic Products Ltd. The overall surface finish on the helideck was 'Sealcoat Green' (Figure 2) whilst the markings were also of the same epoxy finish, but with an added pigment to give 'Safeflor Yellow' (Figure 3) on the aiming circle and 'Safeflor White' on the 'H' and the platform name. The yellow and white pigmented areas contain retro-reflective materials for improved visibility at night.

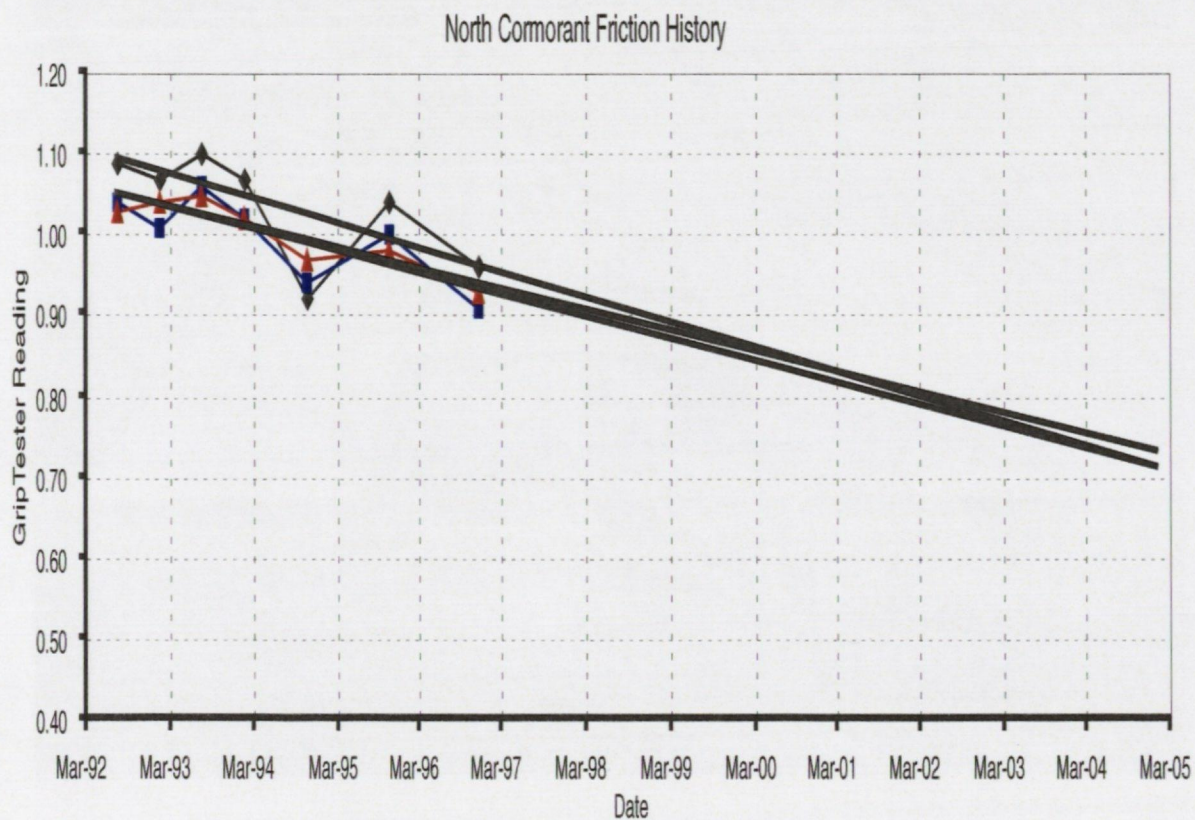
Figure 8 North Cormorant Friction History Showing Extended Trendlines

- 2.8.2 Table 2 is a summary of the friction values since the beginning of the project.
- 2.8.3 The friction values on this helideck have remained high throughout its life to date, but the overall trend in friction readings is downward (Figure 7). Extended trendlines in Figure 8 will cross the 0.7 $\mu$  level at the end of 2005. It should be noted that the test in October 1994 was the only one performed on a wet deck.
