AIR TRANSPORTATION SAFETY INVESTIGATION REPORT A17C0146

LOSS OF CONTROL AND COLLISION WITH TERRAIN

West Wind Aviation L.P.
Avions de Transport Régional ATR 42-320, C-GWEA
Fond-du-Lac, Saskatchewan
13 December 2017

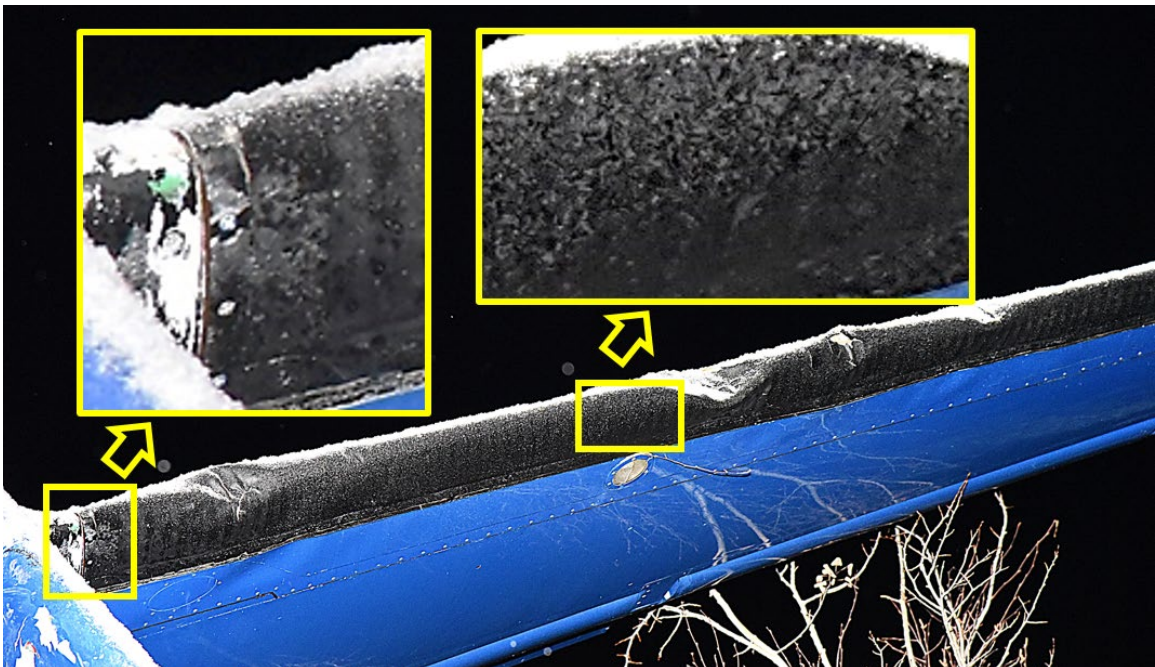
Figure 16. Photo of left horizontal stabilizer, with 2 inset images showing ice contamination on leading edge (Source: Royal Canadian Mounted Police, with TSB annotations)

Examination of photographs taken by the Royal Canadian Mounted Police (RCMP) about 8 hours after the accident revealed the presence of ice contamination on the aircraft (figures 16, 17, and 18). Although ground icing conditions persisted following the crash, these figures provide some indication of the contamination present on the aircraft during the occurrence flight.

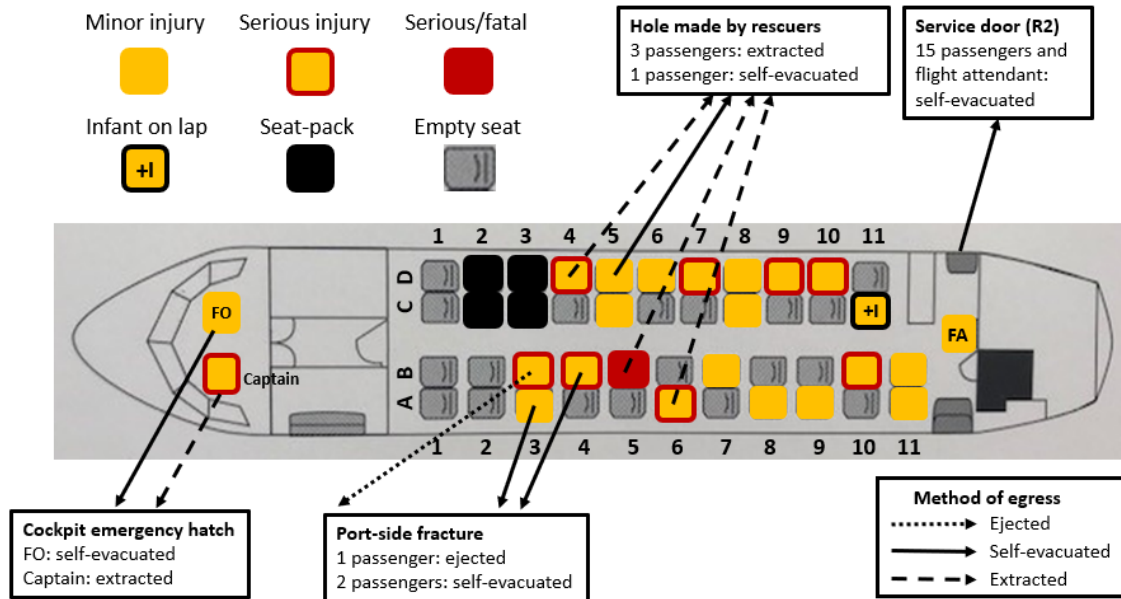
Figure 33. Seating plan of occurrence aircraft showing locations of injured passengers and methods of egress for all aircraft occupants (Source: Avions de Transport Régional, Cabin Crew Operating Manual, Revision no. 4 [April 2018], with TSB annotations)

Figure 33 shows the methods of egress for all aircraft occupants. More details on the evacuation of the aircraft are provided in the following sections.

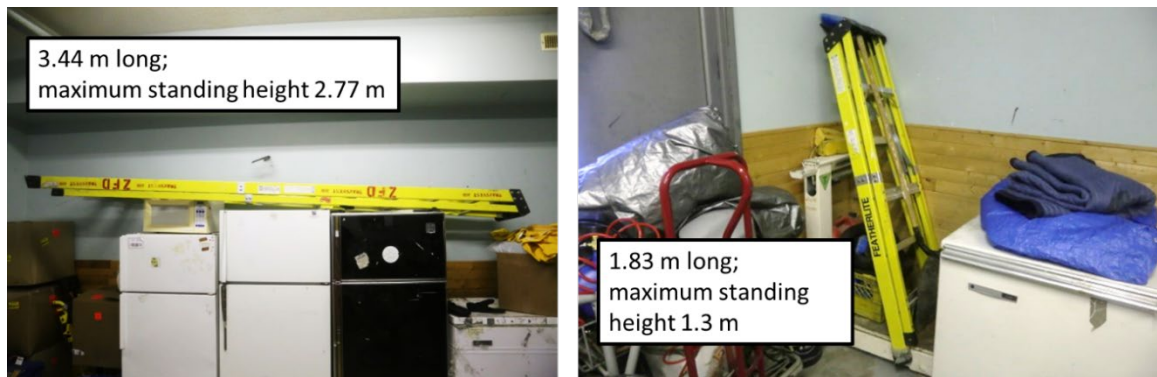
Figure 37. Photos showing ladders available at the Fond-du-Lac Airport terminal (Source: TSB)

At CZFD, there was no equipment available that would enable someone to visually inspect the top portion of an ATR 42’s critical surfaces, given their height, nor to reach them to apply de-icing fluid. The only equipment available were 2 ladders, 1 approximately 3.44 m and the other 1.83 m (Figure 37). The 3.44 m ladder had a maximum standing height of 2.77 m.

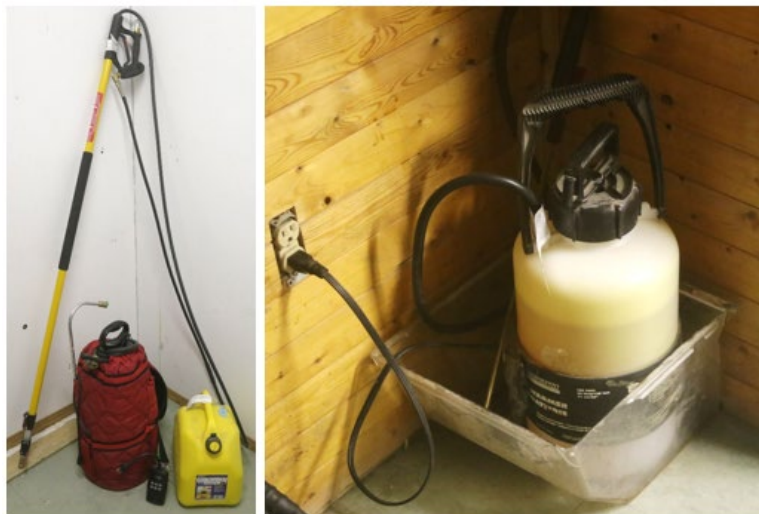
Figure 38. De-icing equipment available at Fond-du-Lac Airport: West Wind's equipment on left, another operator's equipment on right (Source: TSB)

West Wind's de-icing spray equipment at CZFD consisted of a hand-held spray system with a small-capacity heated fluid reservoir and 20 L container of additional type I fluid.²⁶⁹ Another air operator also had a small (20 L), heated hand-held spray system in the terminal building that was available to West Wind personnel on request (Figure 38).

Published de-icing standards recommend that the fluid quantity required to de-ice an aircraft is 1 L/m² of aircraft surface. In the case of an ATR 42 aircraft, more than 66 L would be required.²⁷⁰
