Runway overrun Onur Air

Runway overrun after rejected take-off of the Onur Air MD-88, registration TC-ONP, at Groningen Airport Eelde on 17 June 2003

The Hague, 6 April 2006 (investigation number 2003071)

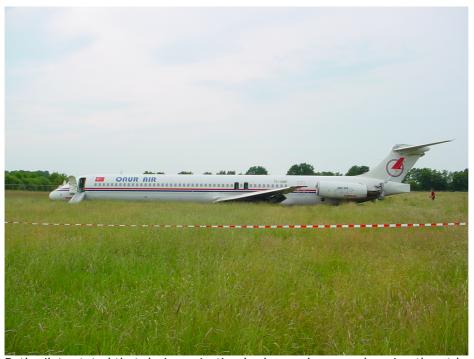
When attempting to rotate the captain experienced a heavy elevator control force. The captain stated that he needed much more than normal back pressure on his control column to lift the nose. He felt "it was impossible to make the take-off", and as the nose did not rise he decided to reject the take-off. Post accident analysis revealed that the rejection was initiated at 128 knots.

Both pilots stated that during rejection brakes and reversed engine thrust had been applied, which is confirmed by the FDR readout. The aircraft overran the runway end with a speed of approximately 75 knots. During the deceleration in the soft soil, it hit the approach lighting system, including the concrete structures embedded in the ground. It came to a stop approximately 100 meters beyond the runway end. There was no fire. All occupants evacuated the aircraft safely. Some of them returned to the aircraft and re-entered it, to pick up their belongings. In addition, the pilots remained on board and only left the aircraft when instructed to do so by the fire brigade.

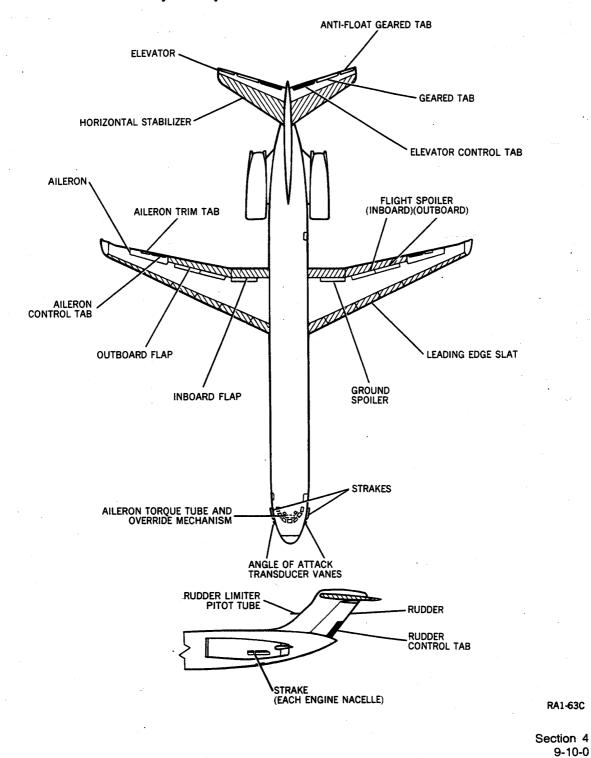
Figure 1: flight crew operating manual 9-10-0 page 1/2.

Each control tab is directly driven by an independent two-way cable system from the corresponding control column (one system for the captain and one for the co-pilot) in the cockpit. The left and right elevator surfaces are not interconnected, but only linked to their own separate driving system. Both control columns are interconnected enabling both left and right system to work in unison. An illustration of the longitudinal control surfaces is shown in figure 1 (next page).

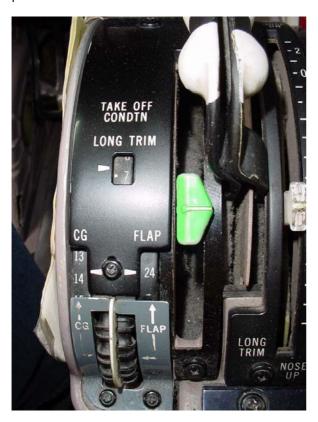
Figure 2: pedestal take-off condition computer.

The stabilizer take-off setting is determined by entering the calculated CG value from the load and trim sheet and the required flap setting in the pedestal mounted take-off condition (mechanical) computer. The stabilizer calculated numeric outcome will appear in the take-off condition long trim window. The crew have to set the horizontal stabilizer by running the stabilizer till the take-off position indicator matches the long trim window numeric outcome, see also the picture left.

By rotating the CG and the flap thumbwheels (See figure 2 Appendix D) the assumed TO-CG and required flap setting for take-off are selected. This drives a rotating scale showing the numeric outcome in the long trim readout window and also a green arrow pointing to the stabilizer position indicator scale. The numeric outcome in the window and the value shown by the green pointer (i.e. the green arrow head with the white arrow in the middle) correspond. See also figure 2 in Appendix D part A.

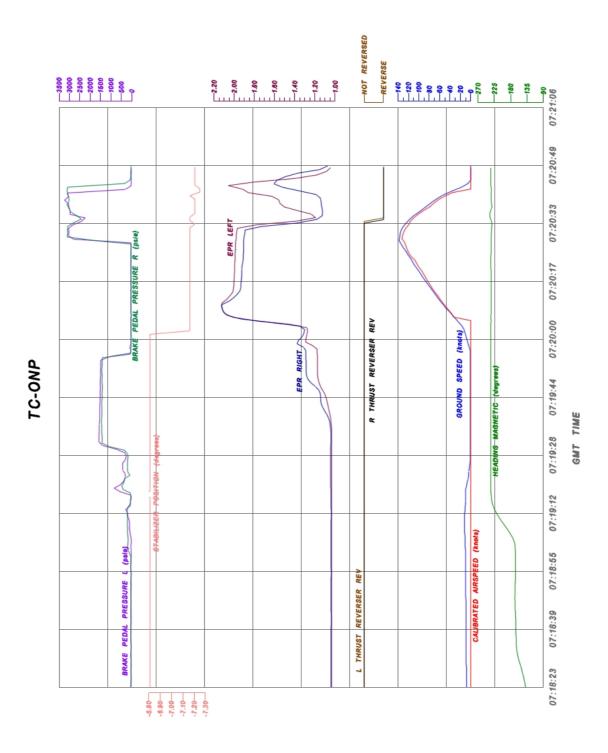
FDR data plot

On the runway checks were performed. FDR data indicated a stabilizer position change from 6.8 to 7.2 degrees aircraft nose up (ANU). Thereafter the crew initiated a static engine spin-up. Again the stabilizer warning sounded. The crew released the brakes and started the take-off roll. From the CVR it is derived that during the entire take-off roll the warning sounded continuously.
