COMMISSION OF
INQUIRY INTO THE
AIR ONTARIO CRASH
AT DRYDEN, ONTARIO

Final Report

Volume I

By Order in Council PC 1989-532 dated the 29th of March, 1989, I was appointed Commissioner to inquire into the contributing factors and causes of the crash of Air Ontario Flight 1363 Fokker F-28 at Dryden, Ontario, on March 10, 1989, and report thereon, including such recommendations as I may deem appropriate in the interests of aviation safety.

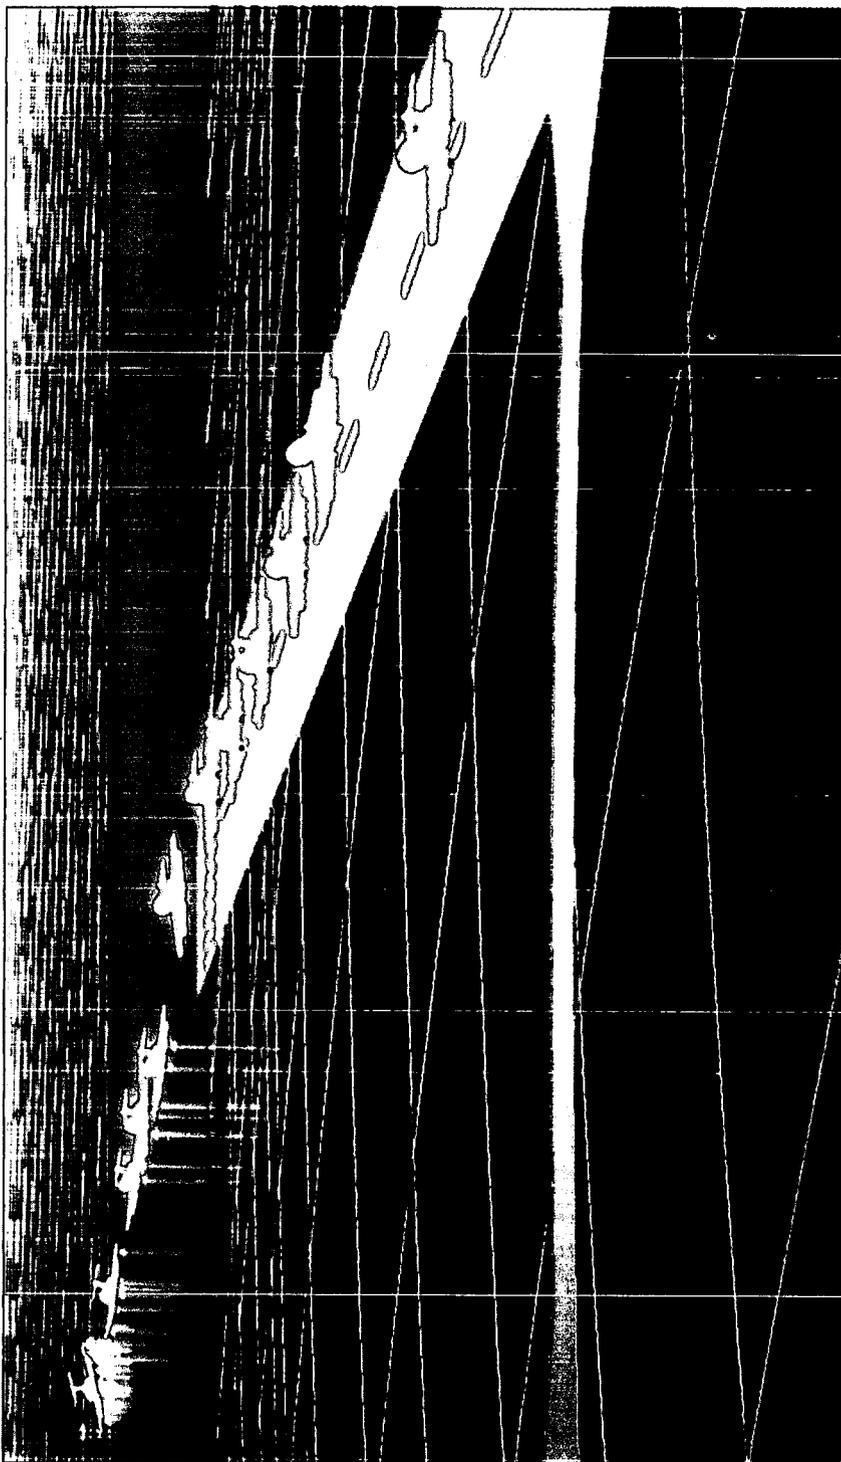
Computer-generated reconstructions of the takeoff were prepared for the Commission of Inquiry by the Canadian Aviation Safety Board (CASB) as part of the investigation of the crash. The first shows the aircraft from the perspective of the terminal: passing taxiway Alpha, attempting liftoff, settling back onto the runway, lifting off again towards the end of the runway, and contacting trees.

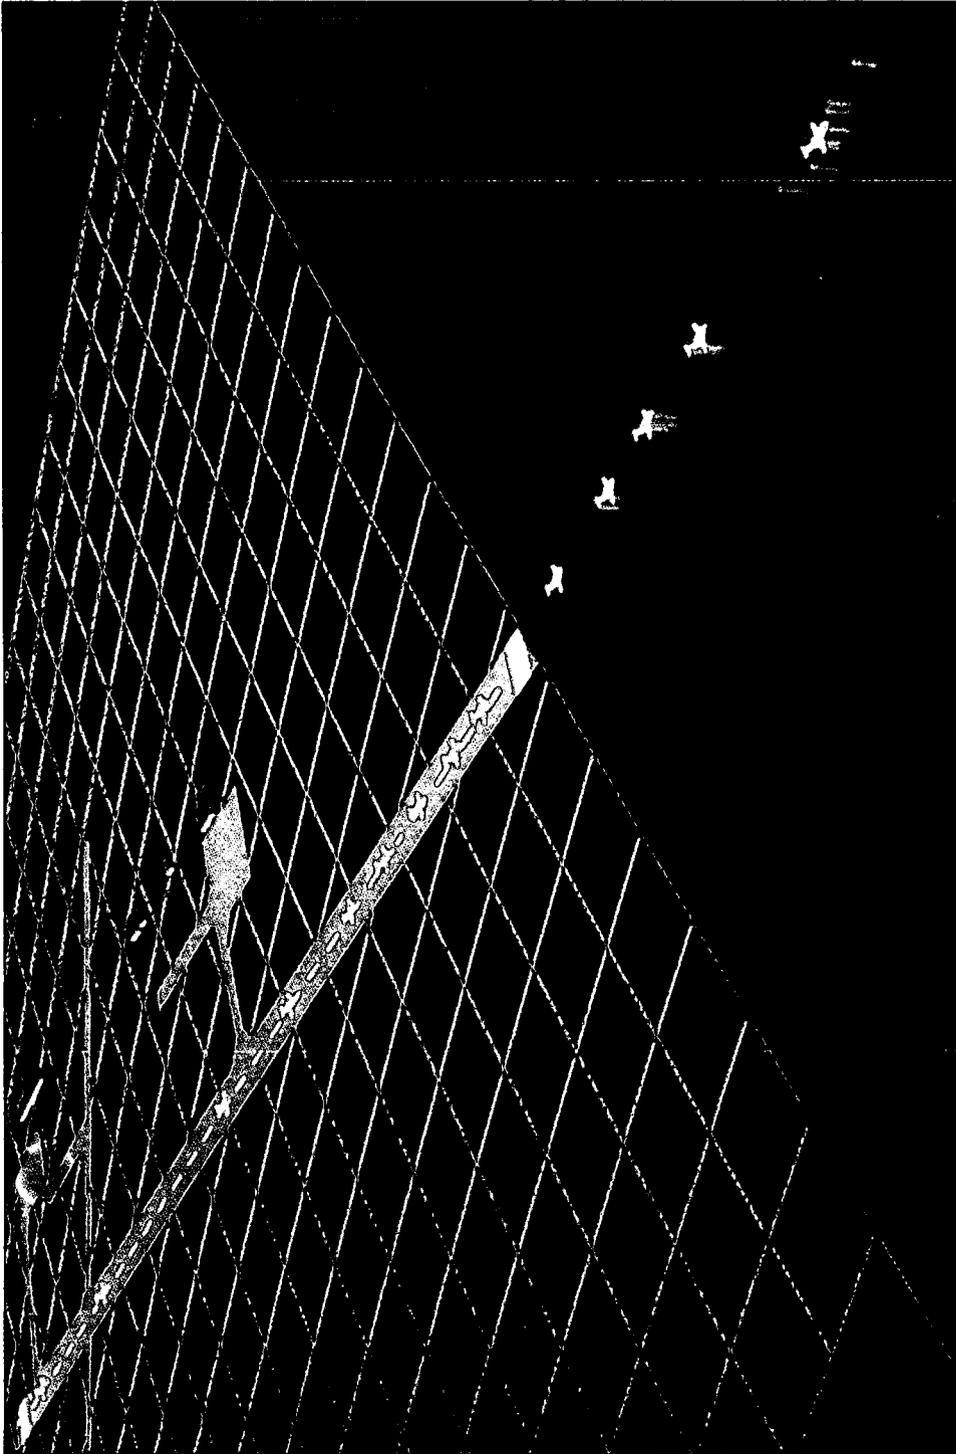
This reconstruction gives an aerial view of Dryden Municipal Airport and the takeoff attempt of flight 1363 on runway 29 on March 10, 1989.

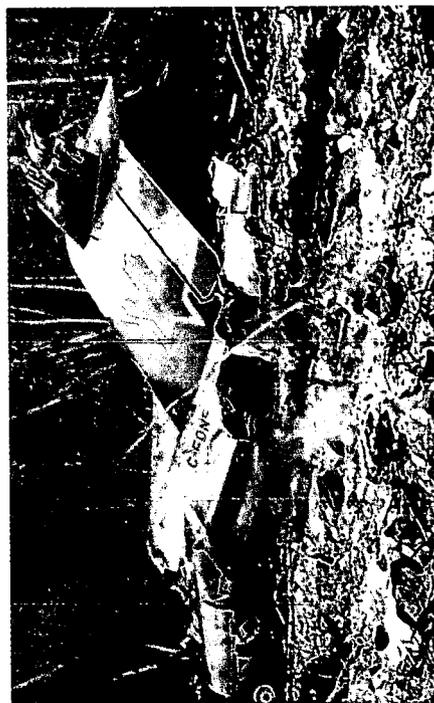
These photographs, taken by one of the fire-fighters in mid-afternoon March 10, 1989, convey the intensity of the fire which, by this time, is nearly extinguished.

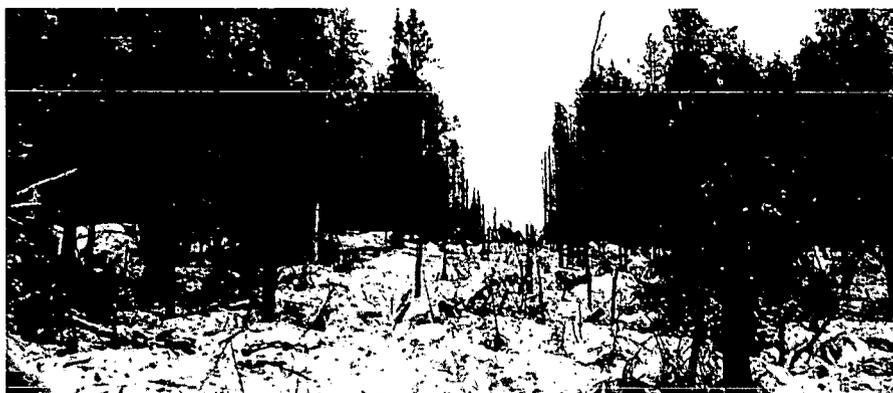
The wreckage trail looking east from the site of the crash

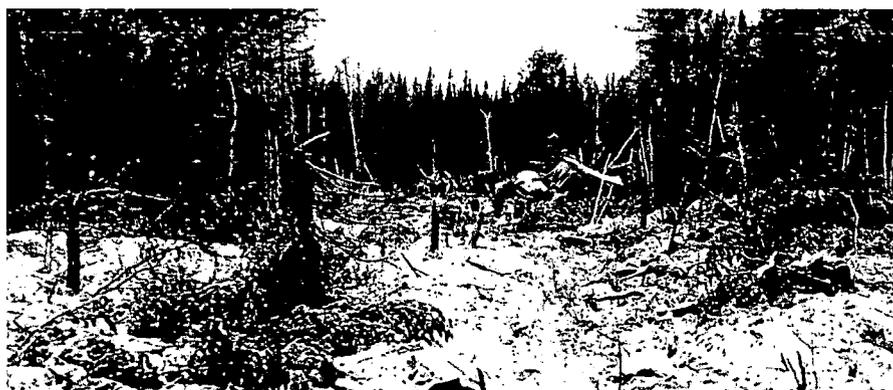
The wreckage trail looking west towards the wreckage from part way along the trail

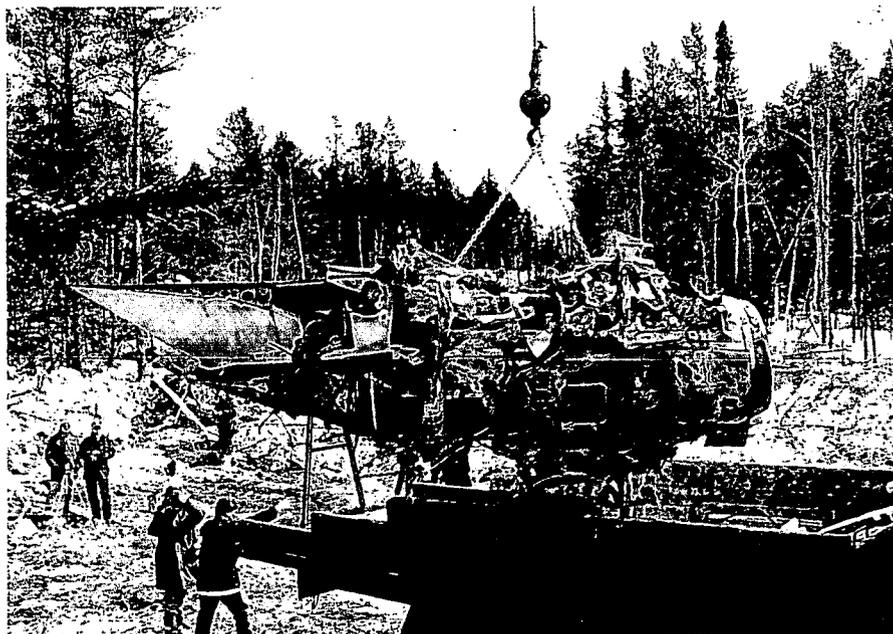
The wreckage was carefully photographed in situ at the crash site by the investigators: top, right engine; bottom, rear section of the right side of the fuselage.
