KOMITE NASIONAL KESELAMATAN TRANSPORTASI REPUBLIC OF INDONESIA

FINAL KNKT.19.05.10.04

Aircraft Accident Investigation Report

PT. Batik Air Indonesia Airbus A320; PK-LZJ Sultan Hasanuddin International Airport Republic of Indonesia 25 May 2019

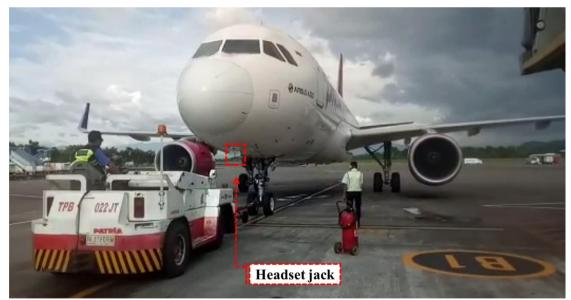
Figure 1: The common push back activity and the location of headset jack on typical Airbus A320

The headset jack (connector) for headset-man to plug his headset was located in the nose area of the aircraft (see figure 1).

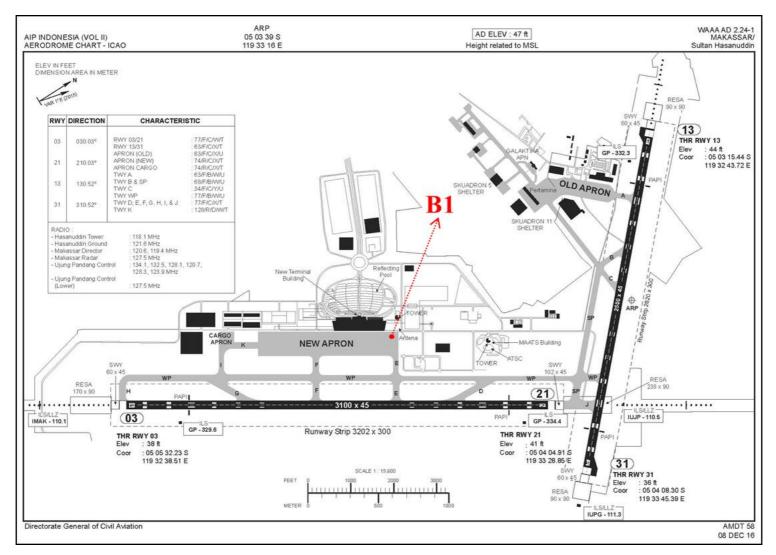
Figure 2: The apron layout

A few meters after following the straight lead-in line, the towing tractor driver maneuvered the towing tractor to the left and made the aircraft facing north. This maneuver made the aircraft out of the straight lead-in line provided, with intention to provide sufficient space when maneuvering aircraft to face south west (see figure 2 for the detail apron layout and figure 4 for the aircraft maneuver illustration).

The airport had two runways (03-21 and 13-31), 13 taxiways, three aprons (new, old and cargo), and 37 parking stands. The airport layout can be seen on figure 2.

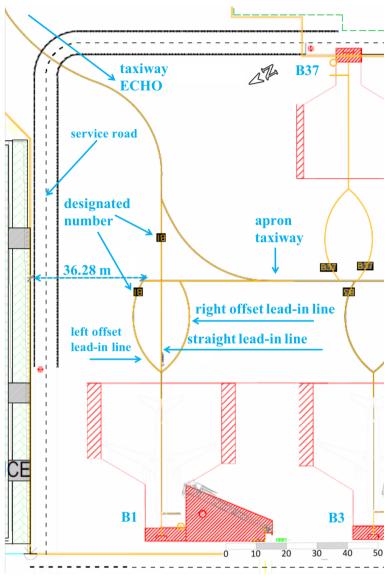
Figure 3: Parking stand B1 layout

The right offset lead-in line could not be used for taxi in guidance, as there was no taxi route from north east direction. The left offset lead-in line is used for aircraft which taxi from taxiway FOXTROT (south-west direction). The straight lead-in line is used for aircraft which taxied from taxiway ECHO (south-east direction). Therefore, the designated number of parking stand B1 only painted on the left offset nose-wheel lead-in line and straight lead-in line.

The left offset lead-in line can be used as pushback guidance for aircraft facing north east, while the right offset lead-in line and straight lead-in line were provided as pushback guidance for aircraft to face south-west direction. If the right offset lead-in line would be used for pushback guidance, the aircraft maneuver will be too close to the service road, and if the straight lead-in line would be used, the aircraft have to be pushed straight back close to taxiway ECHO until the nose wheel can taxi following the apron taxiway centerline marking.

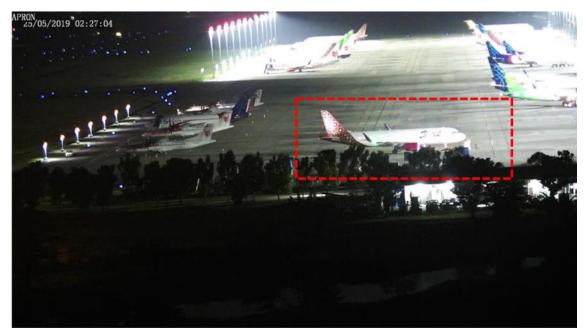
Figure 5: The aircraft as recorded by the ATS provider CCTV system

The Air Traffic Services (ATS) provider also utilized CCTV system for security purposes. One of the CCTV cameras located outside the tower building facing to the apron recorded the push back maneuver. Based on the CCTV record, throughout the pushback maneuver, the headset-man position as such that the nose wheels were behind him (figure 6).

The CCTV from the airport operator or ATS provider indicated that the apron was provided with sufficient light.

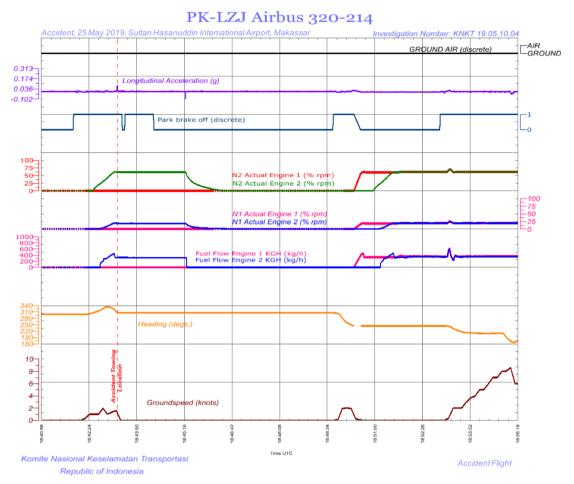
Figure 7: The relevant parameters of the FDR

The FDR of the aircraft was L-3 FDR model with part number 2100-4245-00 and serial number 001303540. The FDR was downloaded in the KNKT facility and contained data of 1,064 parameters with approximately 95 hours of aircraft operation, which was containing 40 flights including the accident flight.

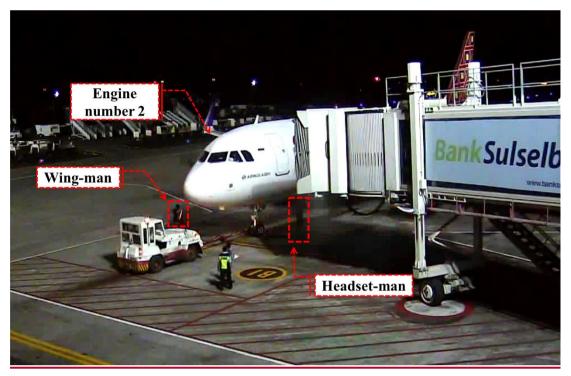
Figure 8: The view from CCTV, 4 seconds after the aircraft moved

After the bump, the towing tractor driver stopped the towing tractor and the aircraft stopped by facing south east. The aircraft was undamaged.

The location of the blood spills on coordinate $5^{\circ}4'32.86''S$; $119^{\circ}32'55.67''E$, about 50 meters from the beginning of parking stand B1, was considered as the location when the nose wheel passed over the headset-man right foot.

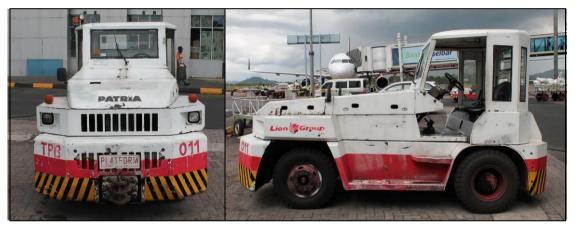
Figure 12: The towing tractor

The towing tractor manufactured by PT. United Tractors Pandu Engineering (PATRiA), Indonesia and the model PTD 50 is capable to tow Airbus A320. According to the product specification, the maximum speed for PTD 50 with forward-1 clutch is 12 km/hour and forward-2 clutch is 32 km/hour. The steering wheel of the PTD 50 is left hand drive which the steering wheel is on the left side.

Prior to the accident, there was no report or record of towing tractor system malfunction.

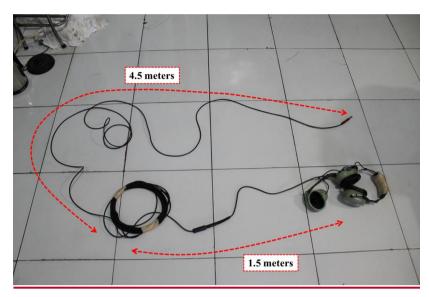
Figure 13: The headset used by the headset-man during the accident

The headset-man utilized wired headset manufactured by David Clark Company with product code of ML0715-28. During the accident the headset cable was rolled up and headset-man held the rolled-up cable. The total length the headset on rolled-up condition was 6 meters, from the headset to rolled-up cable was about 1.5 meters while from rolled-up to headset jack was about 4.5 meters. Prior to and during the accident, there was no record or report of headset malfunction.
