# AIR ACCIDENT INVESTIGATION SECTOR

## SERIOUS INCIDENT INVESTIGATION REPORT

### Pushback Collision

Airbus A330-243 [A6-EYN]  
Boeing 777-300 [A6-ETD]  
Abu Dhabi International Airport [AUH]  
Terminal 1, Stands 121 and 122  
May 06 2012

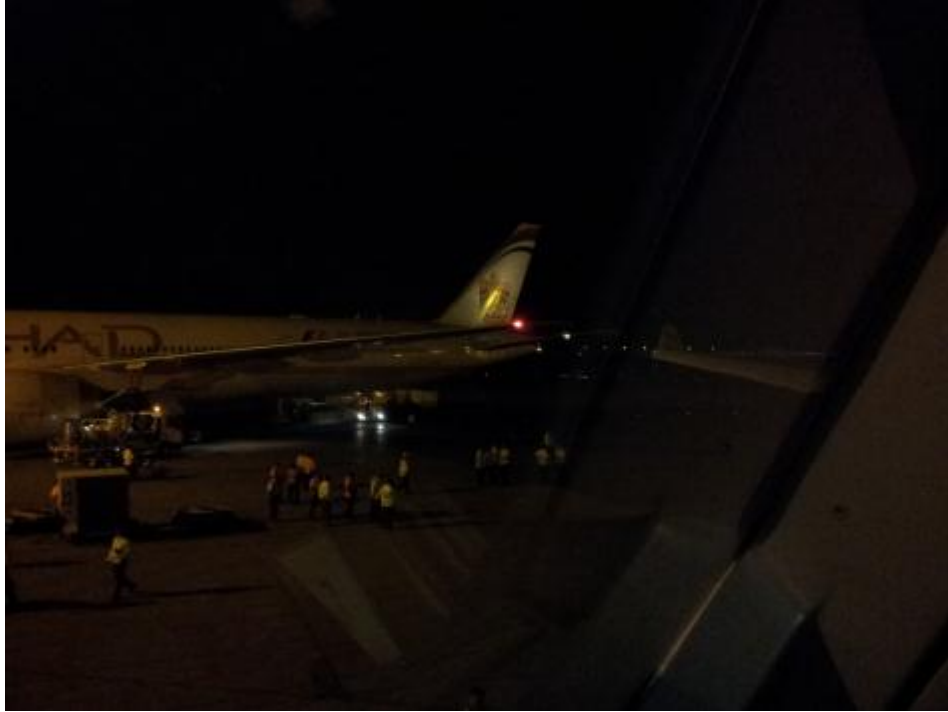
Photo 1 View from F.O. Position

Pilot's view from the First Officer position when seated, head up in the F.O. seat, with the seat restraints attached [seat belts] is limited to a cone range of 135° from the aircraft's longitudinal axis.

From 135°-180° from the static position is a wingtip blind spot. The visual field of the human eye spans approximately 120 degrees of arc from the static position, most of the arc range is peripheral vision only.

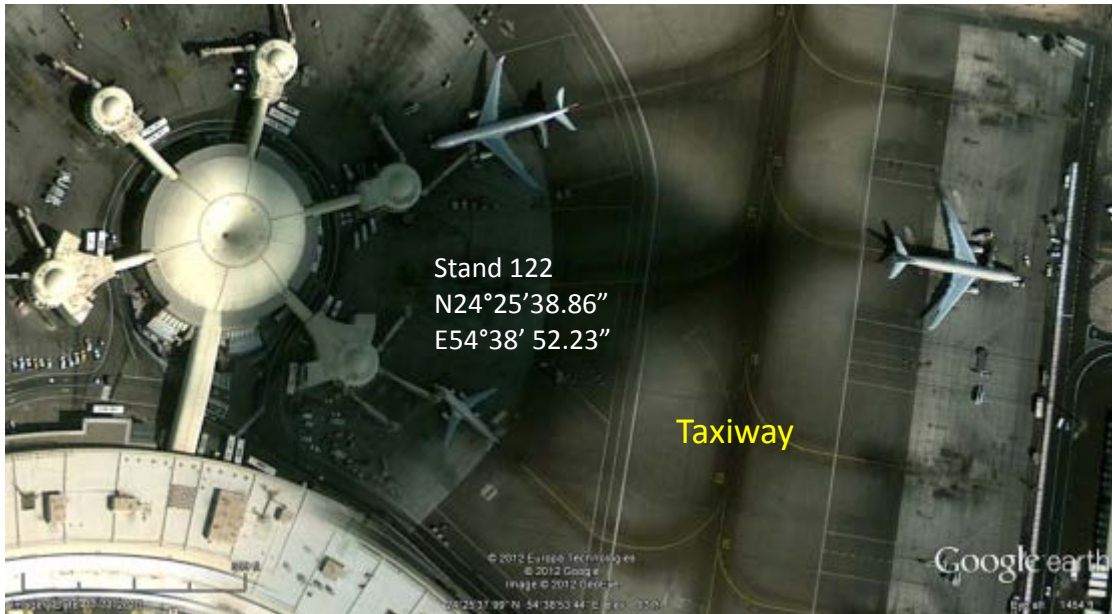
Figure 10: AUH T1 Stand 122

Overview of the parking stand position and location.

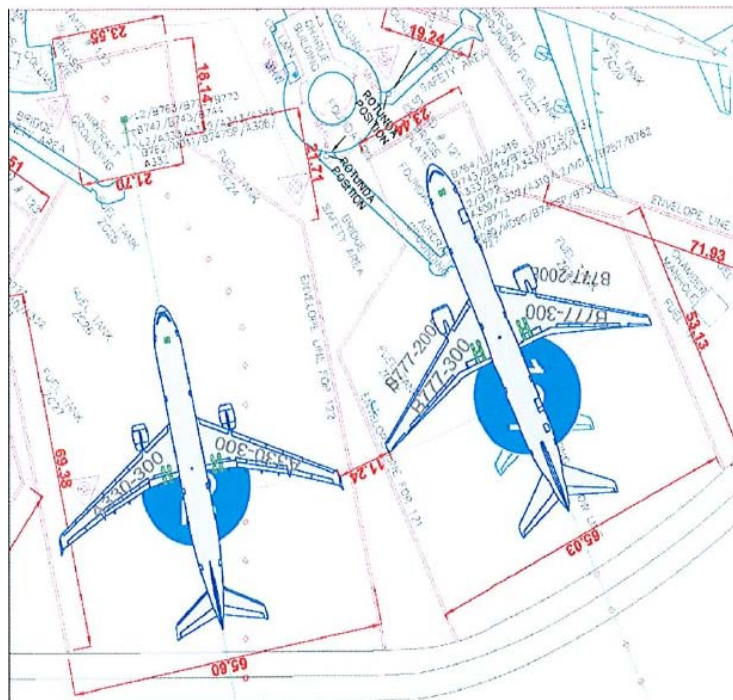
Figure 11 Stand 121/122 CAD Simulation

An airport planner computer model of the aircraft positions and wingtip clearance distances

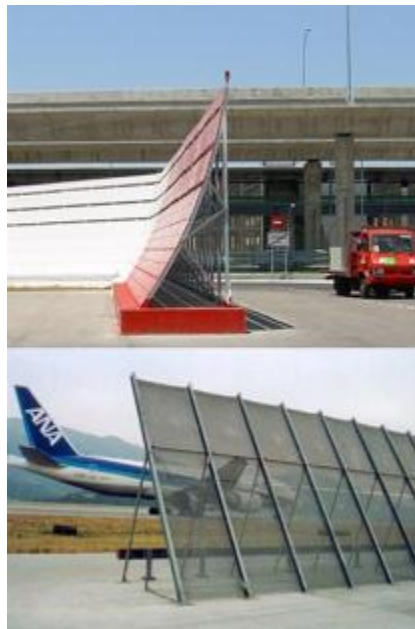
Figure 13 Jet Blast Deflectors

Jet-Blast Deflectors, Blast Screens and Blast Fences are effective and easily installed jet blast mitigation installations that allow unrestricted traffic access to boundary roads airport service roads.
