ATSB TRANSPORT SAFETY REPORT
Aviation Occurrence Investigation
AO-2009-034
Final

Aircraft loading event
Sydney Airport, NSW
4 July 2009
VH-EBB
Airbus A330-202

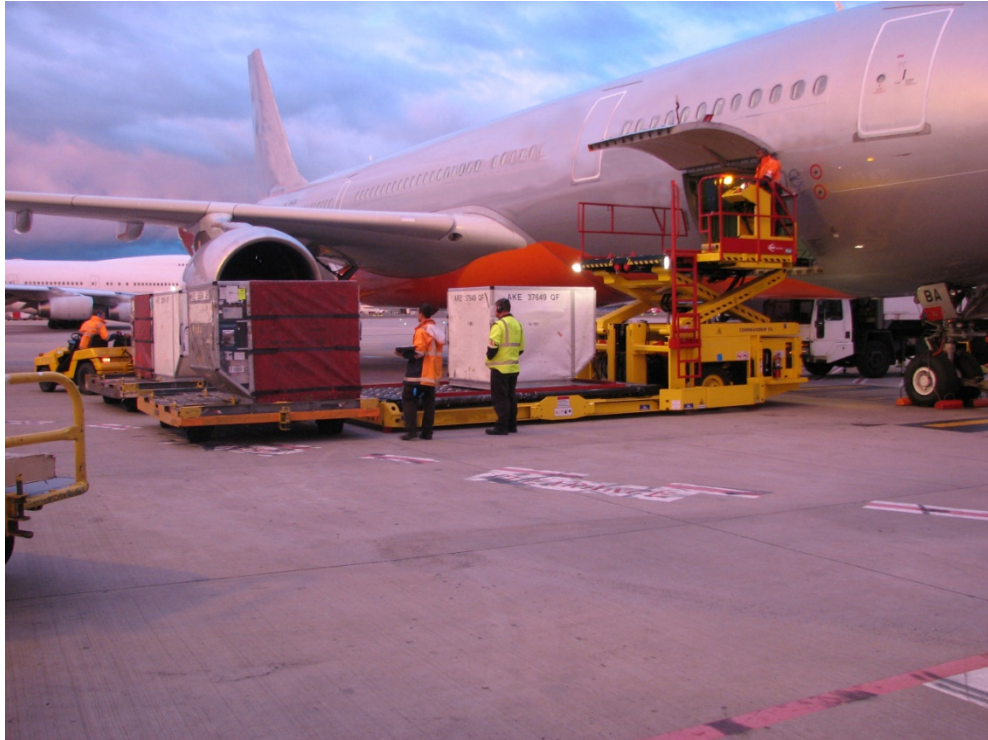
Figure 1: Typical AKE-type ULD loading into an A330 forward hold

Ground handling personnel began loading the freight to the aircraft's forward cargo hold by progressively transferring the ULDs onto the loader (Figure 1 shows a typical loading process). The loader operator, assisted by one of the ground handling company ramp trainers, used the loader to elevate each ULD to hold height and transfer it into the hold. Further movement to the specific position in the hold as depicted on the load instruction report (LIR)³ was achieved using the aircraft's in-hold conveyer system.

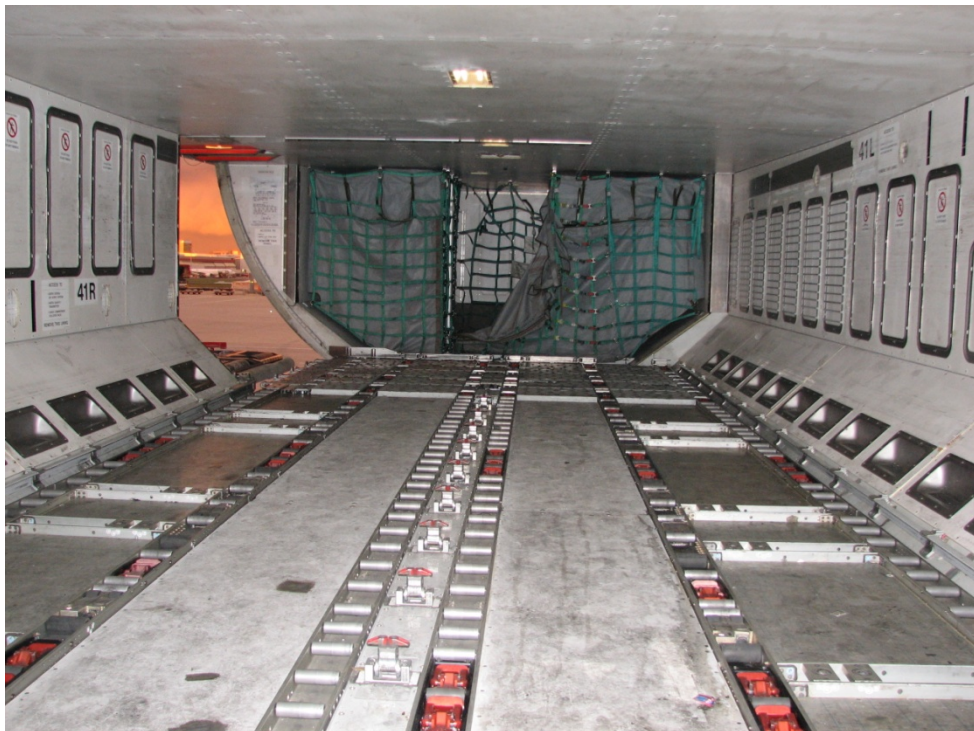
Figure 2: Typical A330 aft cargo hold (looking aft)

The A330 is a wide-body aircraft with underfloor cargo hold areas used for the carriage of baggage and freight. As is typical of wide-body aircraft, all of the freight in the main cargo holds was containerised. That required specialised loading equipment with operators trained in the use of the equipment and in-hold methods of positioning and securing freight (Figure 2). The loading of wide-body aircraft was generally considered to be a more complex operation than the loading of smaller, narrow-body aircraft in which freight was predominantly handled manually.
