OCCURRENCES

Cracking job

Sorting a problem doesn't have to be an issue

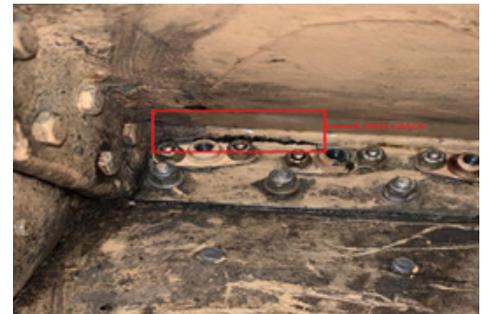
During an annual maintenance inspection on an Avions Max Holst MH 1521 'Broussard' in 2021, longitudinal cracks were found in an undercarriage bracket.

The engineers were initially alerted to the problem due to a deformation or skin ripple effect forward of the 'letterbox' fitting, initially on the left-hand side and then subsequently in the starboard undercarriage leg outboard lower support bracket ('letterbox bracket').
