CAP 476 – MANDATORY AIRCRAFT MODIFICATIONS AND INSPECTIONS SUMMARY

SEPTEMBER 2004 AMENDMENT – ISSUE 287

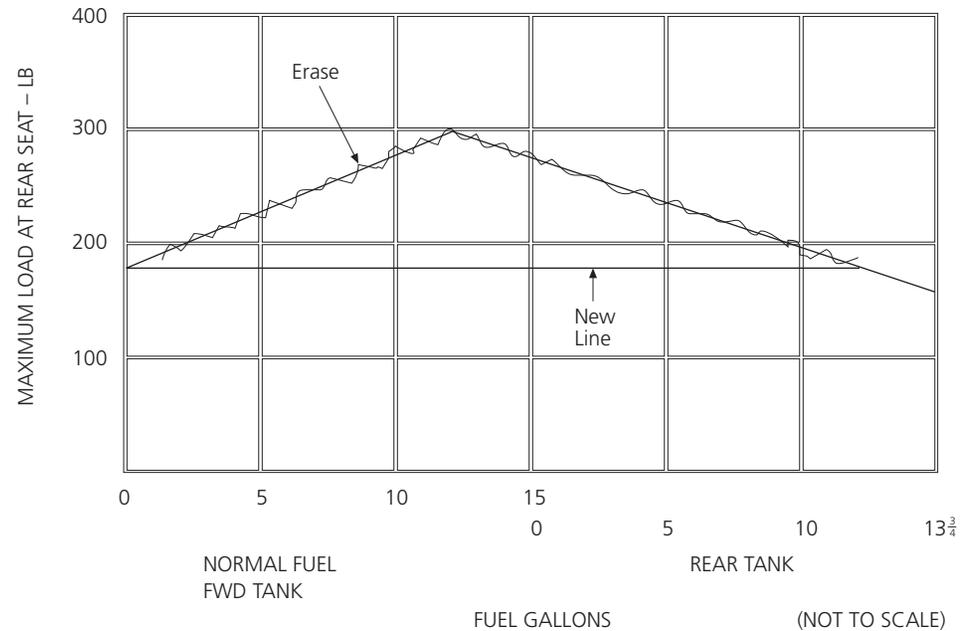
**TYPICAL REAR SEAT LOADING CHART
 FOR AUSTER AIRCRAFT WITH FORWARD FUSELAGE FUEL TANK**
