CAA PAPER 2001/2

**CRASHWORTHINESS OF HELICOPTER
EMERGENCY FLOTATION SYSTEMS**

Study I (Main Study)

Study II (Supplementary Study)

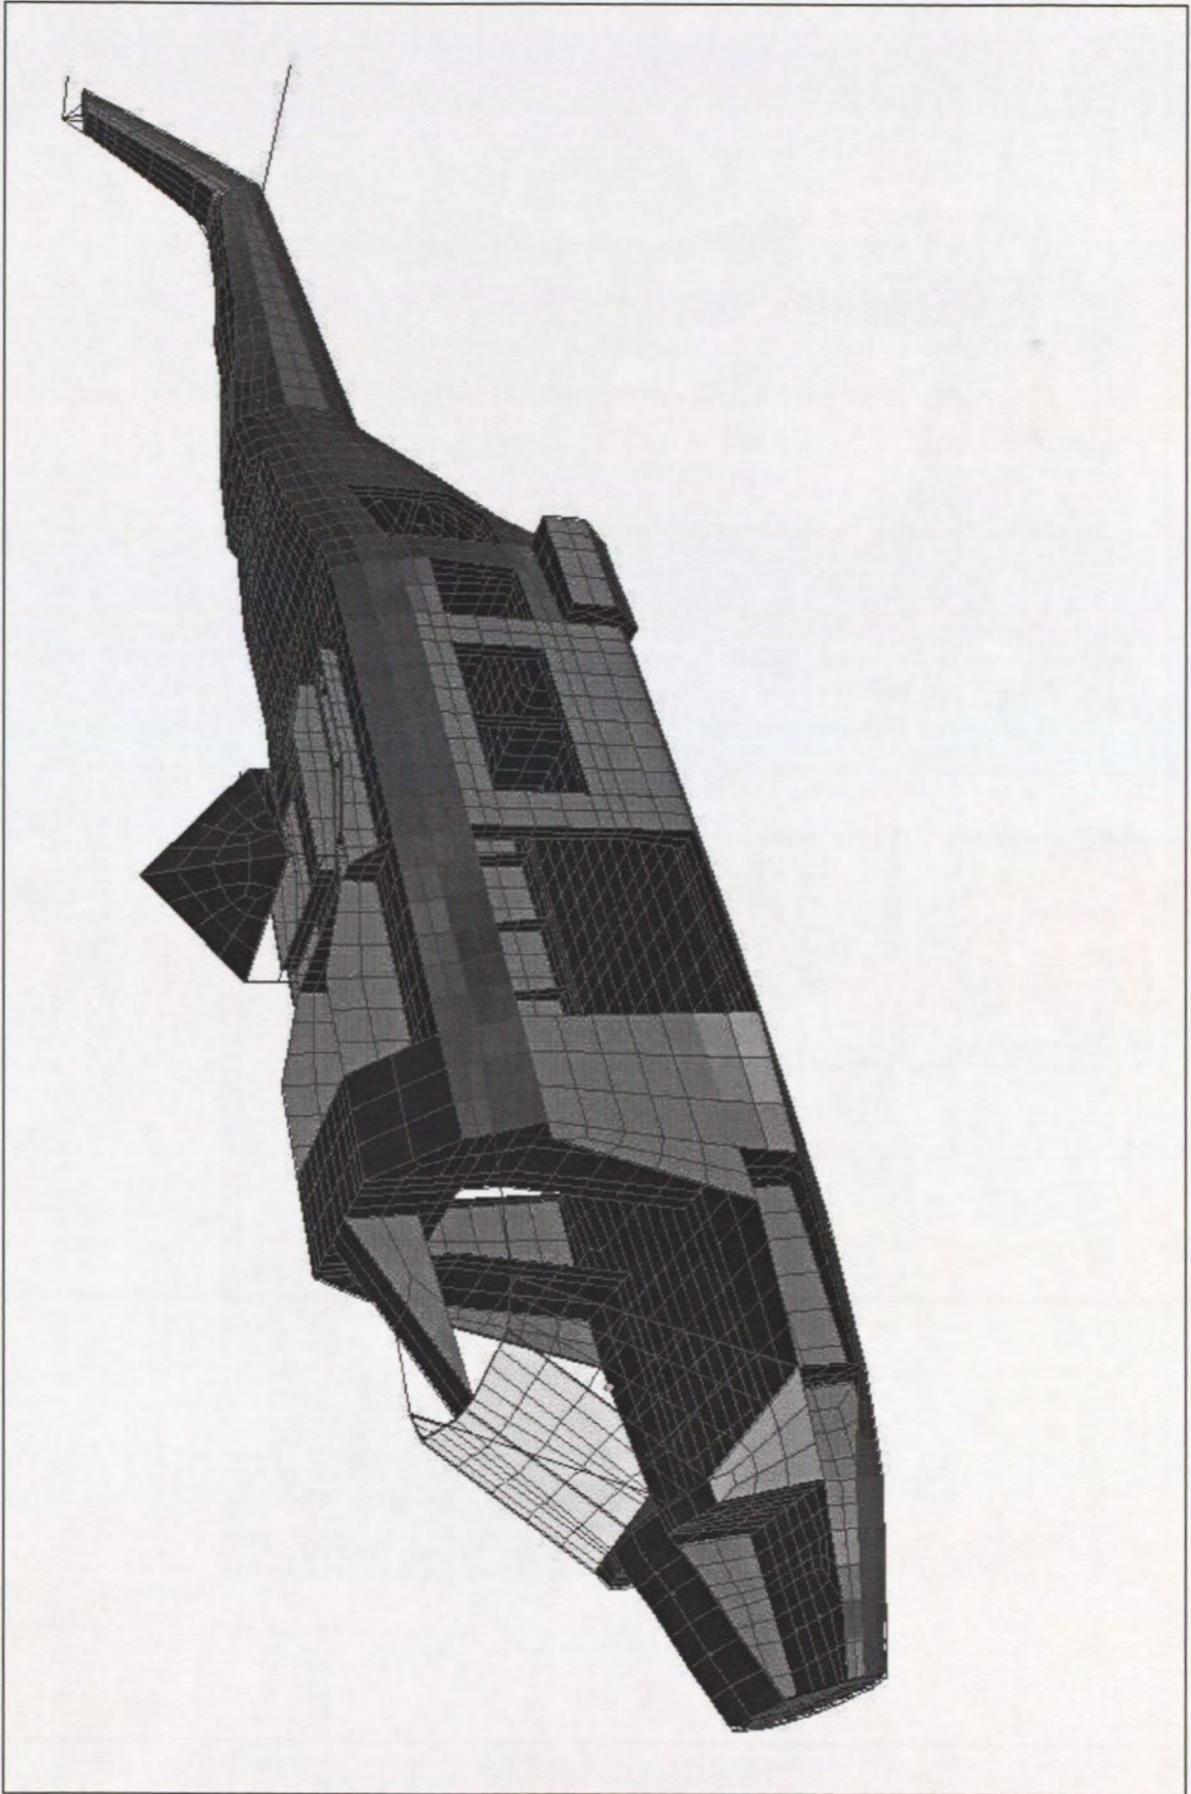
Figure 1: WG30 Finite Element Model

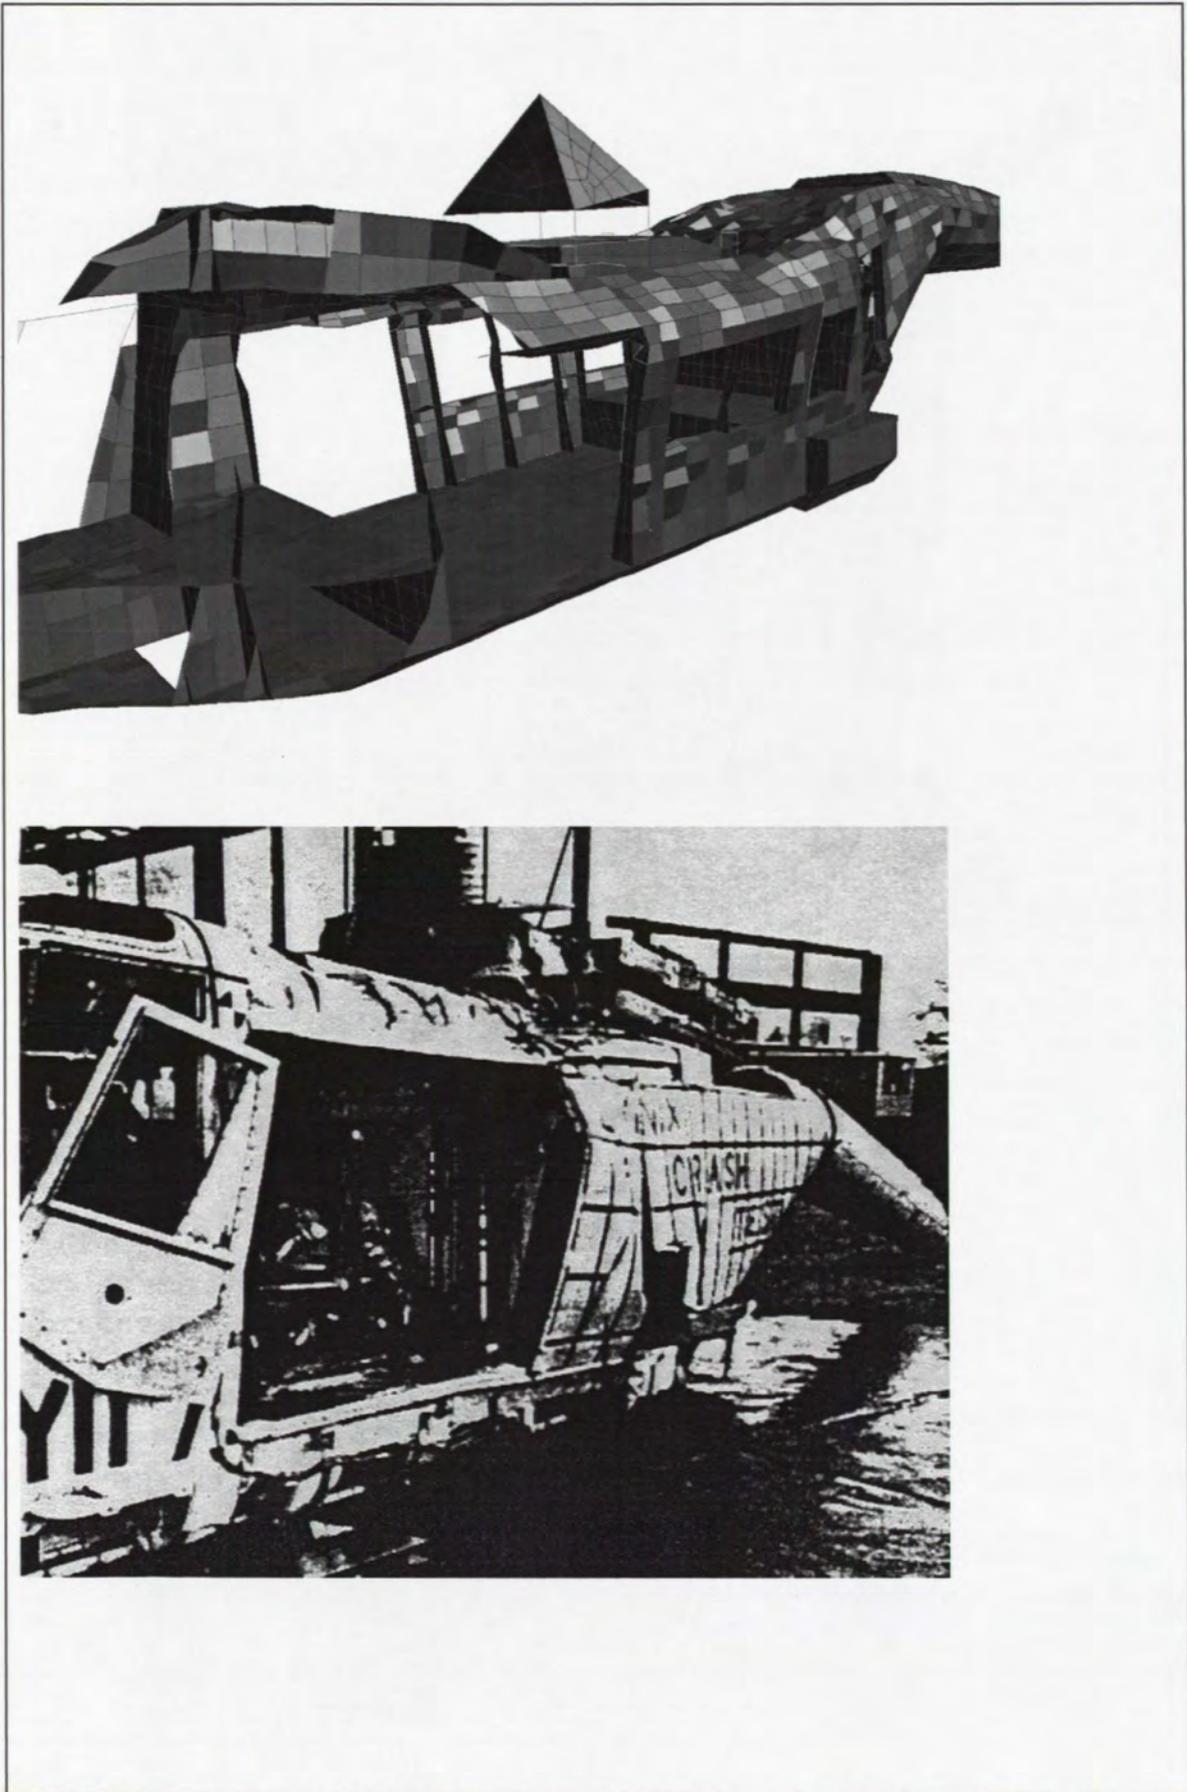
Figure 2: Cut Away of WG30 Model after Ground Impact, Together With Lynx Test Comparison

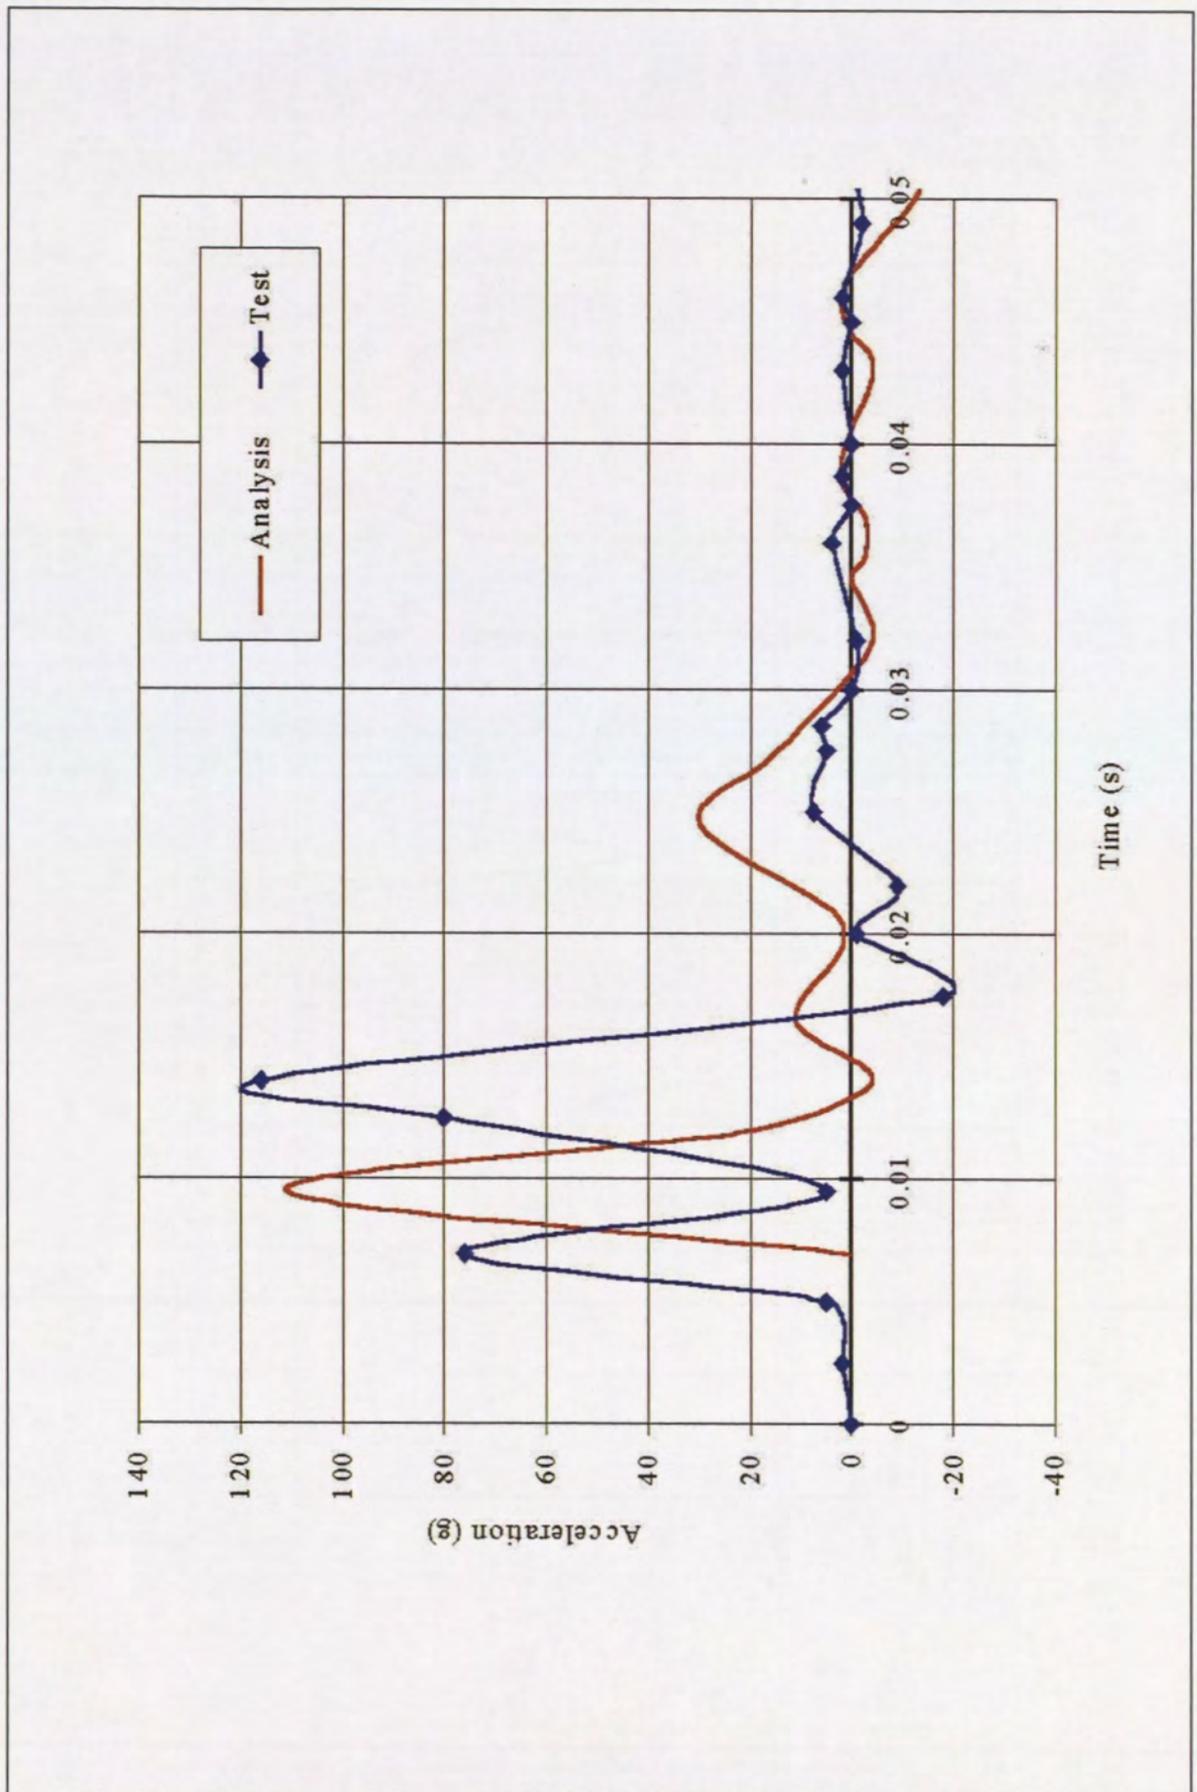
Figure 3: Acceleration Time History Pulse Recorded at Cabin Floor

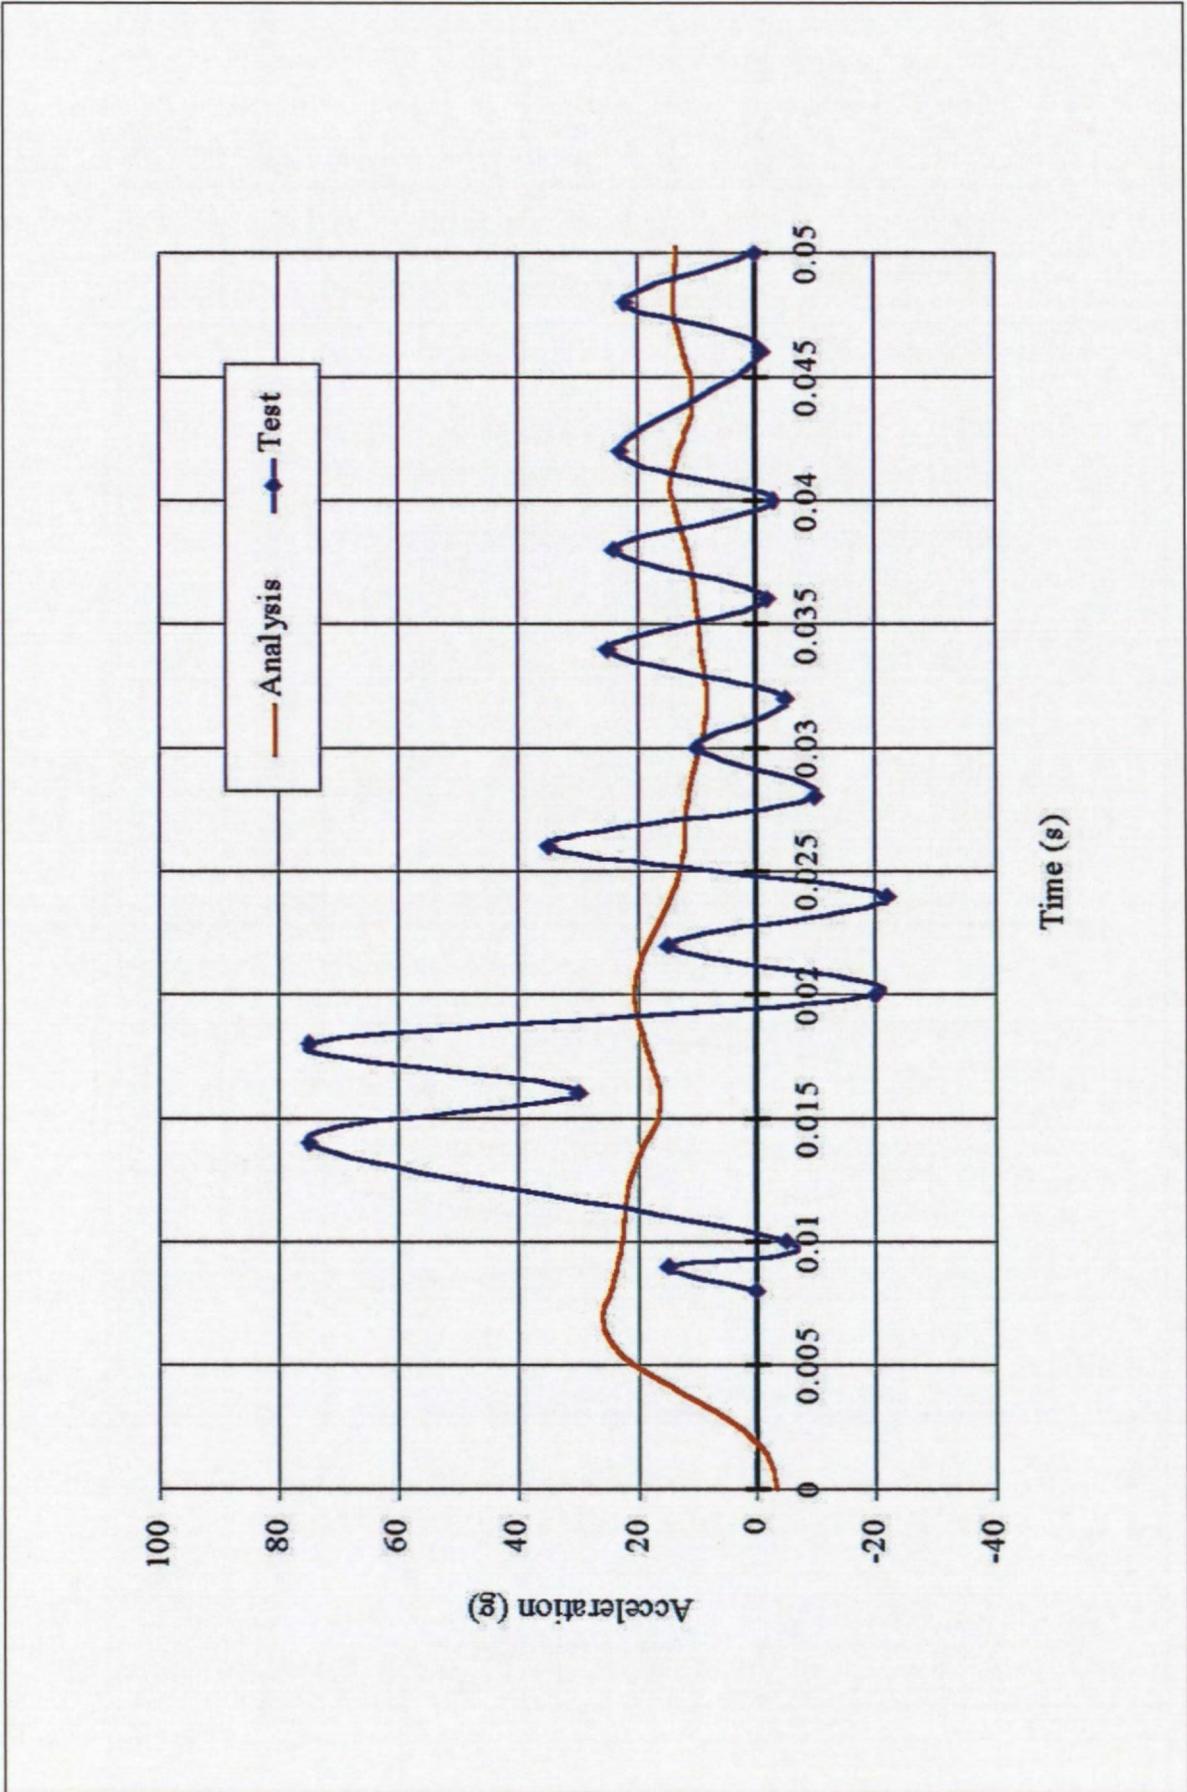
Figure 4: Acceleration Time History Pulse Recorded at Main Rotor Gearbox

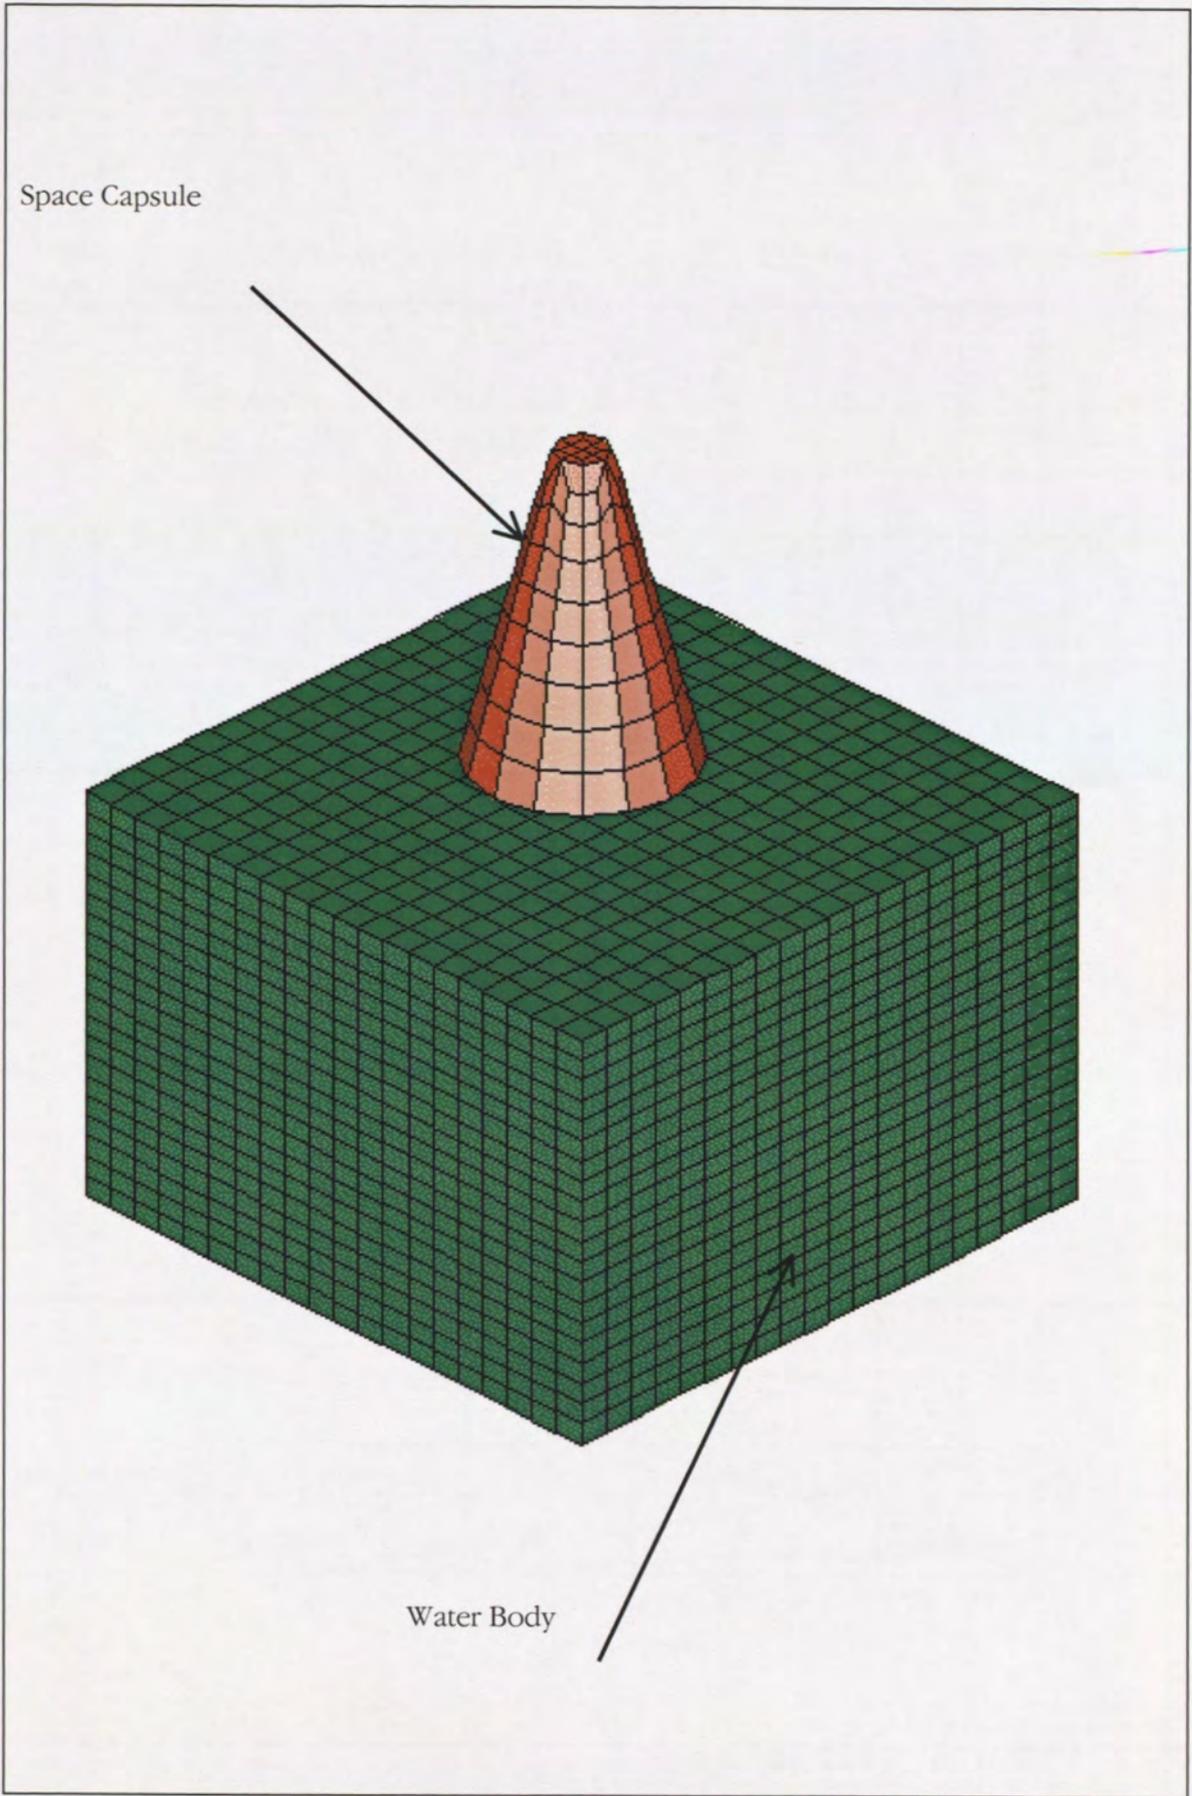
Figure 5: Arrangement of the Space Capsule Impact Scenario

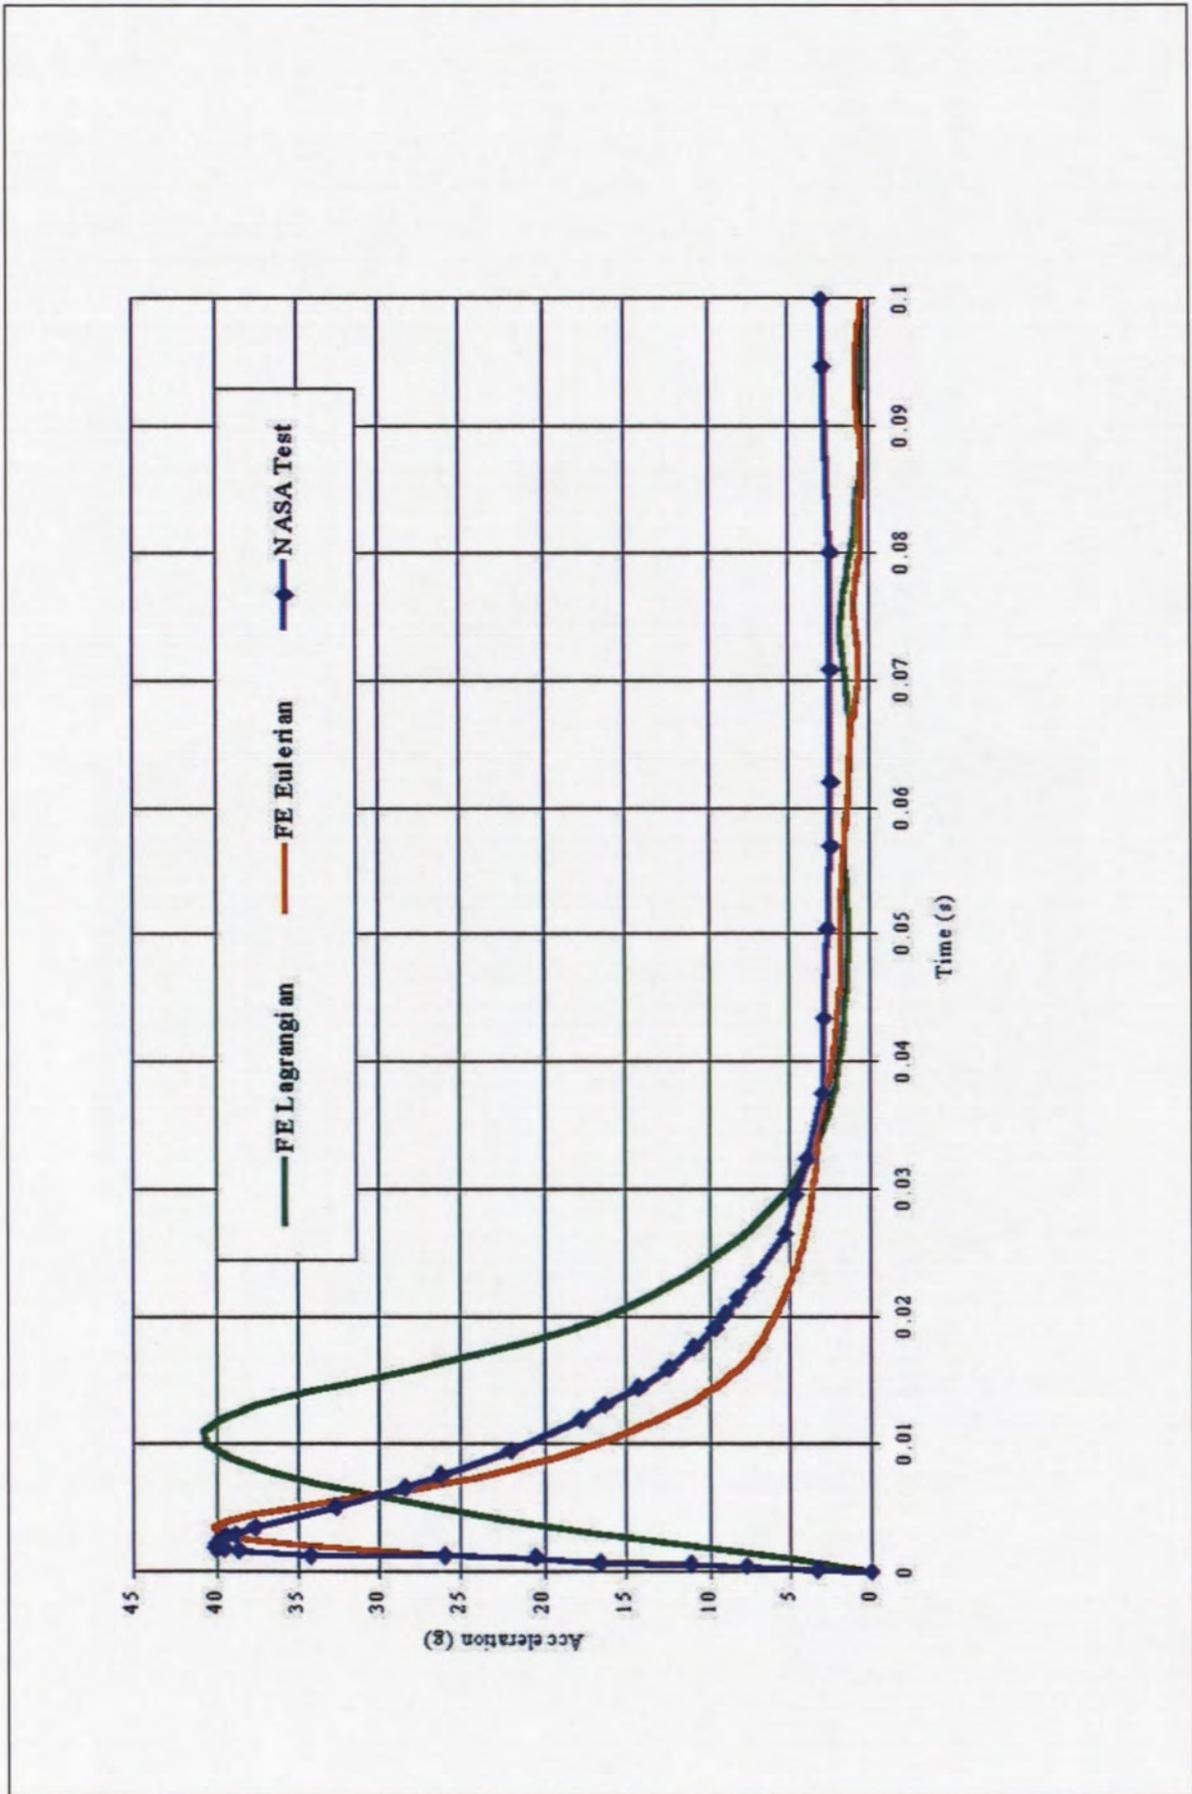
Figure 6: Acceleration of Space Capsule from Test and Analysis

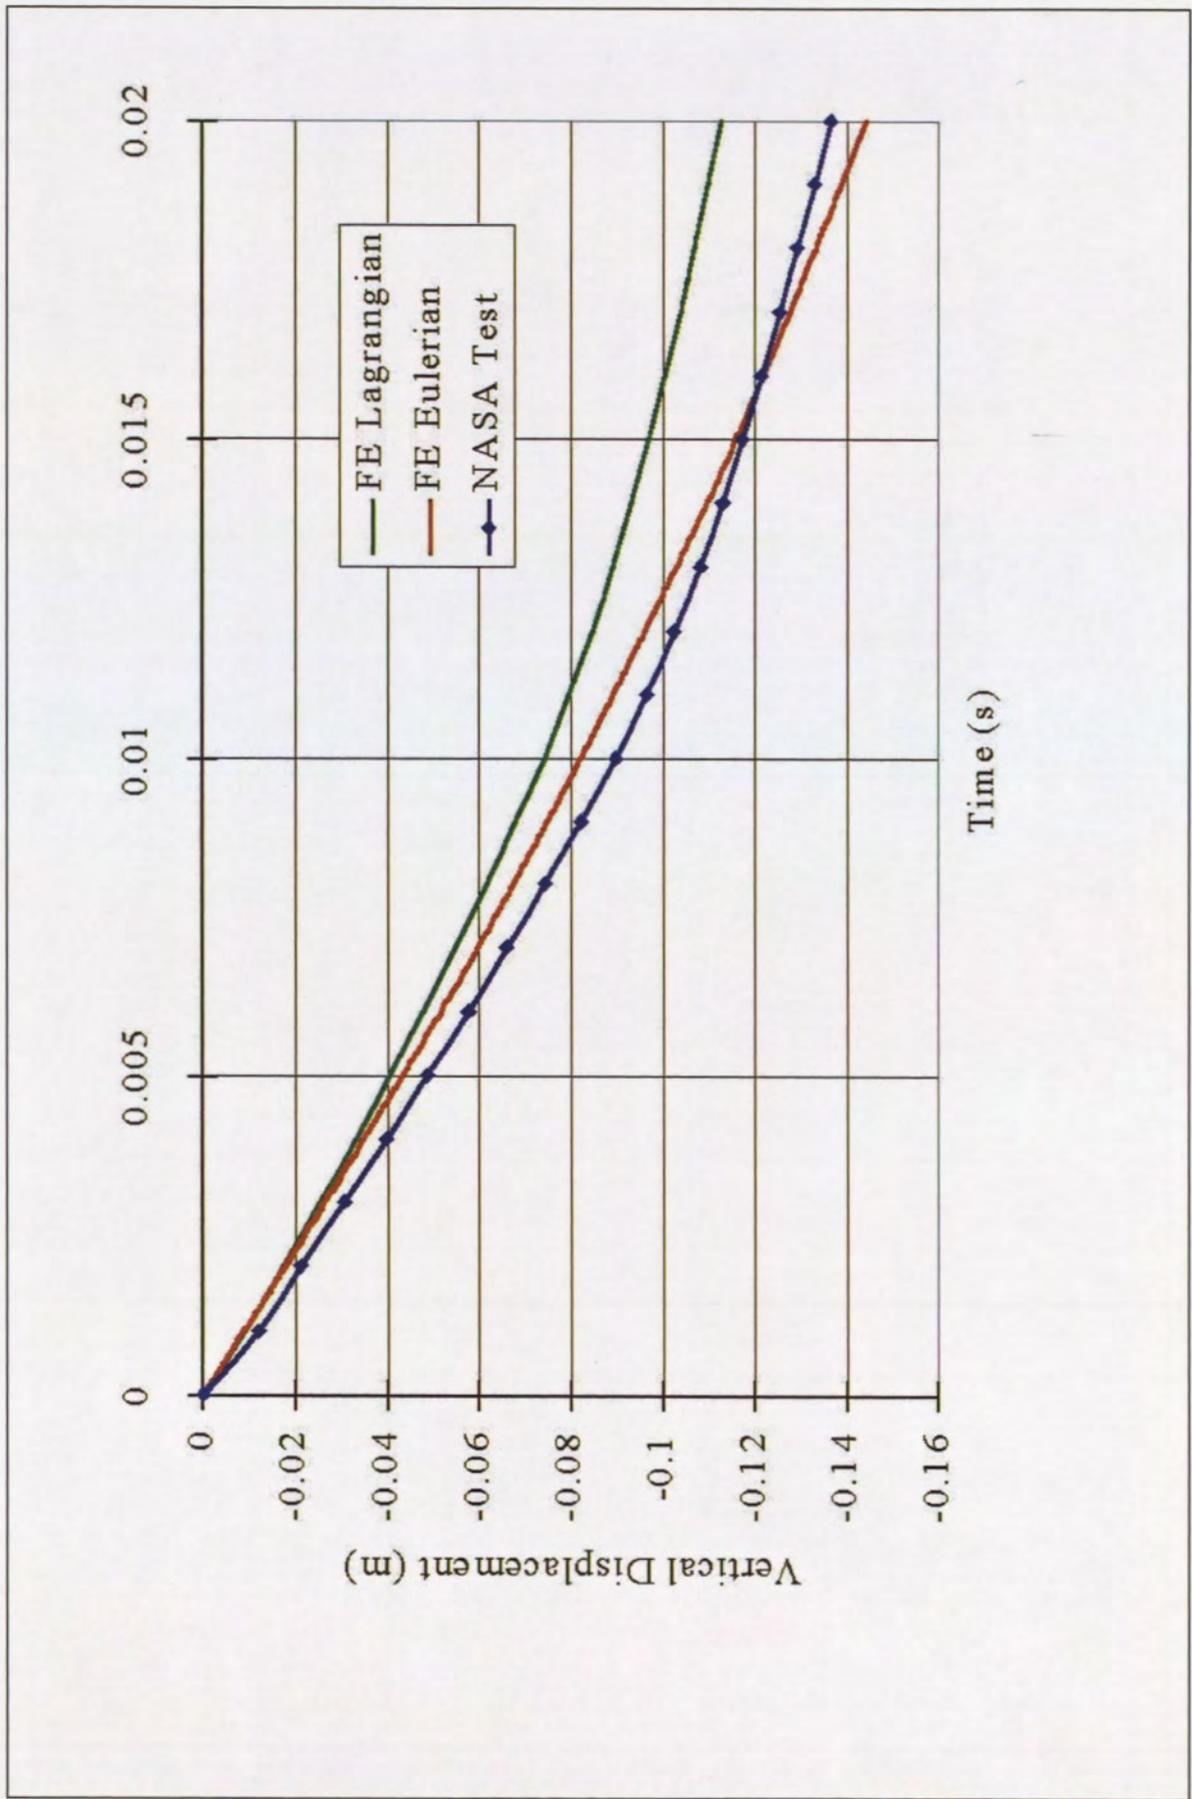
Figure 7: Vertical Displacement of Space Capsule from Test and Analysis

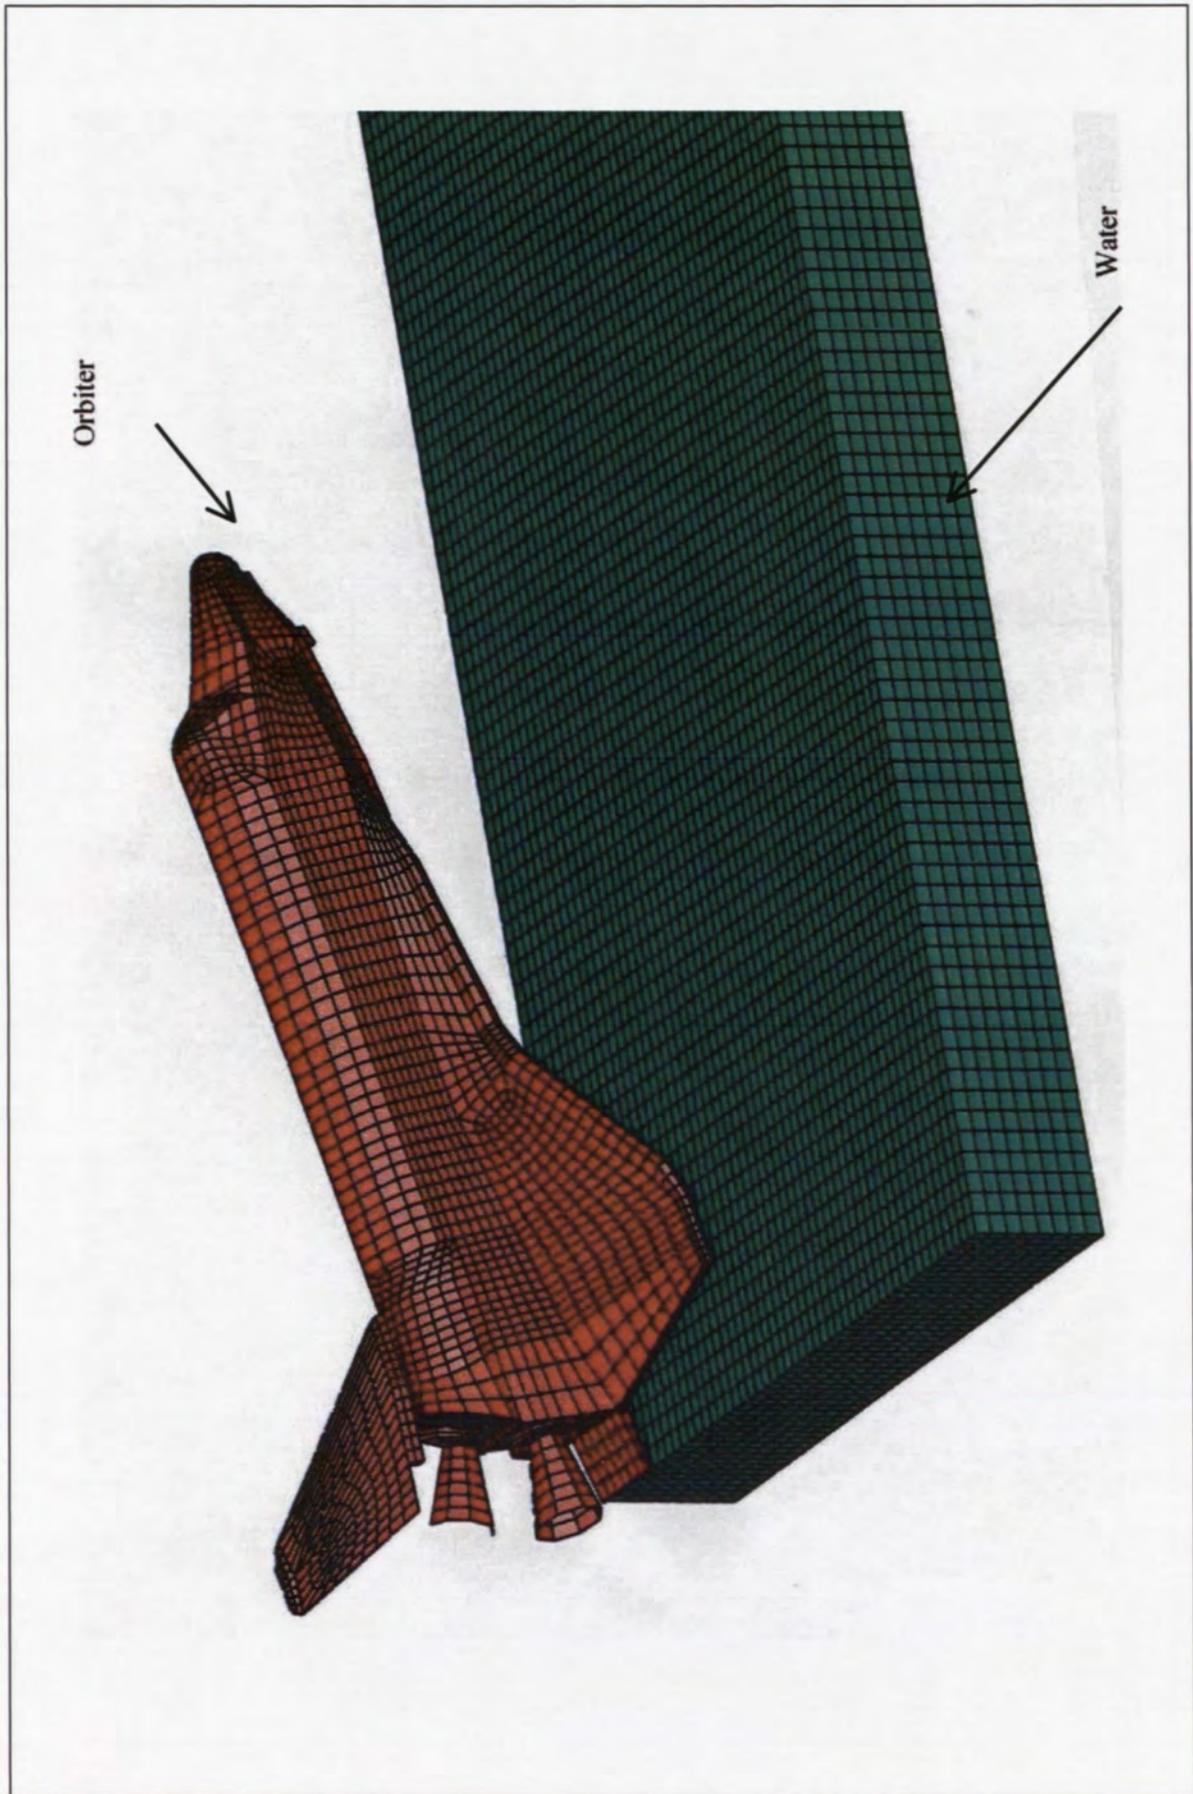
Figure 8: Finite Element Mesh of Orbiter Space Shuttle

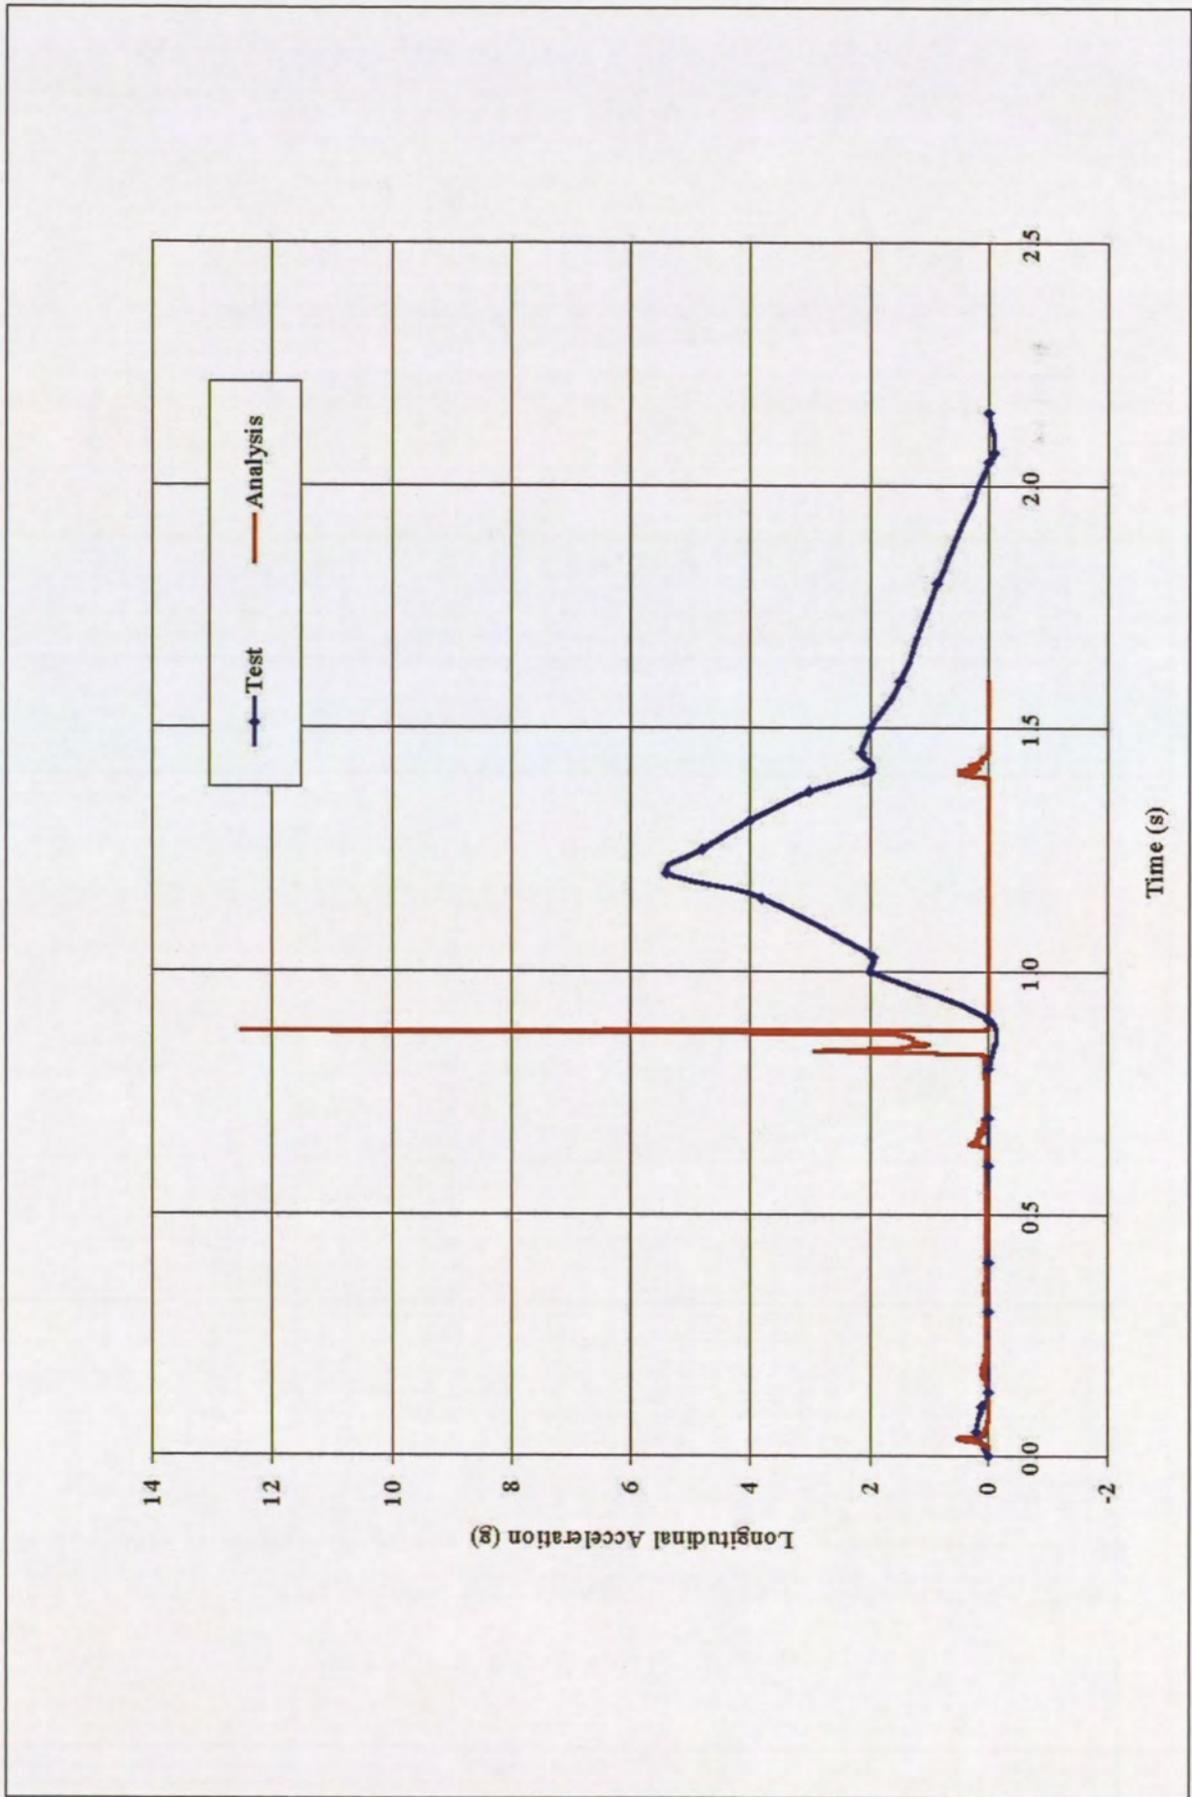
Figure 9: Lateral Acceleration of Orbiter using Lagrangian Mesh

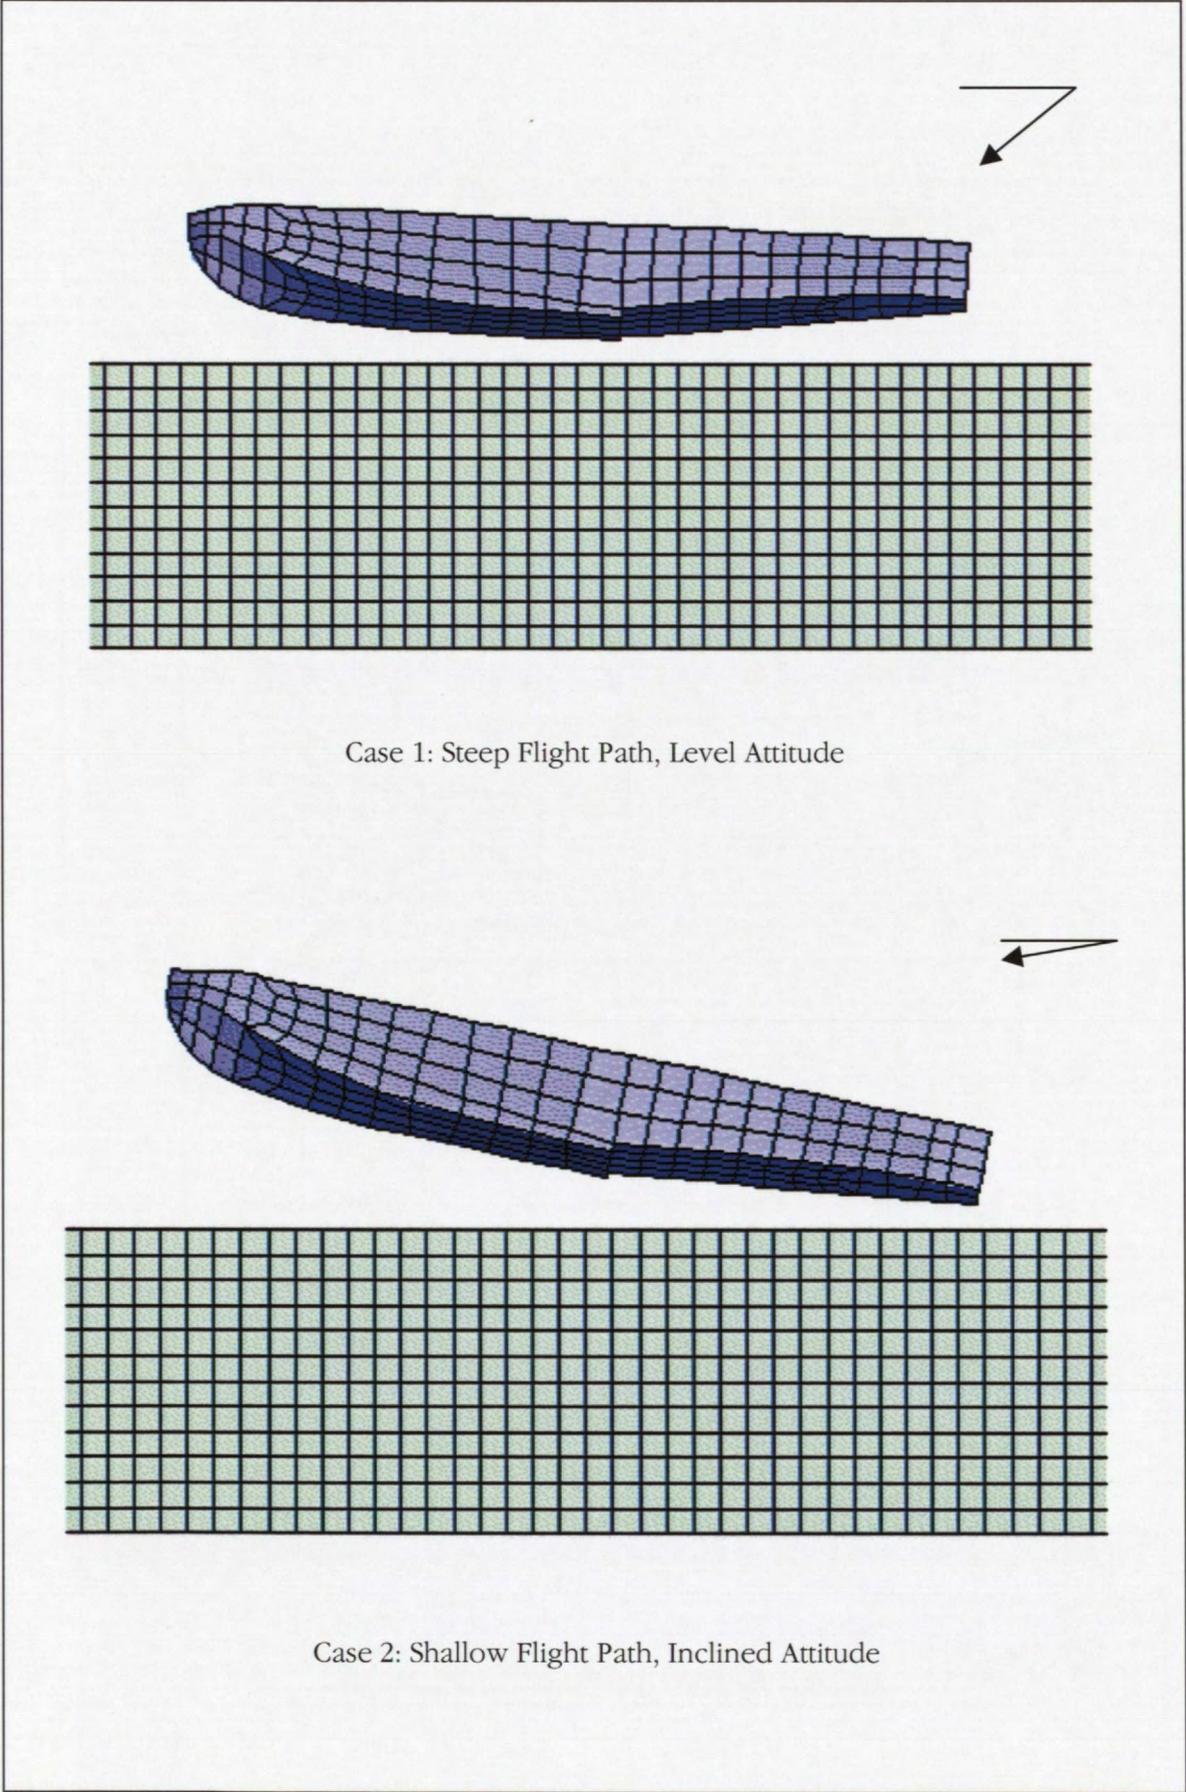
Figure 10: Set up of Two Hull Scenarios Showing Differences in Trim Angle and Flight Path

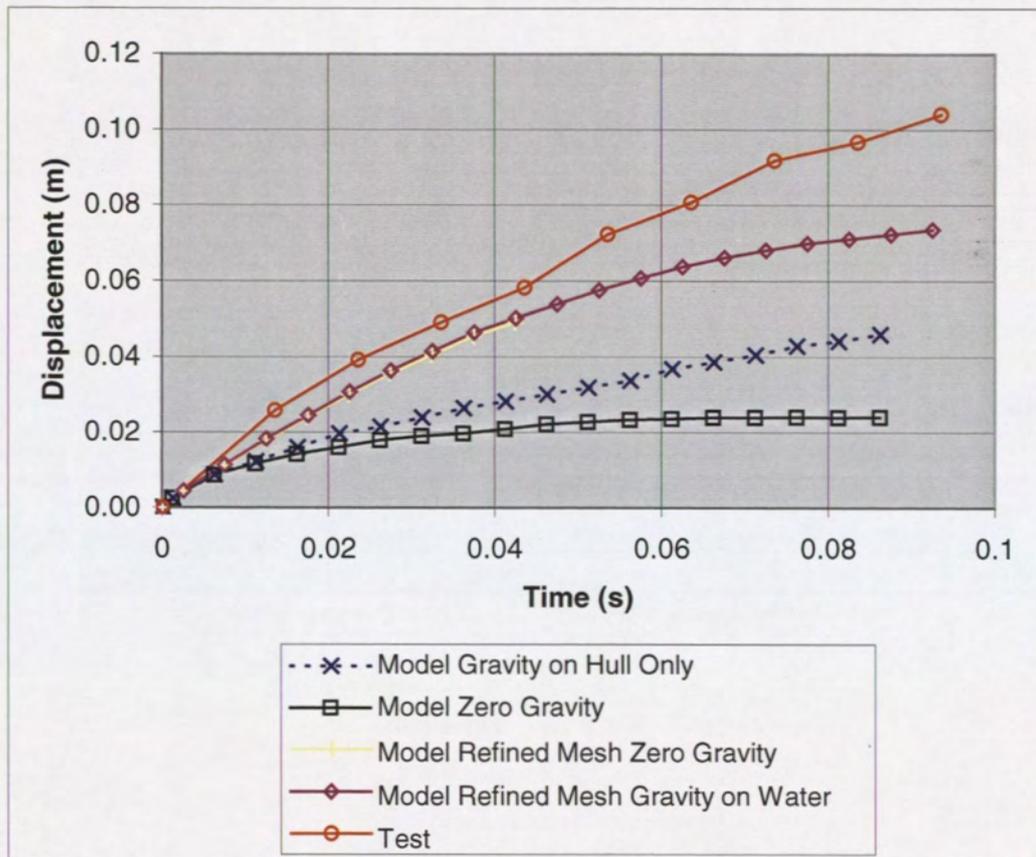
Figure 11: Vertical Displacement of Hull for Case 1
