CAA PAPER 2001/2

**CRASHWORTHINESS OF HELICOPTER
EMERGENCY FLOTATION SYSTEMS**

Study I (Main Study)

Study II (Supplementary Study)

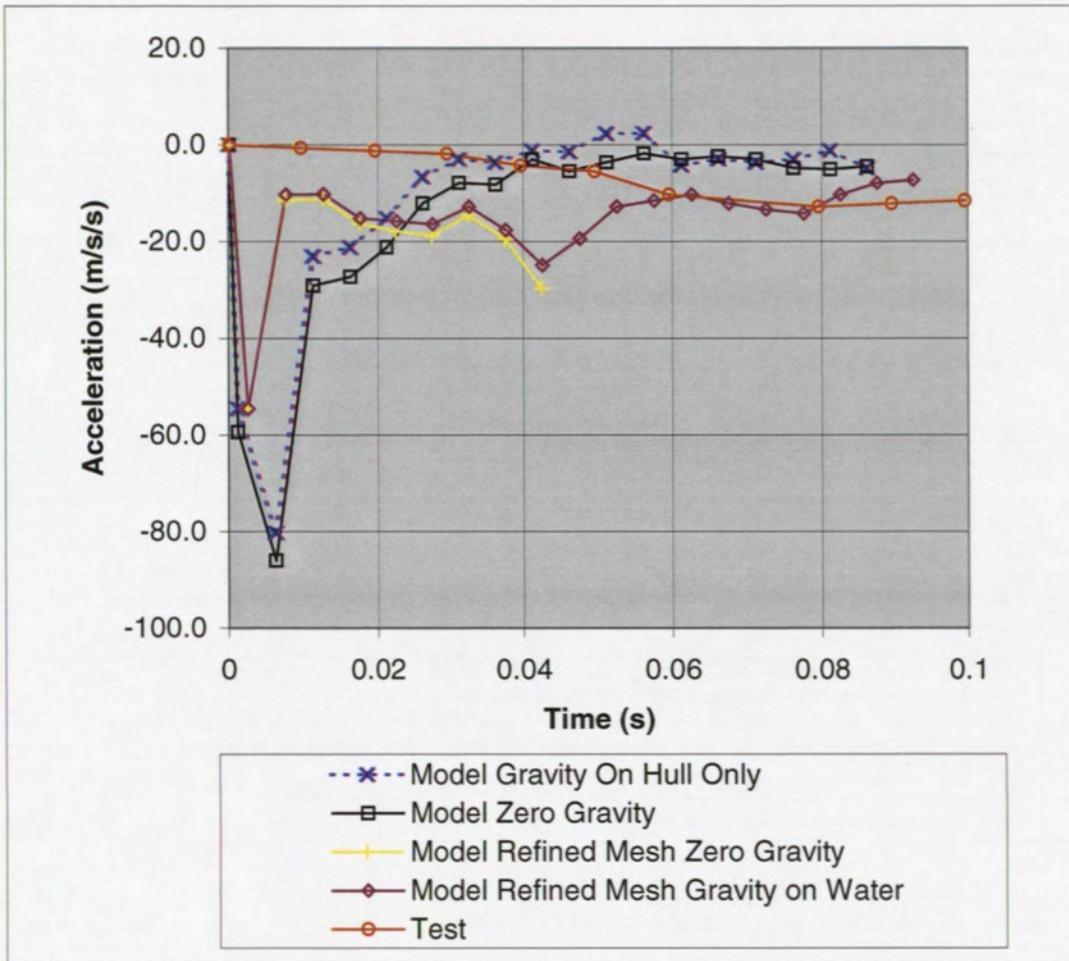
Figure 12: Vertical Acceleration of Hull for Case 1

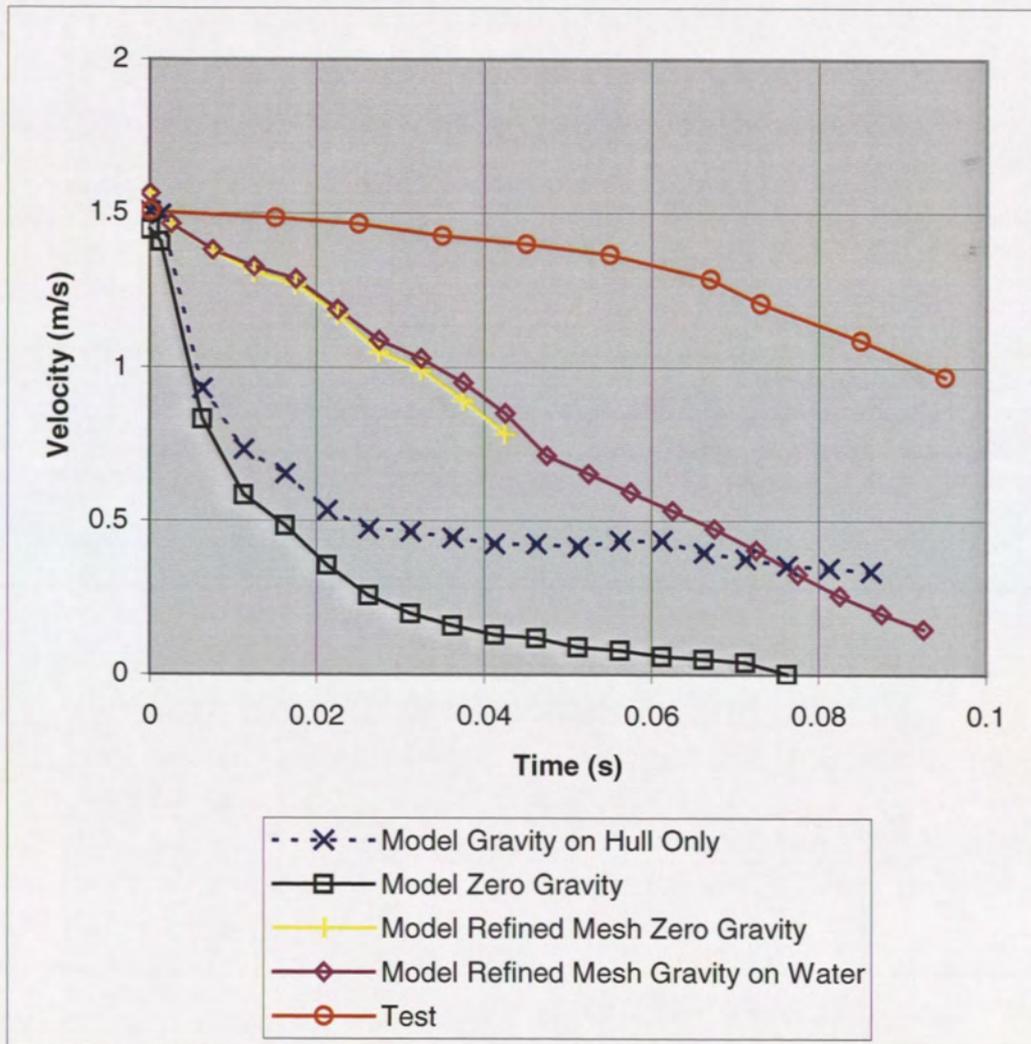
Figure 13: Vertical Velocity of Hull for Case 1

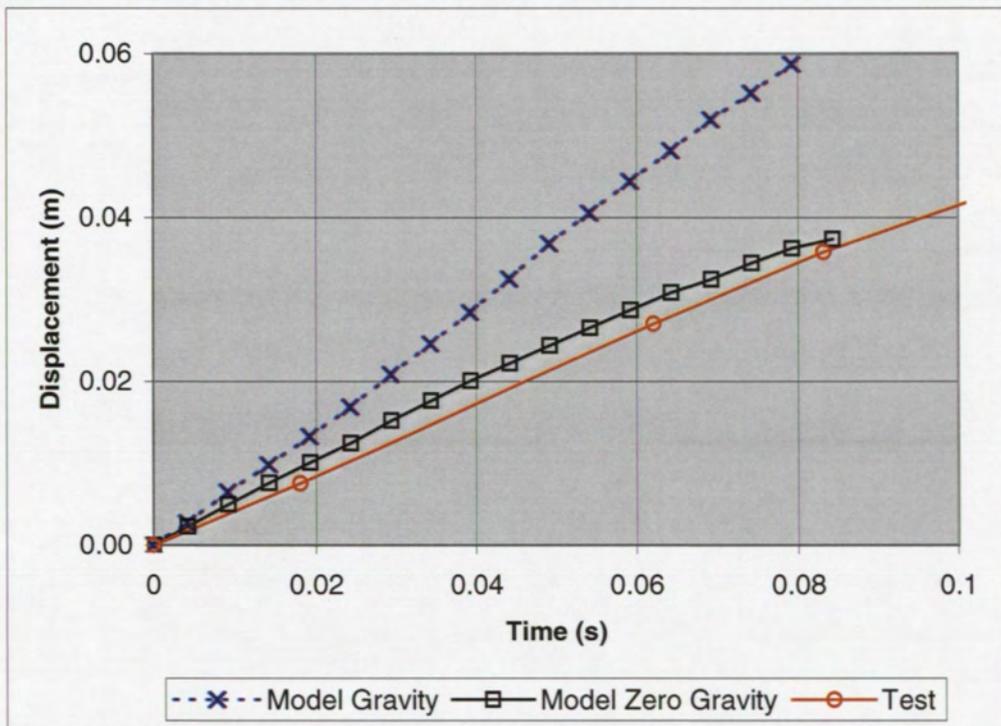
Figure 14: Vertical Displacement of Hull for Case 2

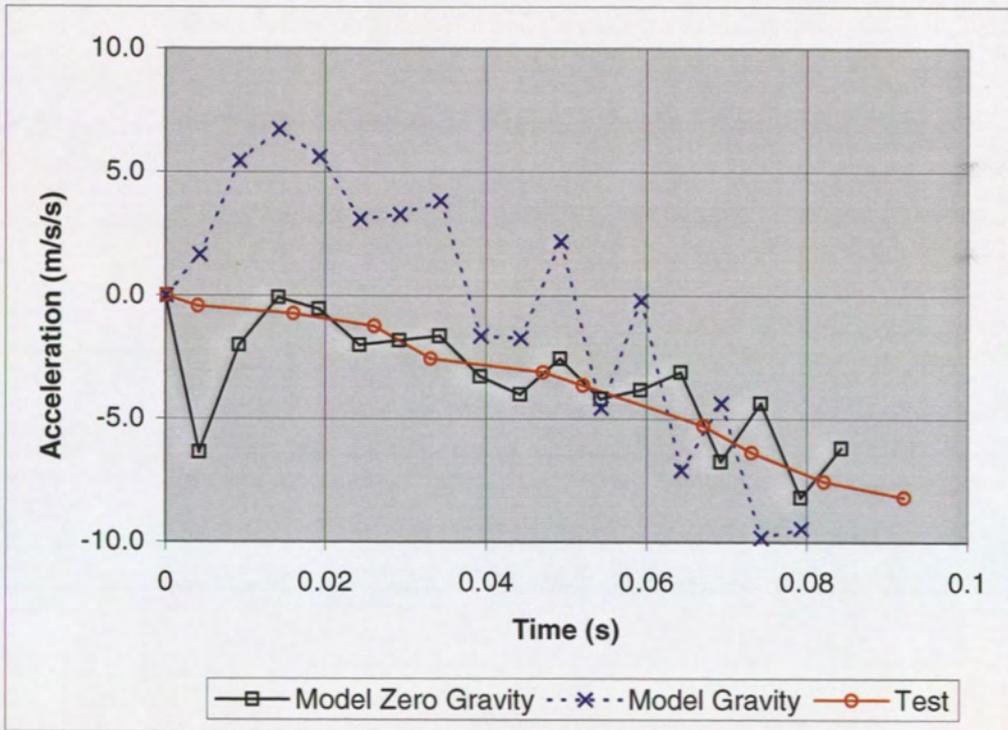
Figure 15: Vertical Acceleration of Hull for Case 2

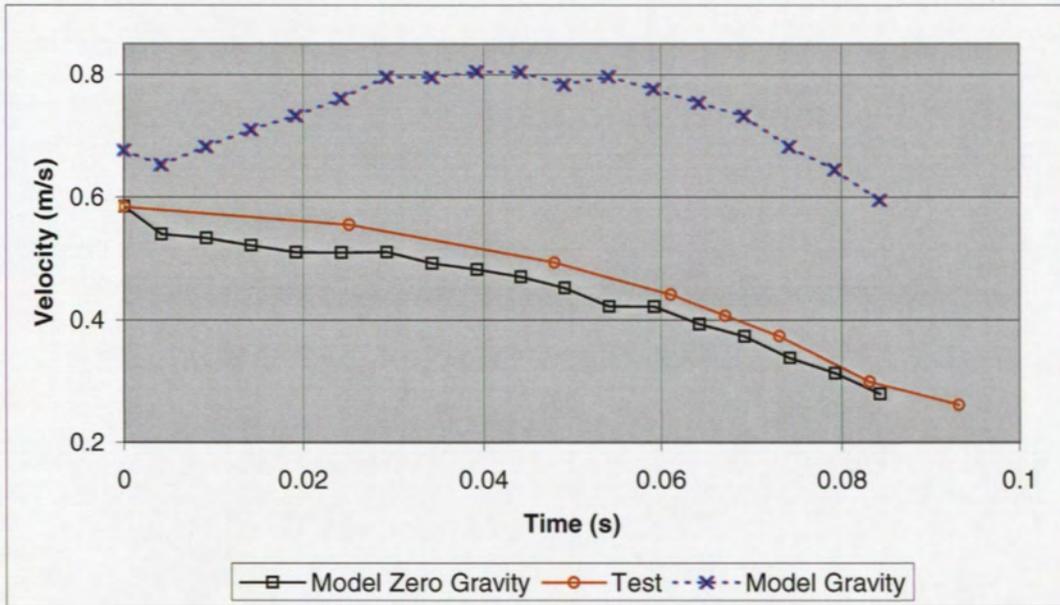
Figure 16: Vertical Velocity of Hull for Case 2

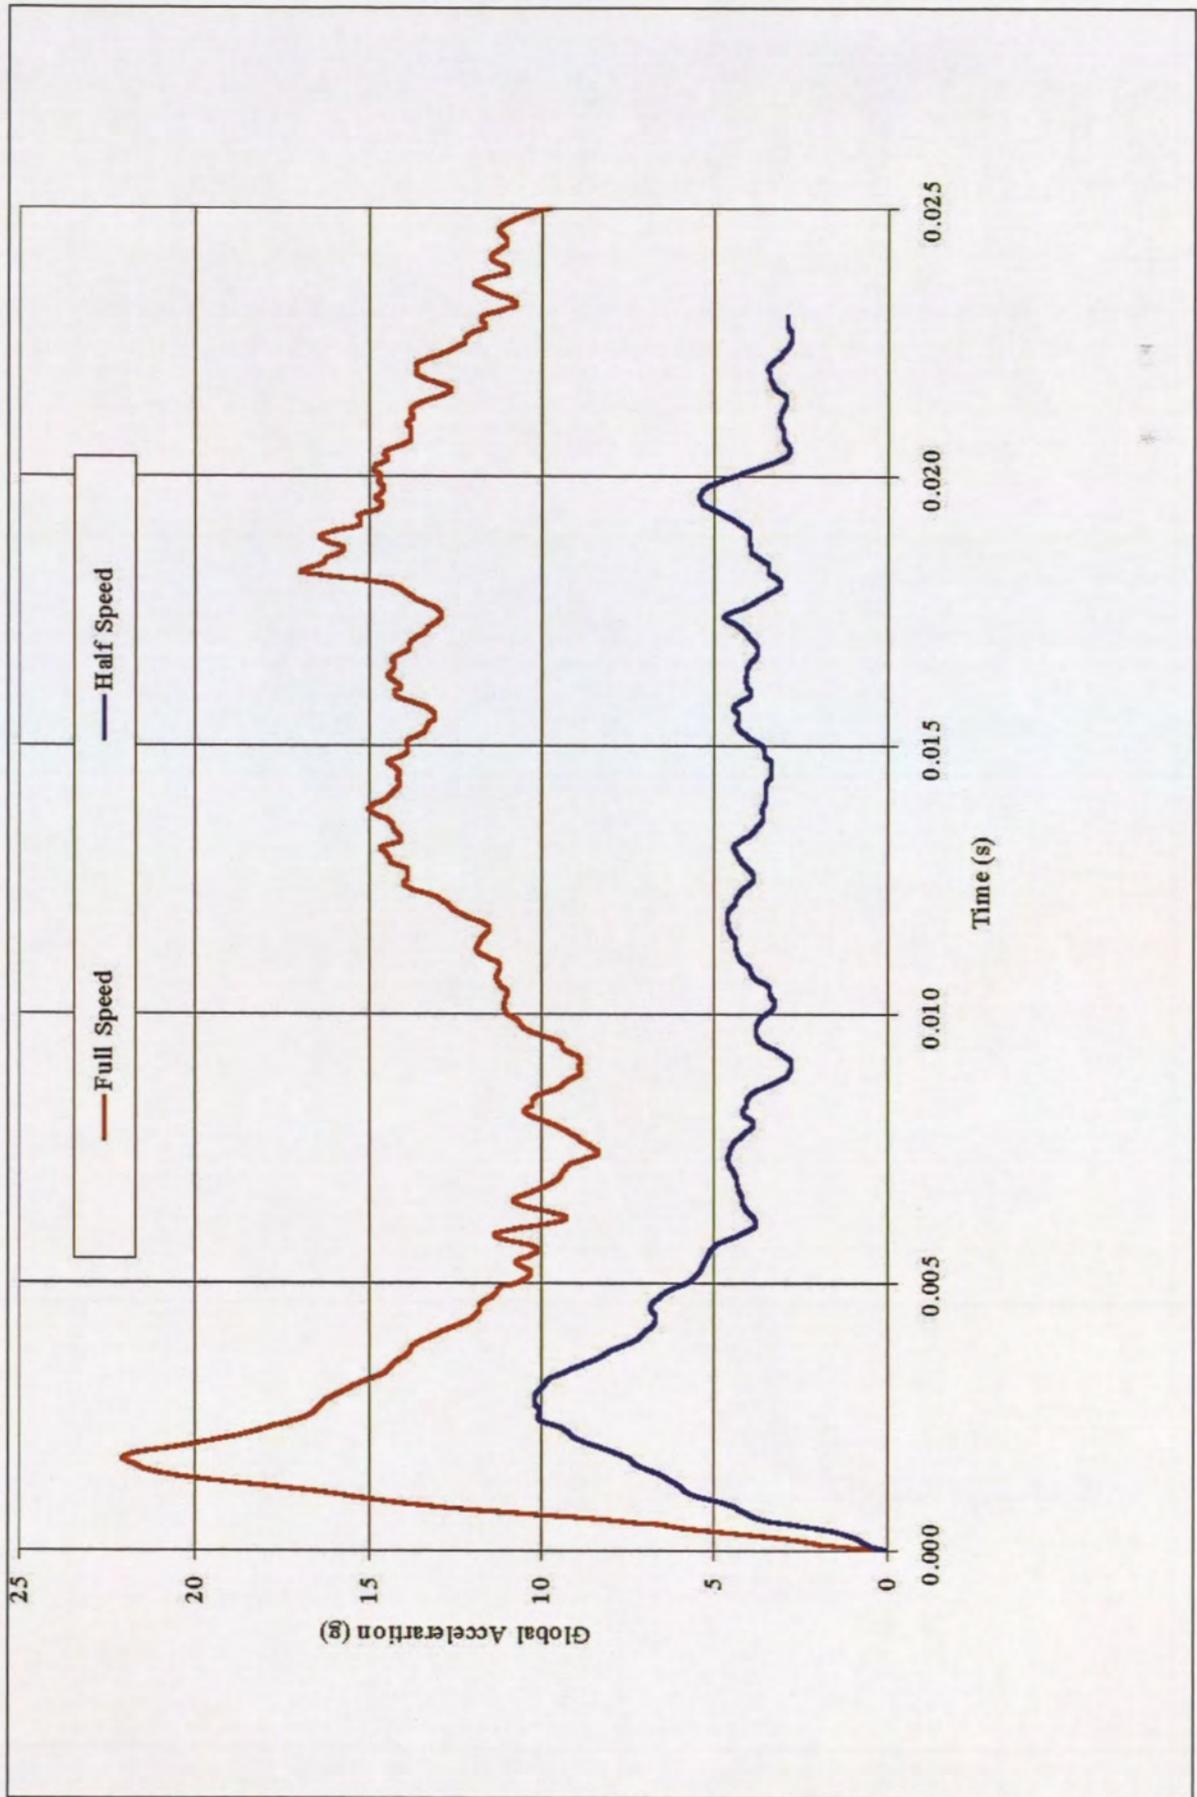
Figure 17: Brent Spar – Global Acceleration at Full and Half Speed

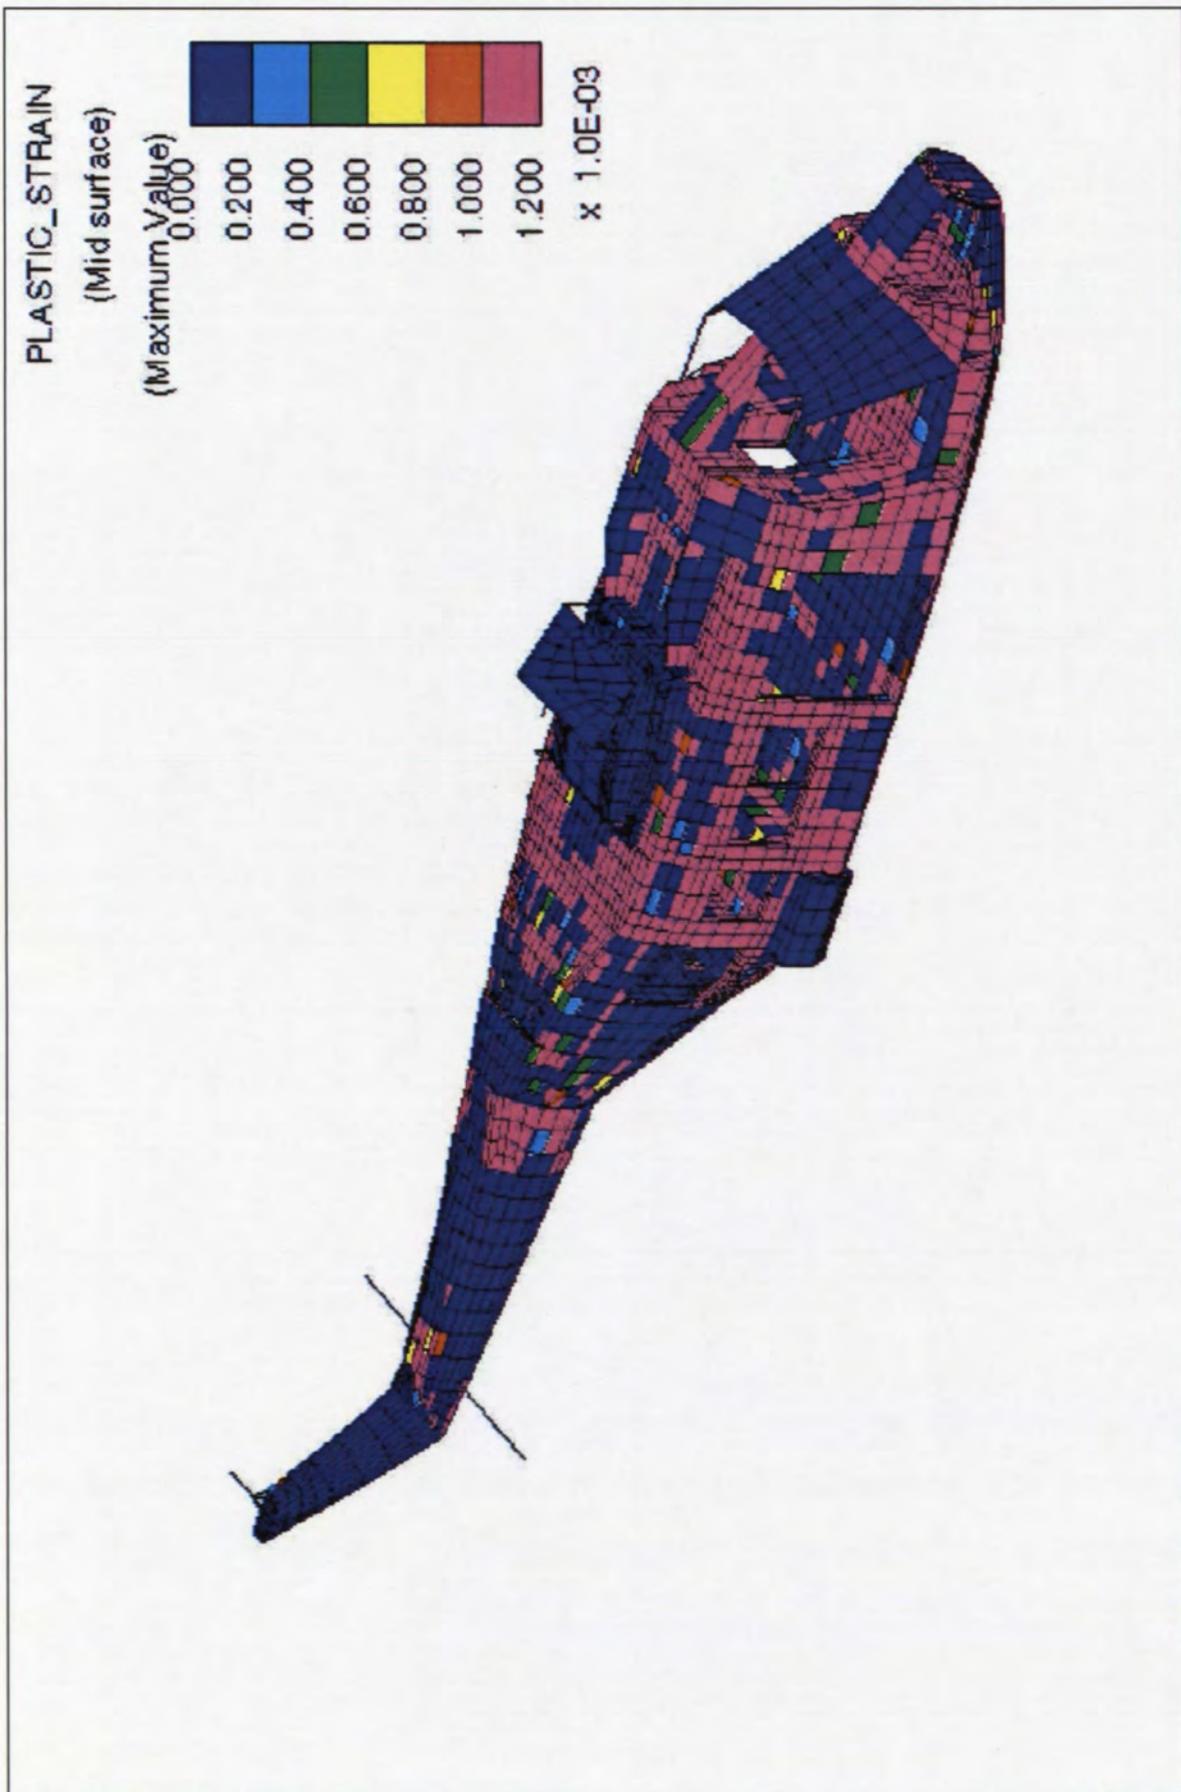
Figure 18: Brent Spar – Full Speed: Maximum Plastic Strain Throughout Time Period

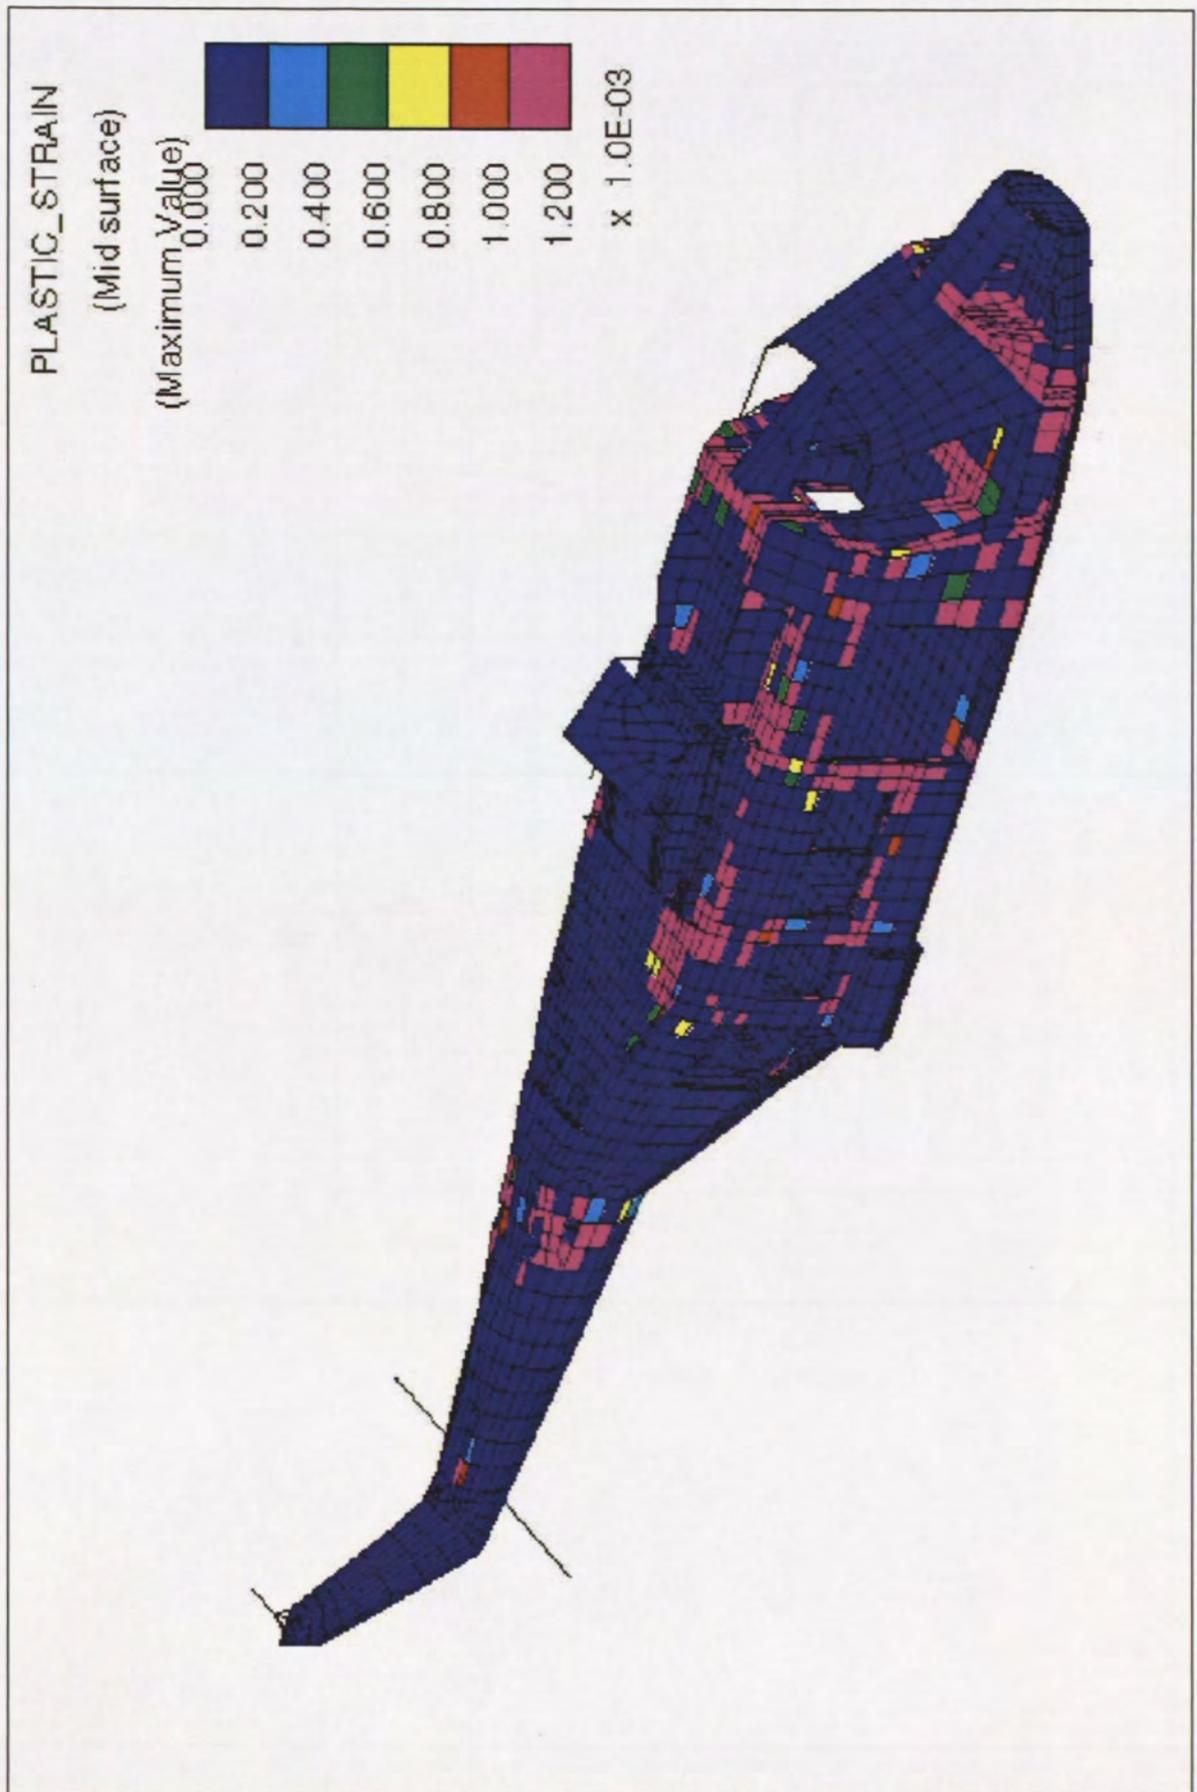
Figure 19: Brent Spar – Half Speed: Maximum Plastic Strain Throughout Time Period

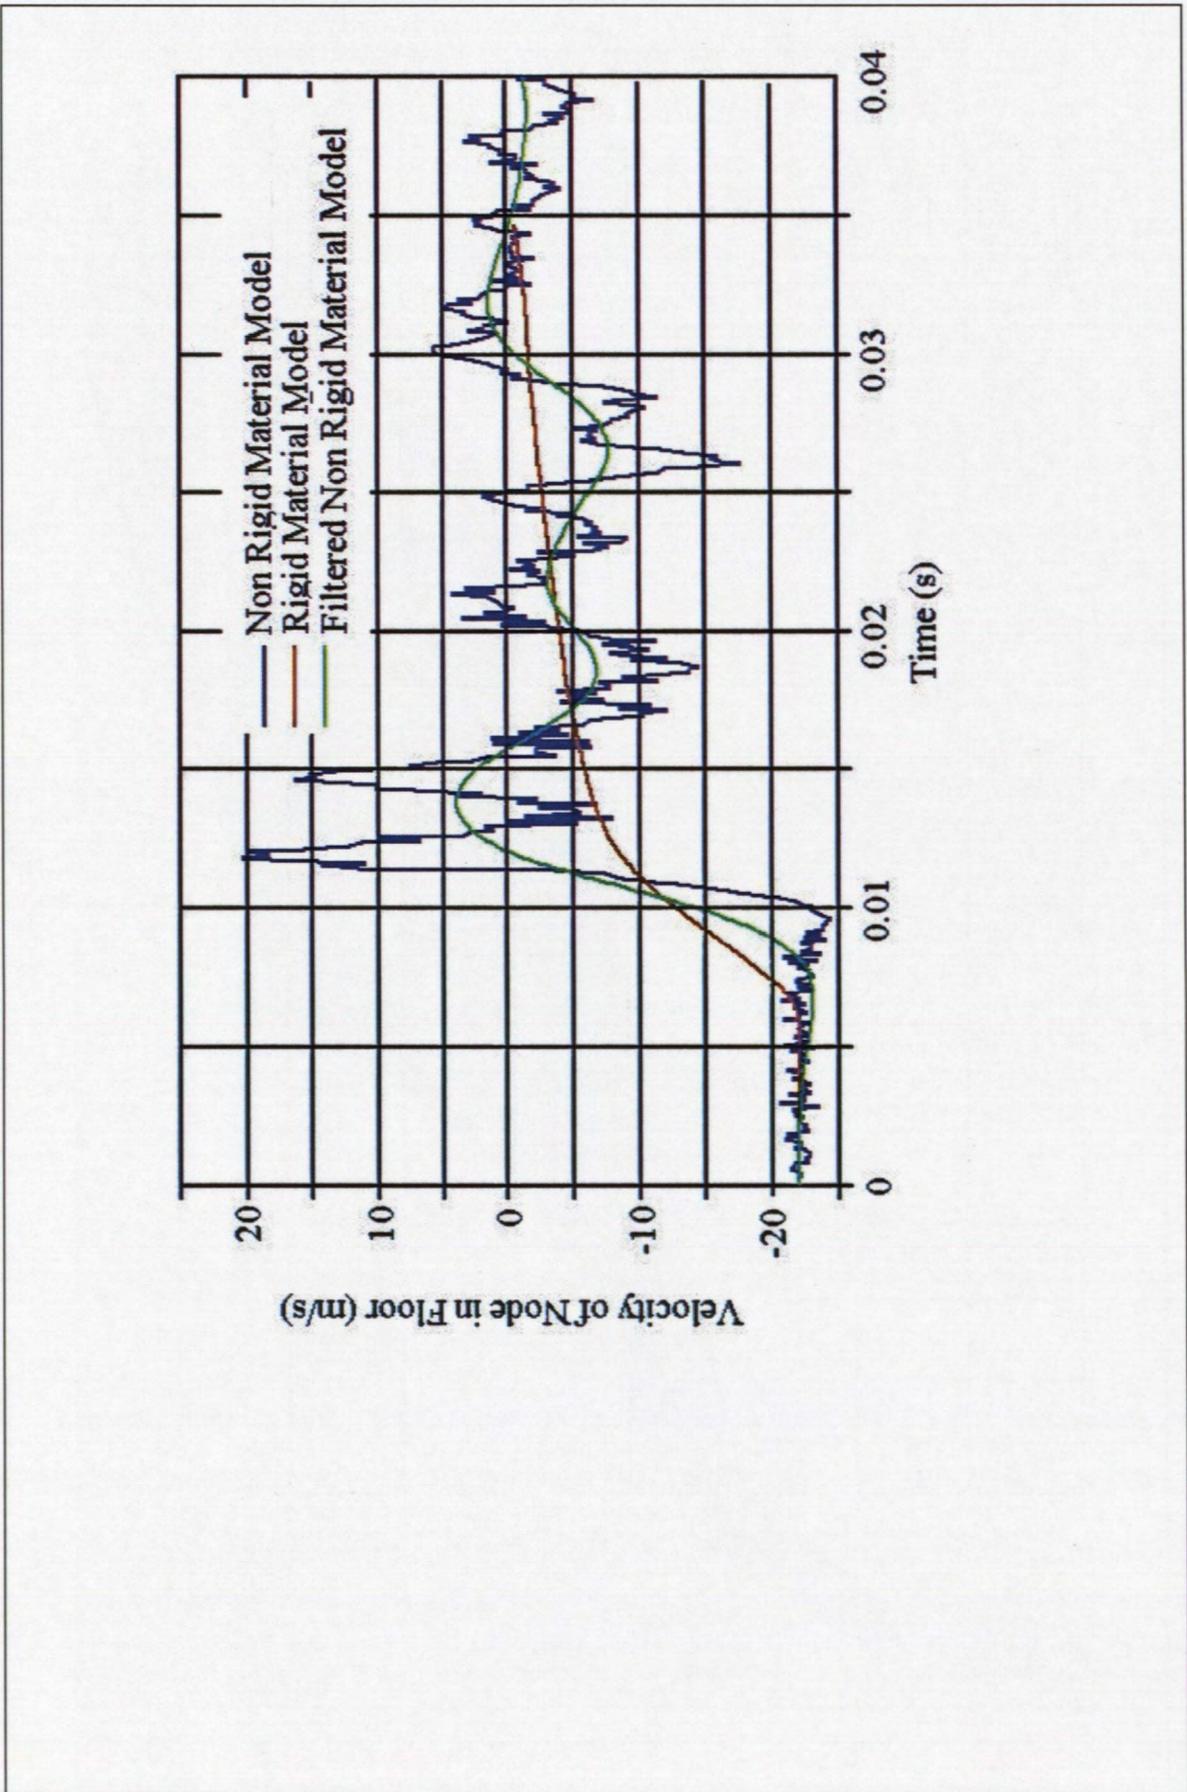
Figure 20: Comparison of Nodal Velocity for Rigid and Non-Rigid Analysis

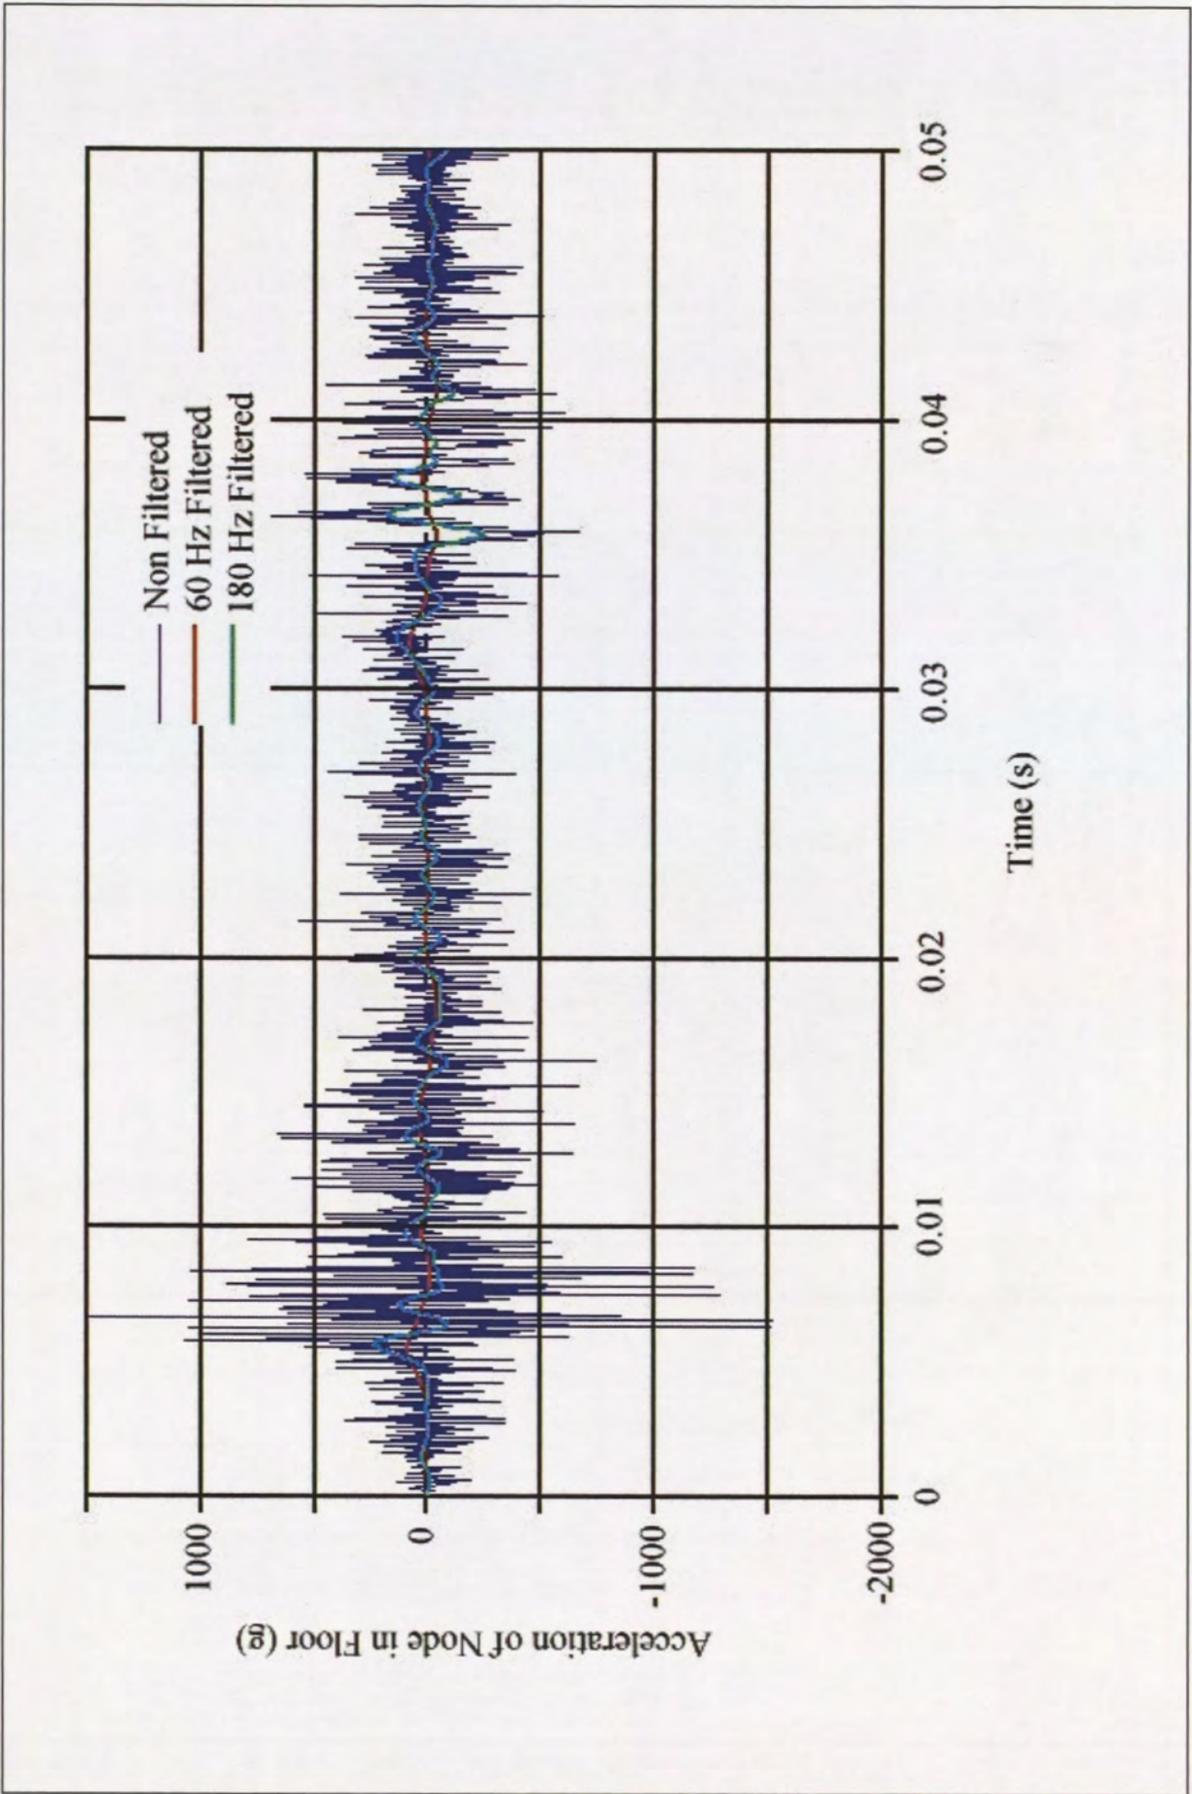
Figure 21: Nodal Acceleration Before and After Filtering

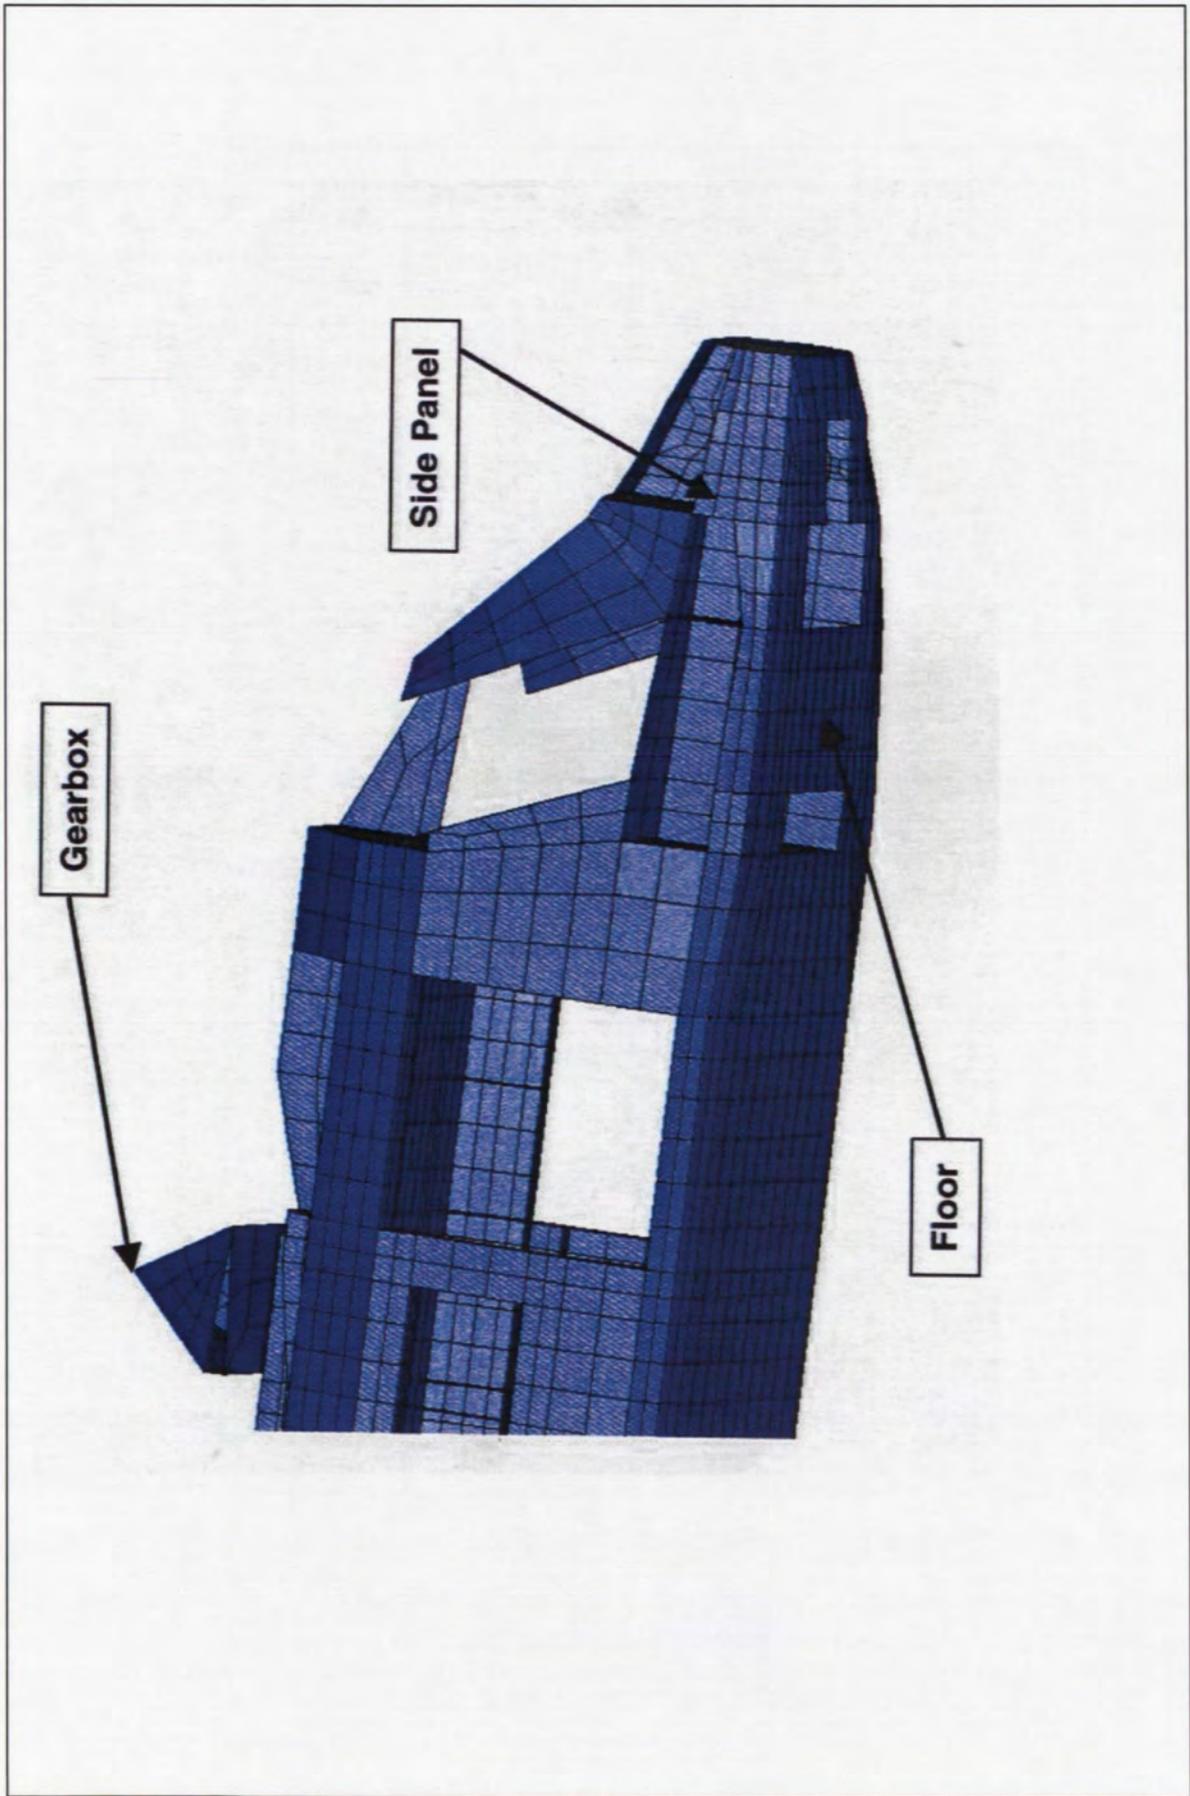
Figure 22: Location of Nodes for Monitoring Acceleration

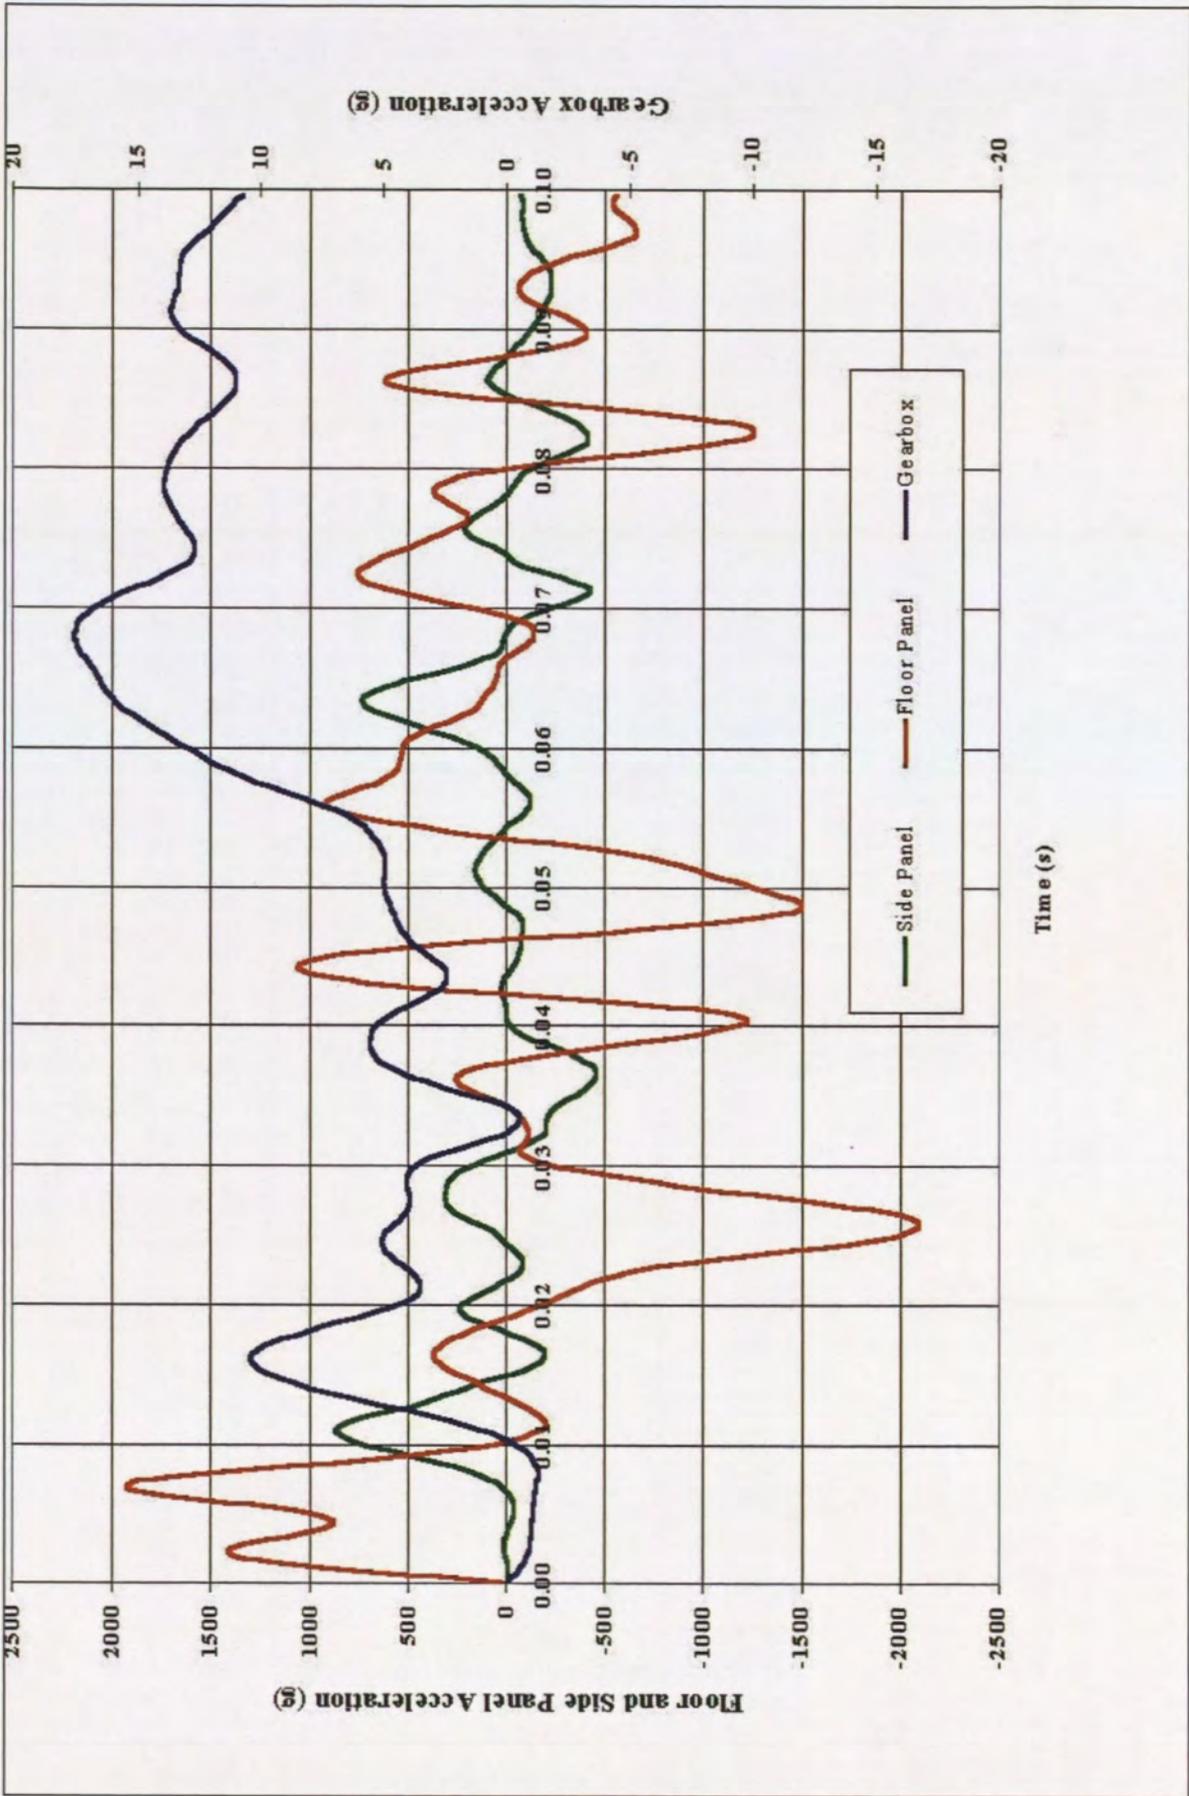
Figure 23: Filtered Vertical Acceleration for Gearbox, Floor and Side Panels

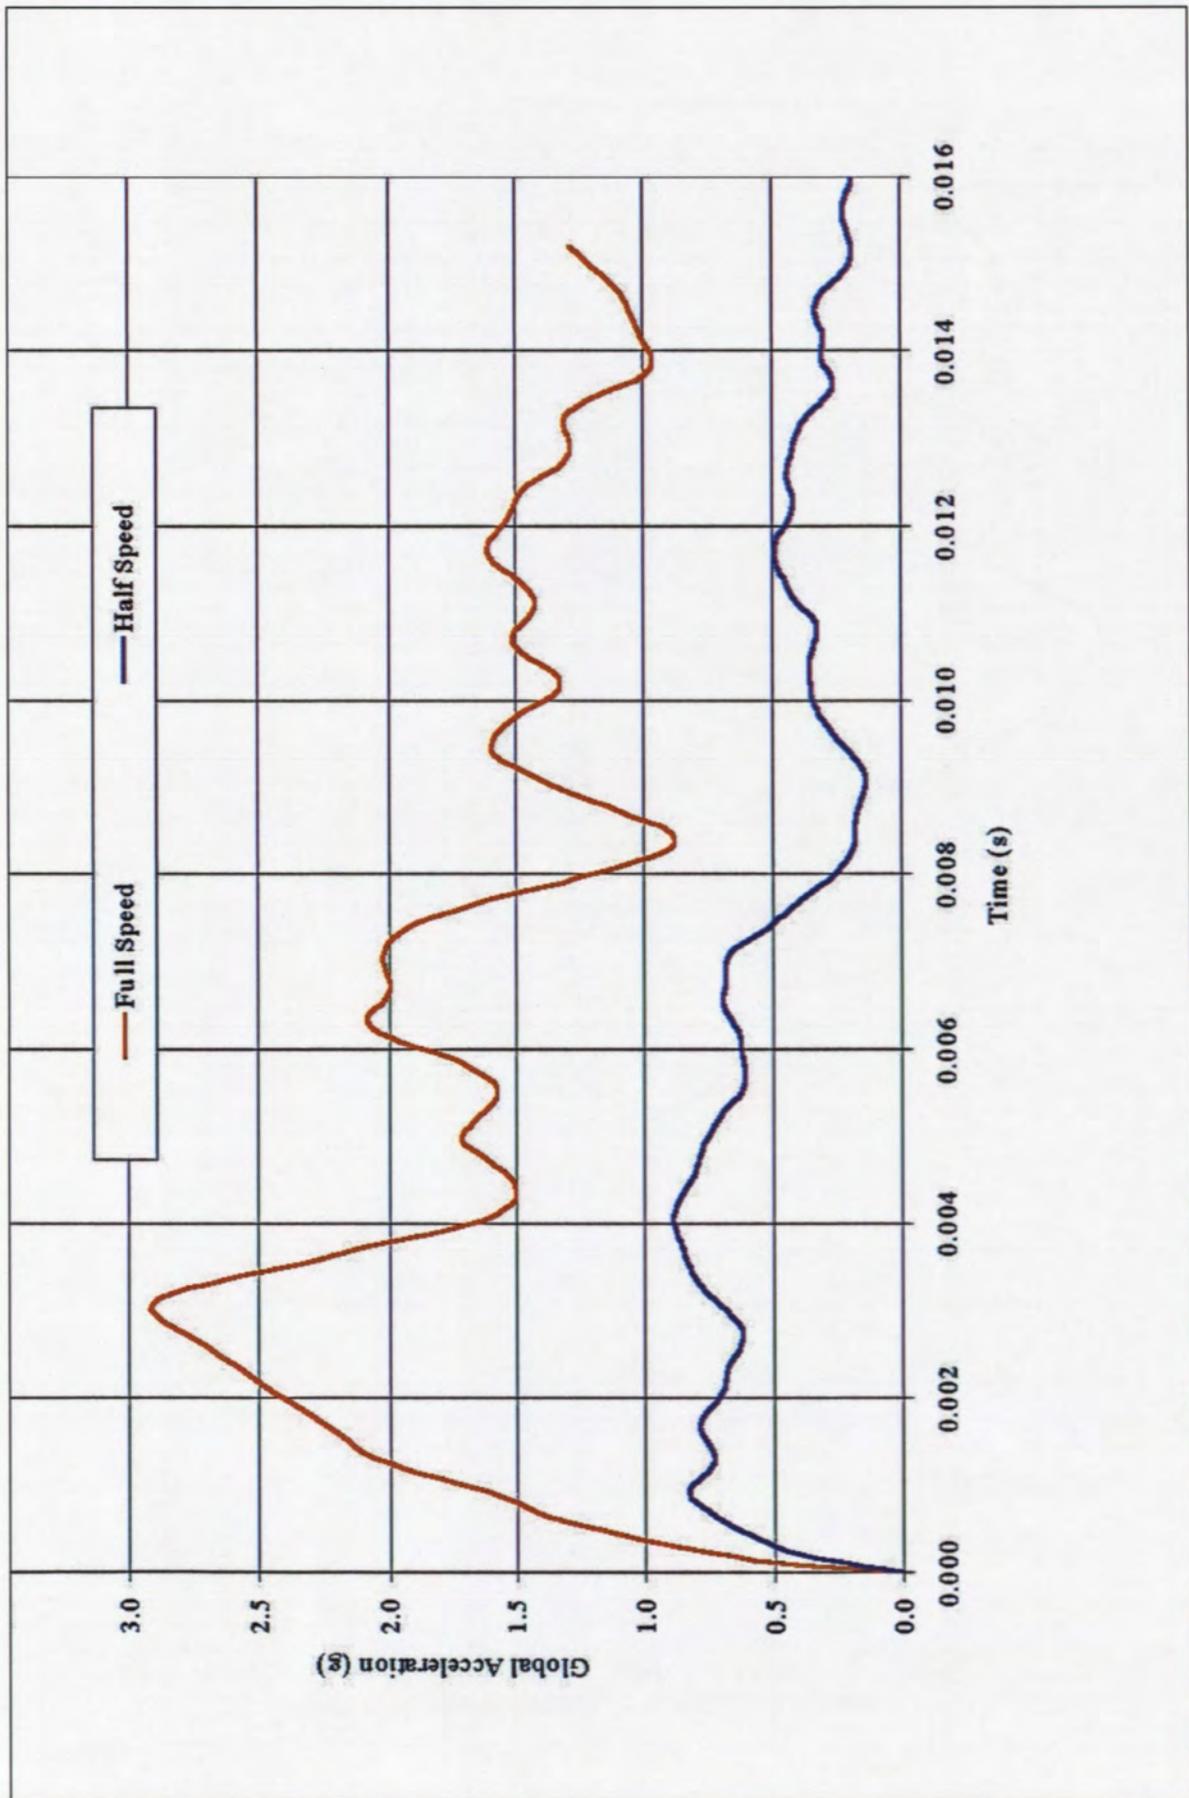
Figure 24: Cormorant Alpha – Global Acceleration at Full and Half Speed
