CAA PAPER 2001/2

**CRASHWORTHINESS OF HELICOPTER
EMERGENCY FLOTATION SYSTEMS**

Study I (Main Study)

Study II (Supplementary Study)

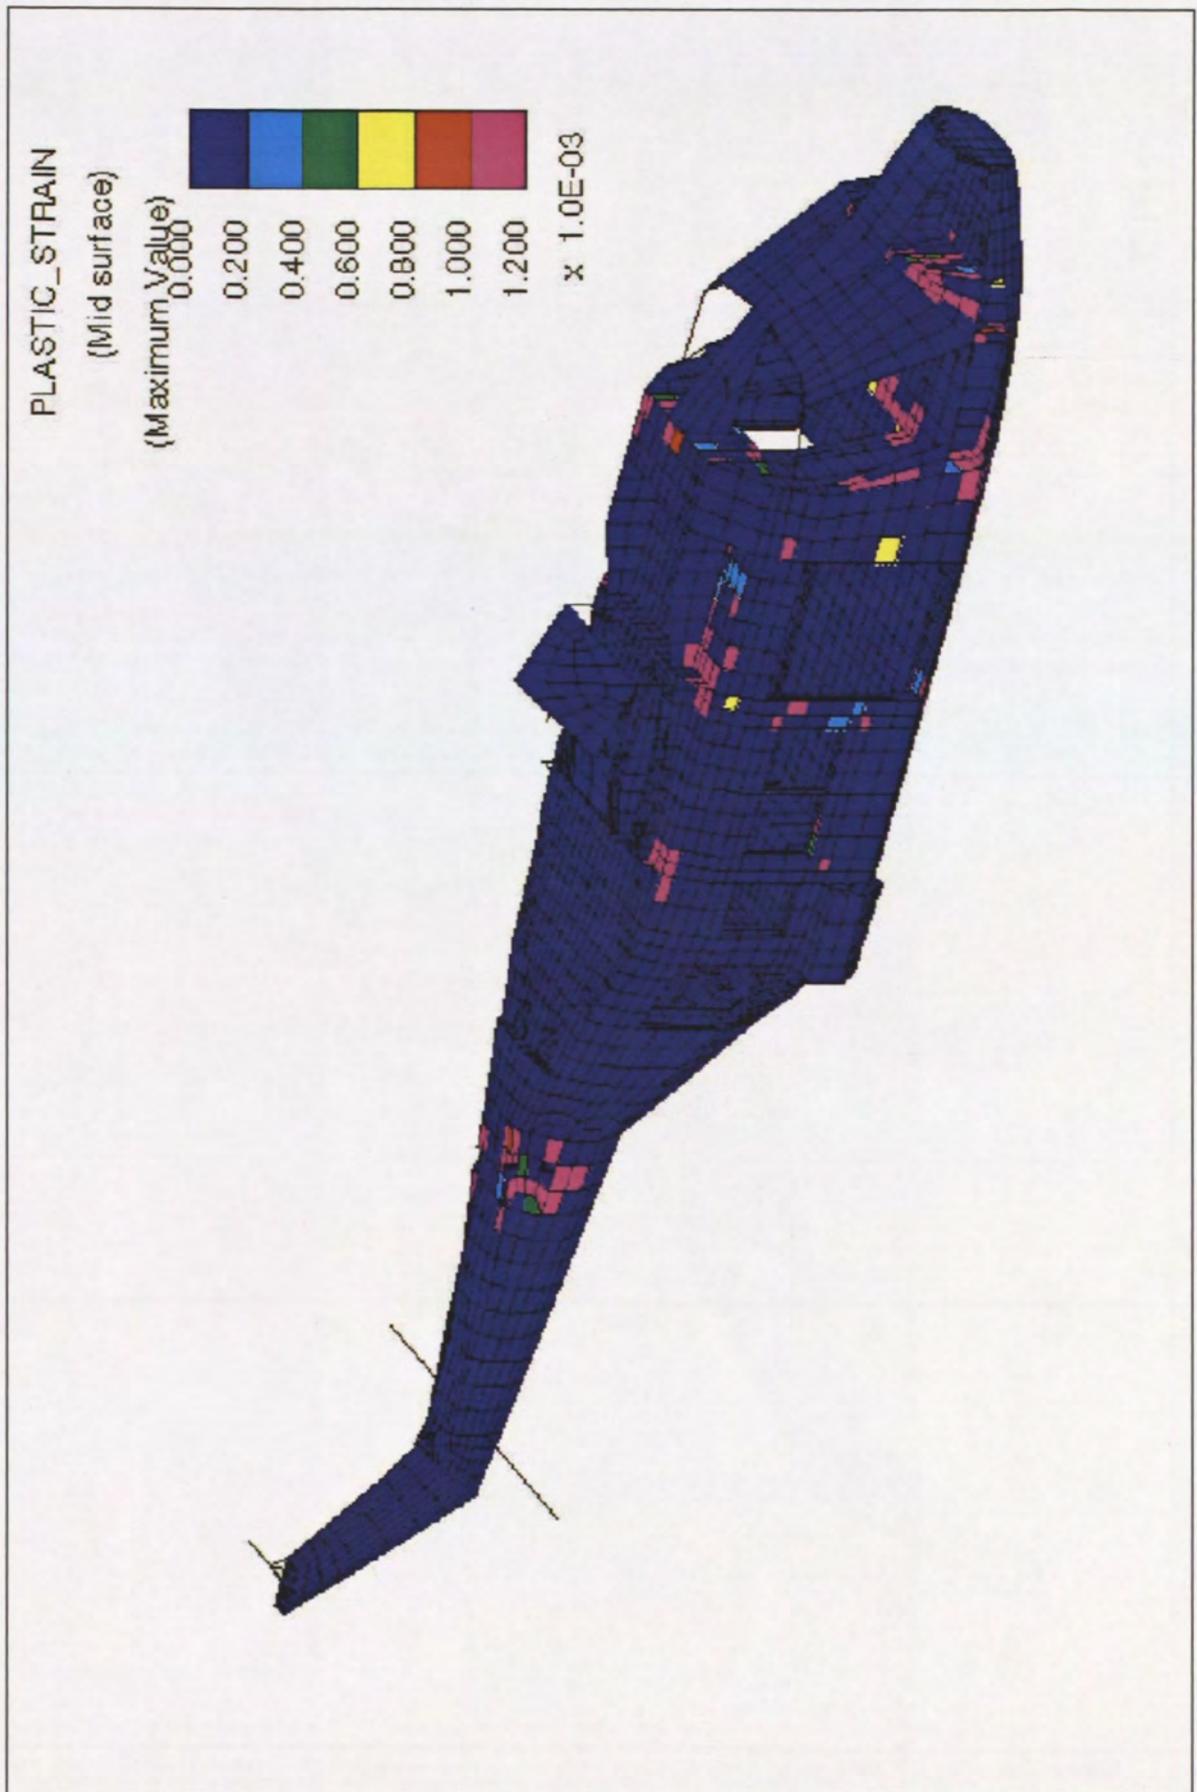
Figure 25: Cormorant Alpha – Full Speed: Maximum Plastic Strain Throughout Time Period

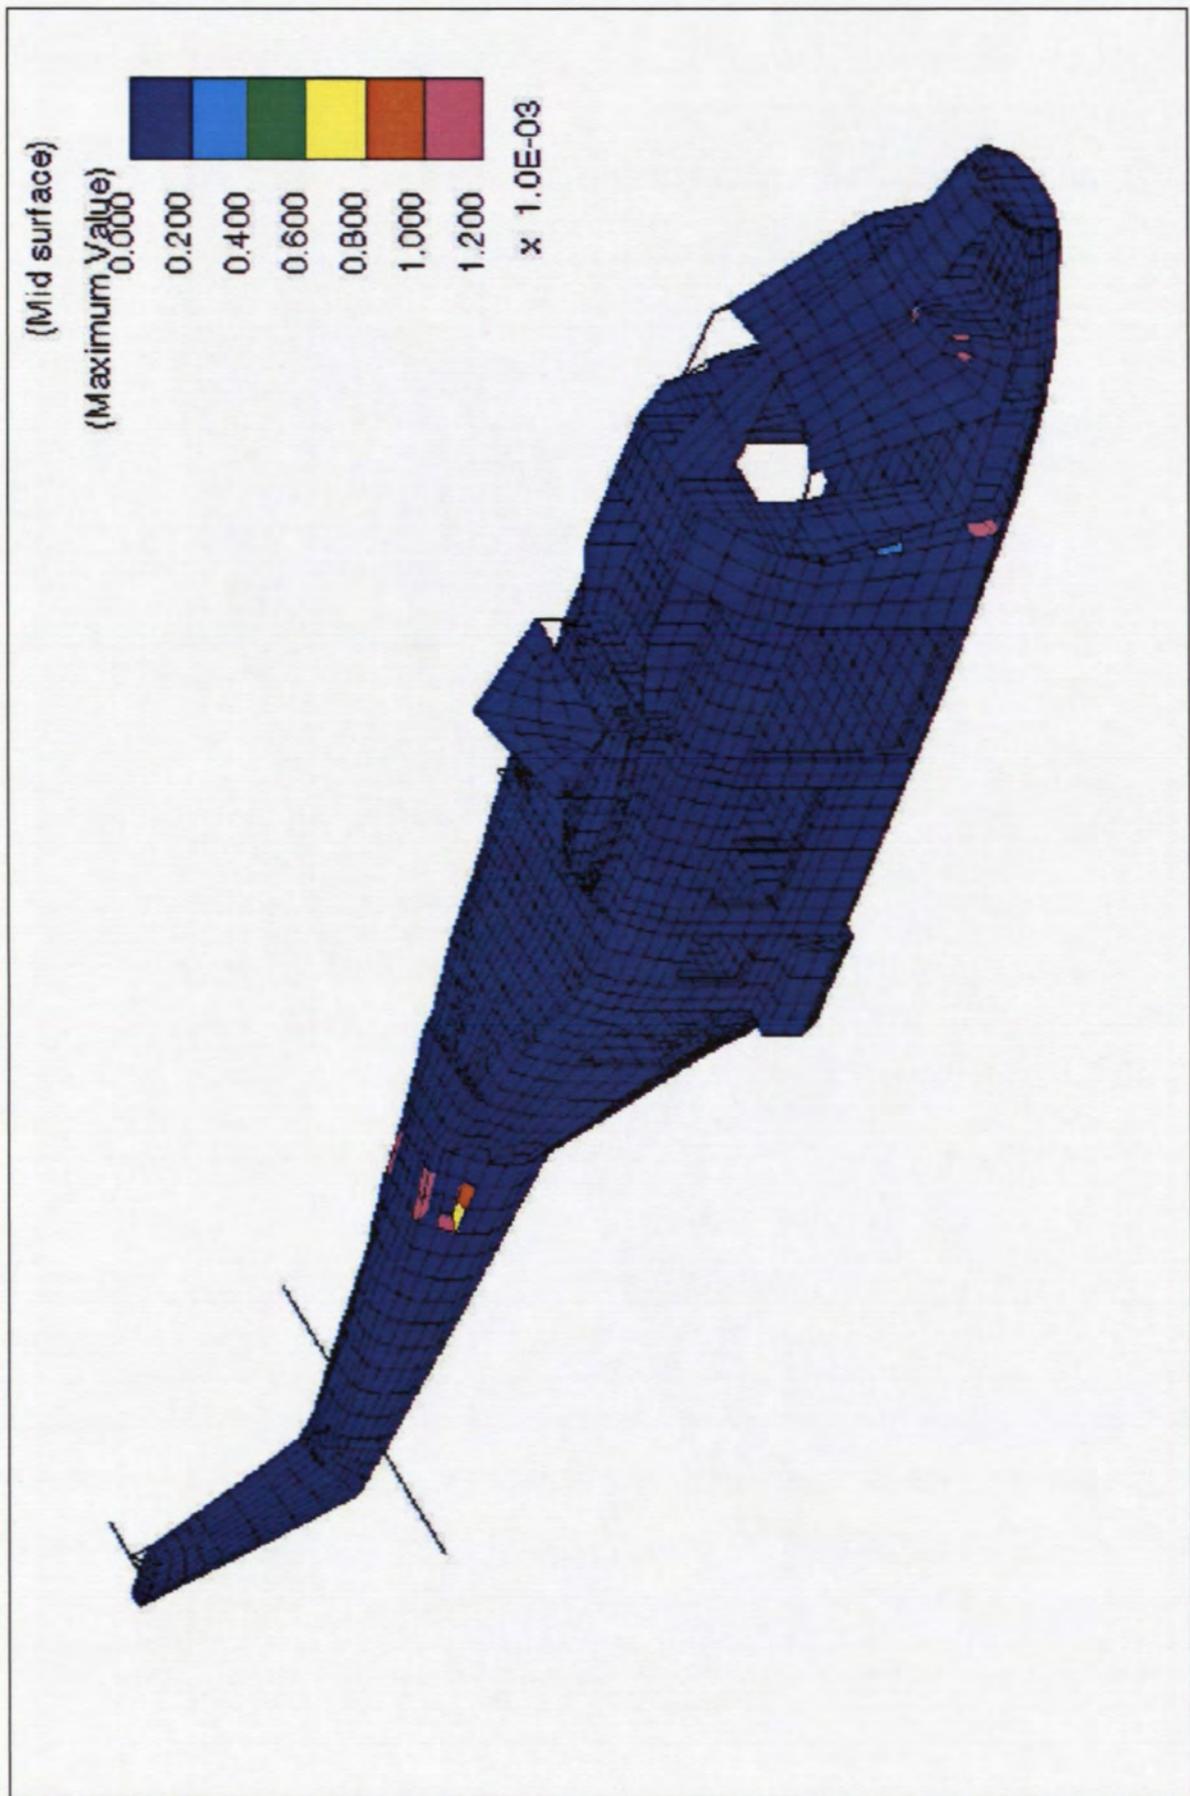
Figure 26: Cormorant Alpha – Half Speed: Maximum Plastic Strain Throughout Time Period

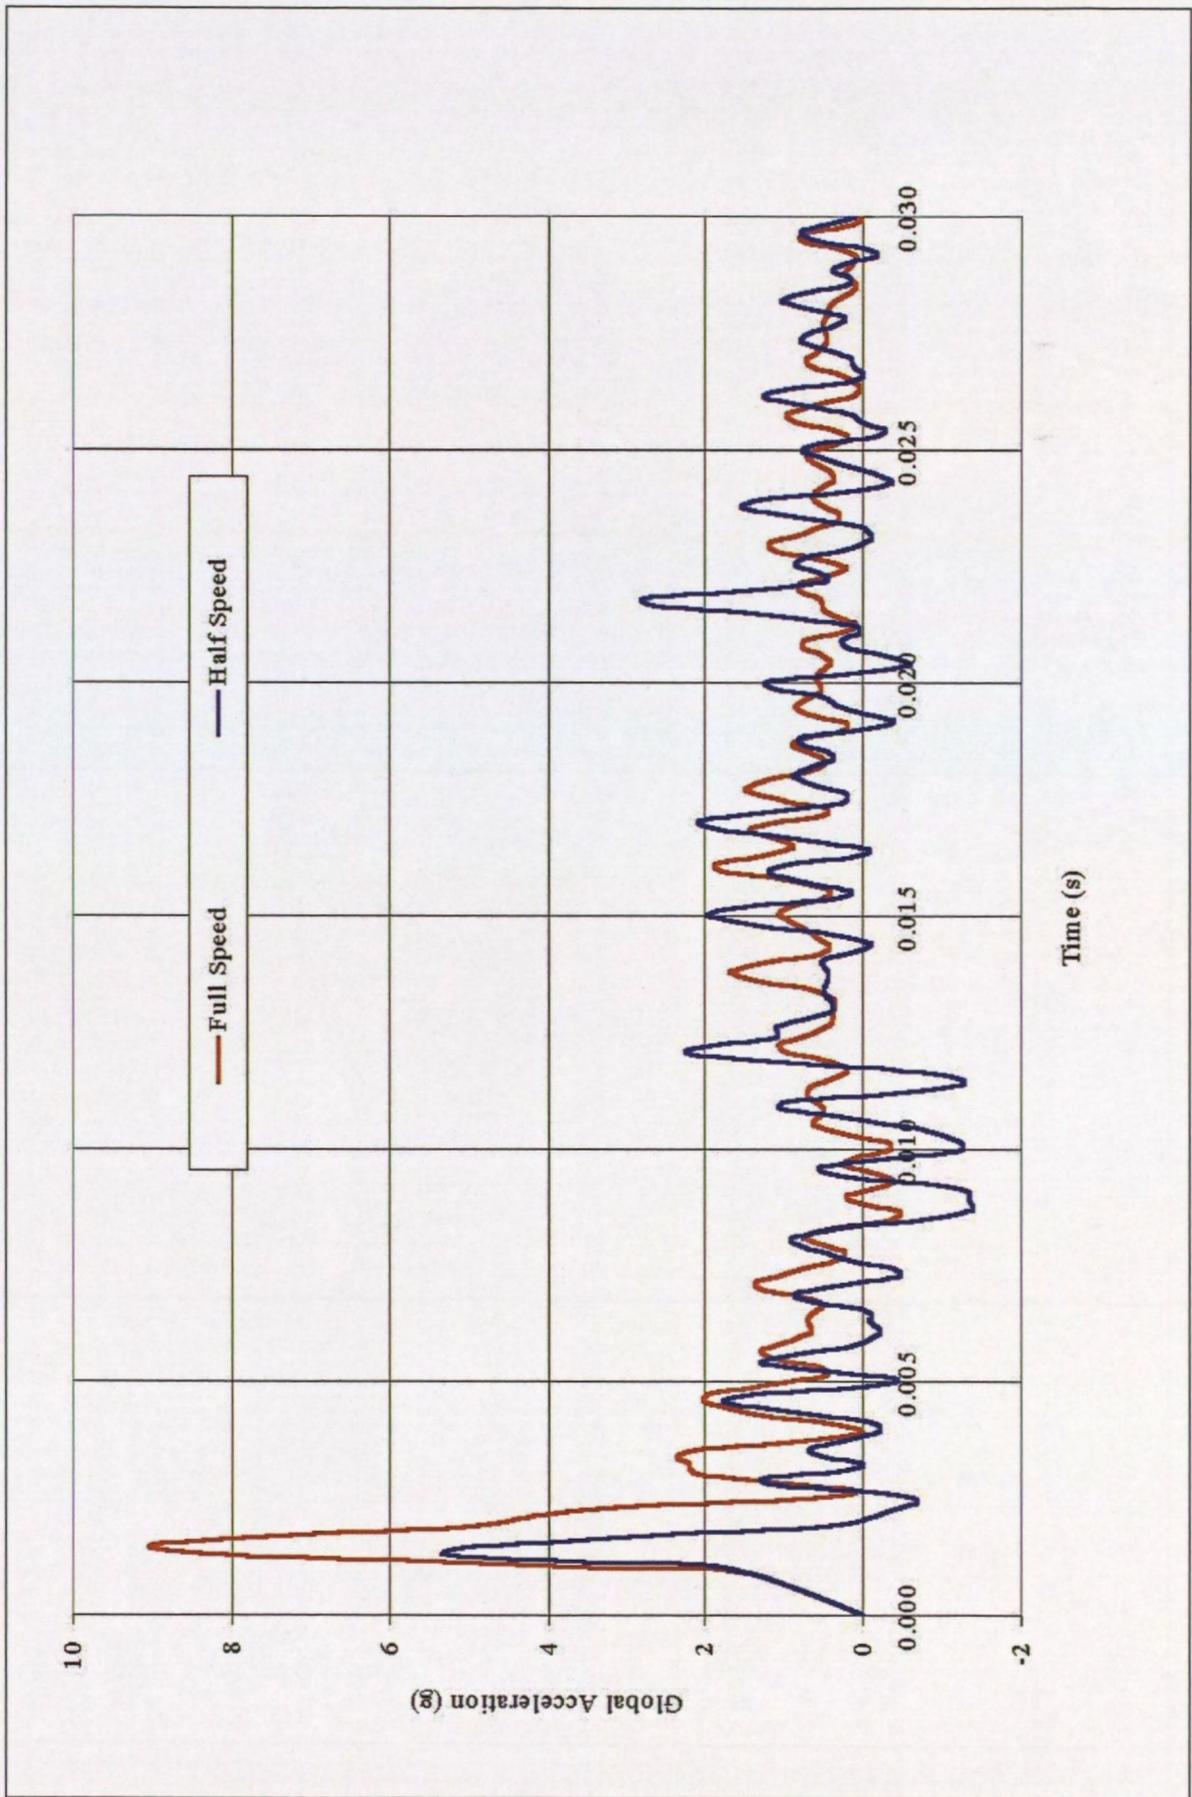
Figure 27: Isles of Scilly – Global Acceleration at Full Speed

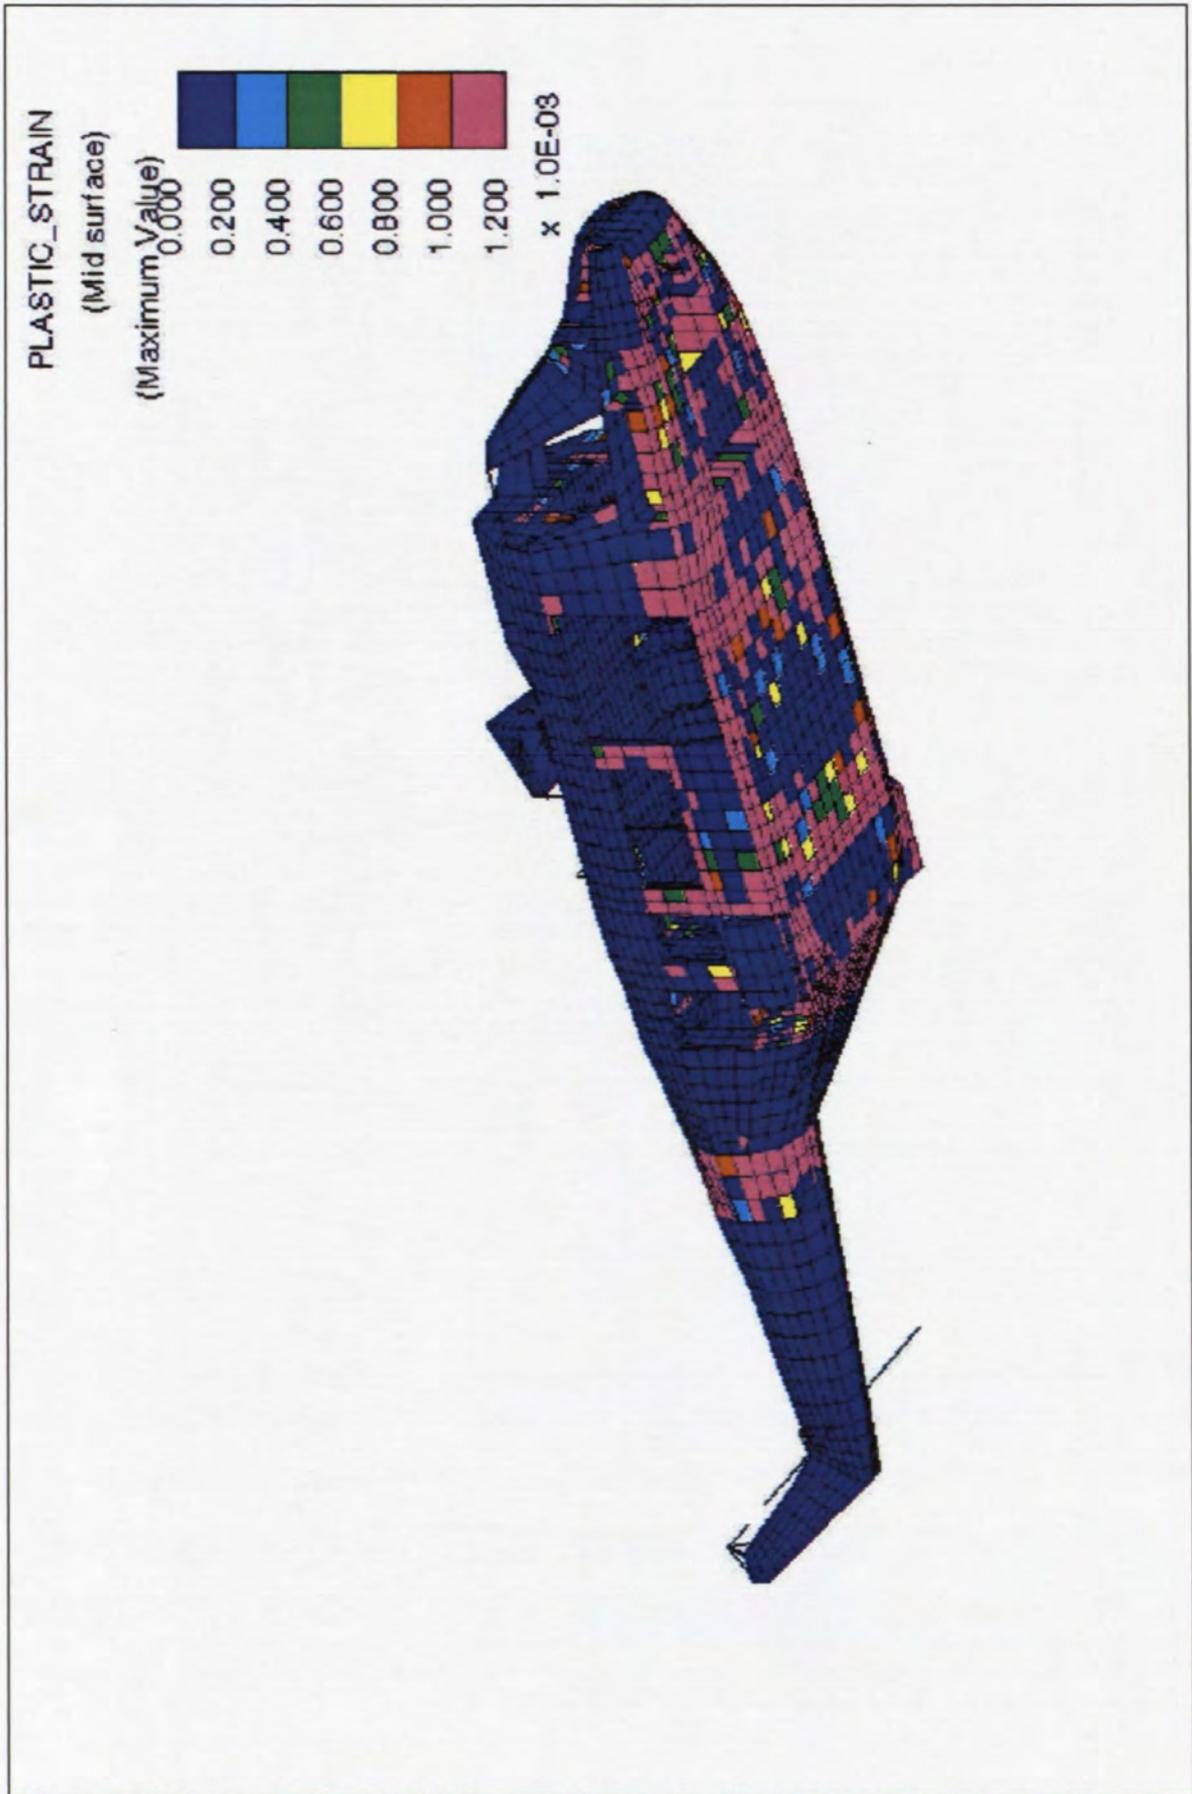
Figure 28: Isles of Scilly – Full Speed: Maximum Plastic Strain Throughout Time Period

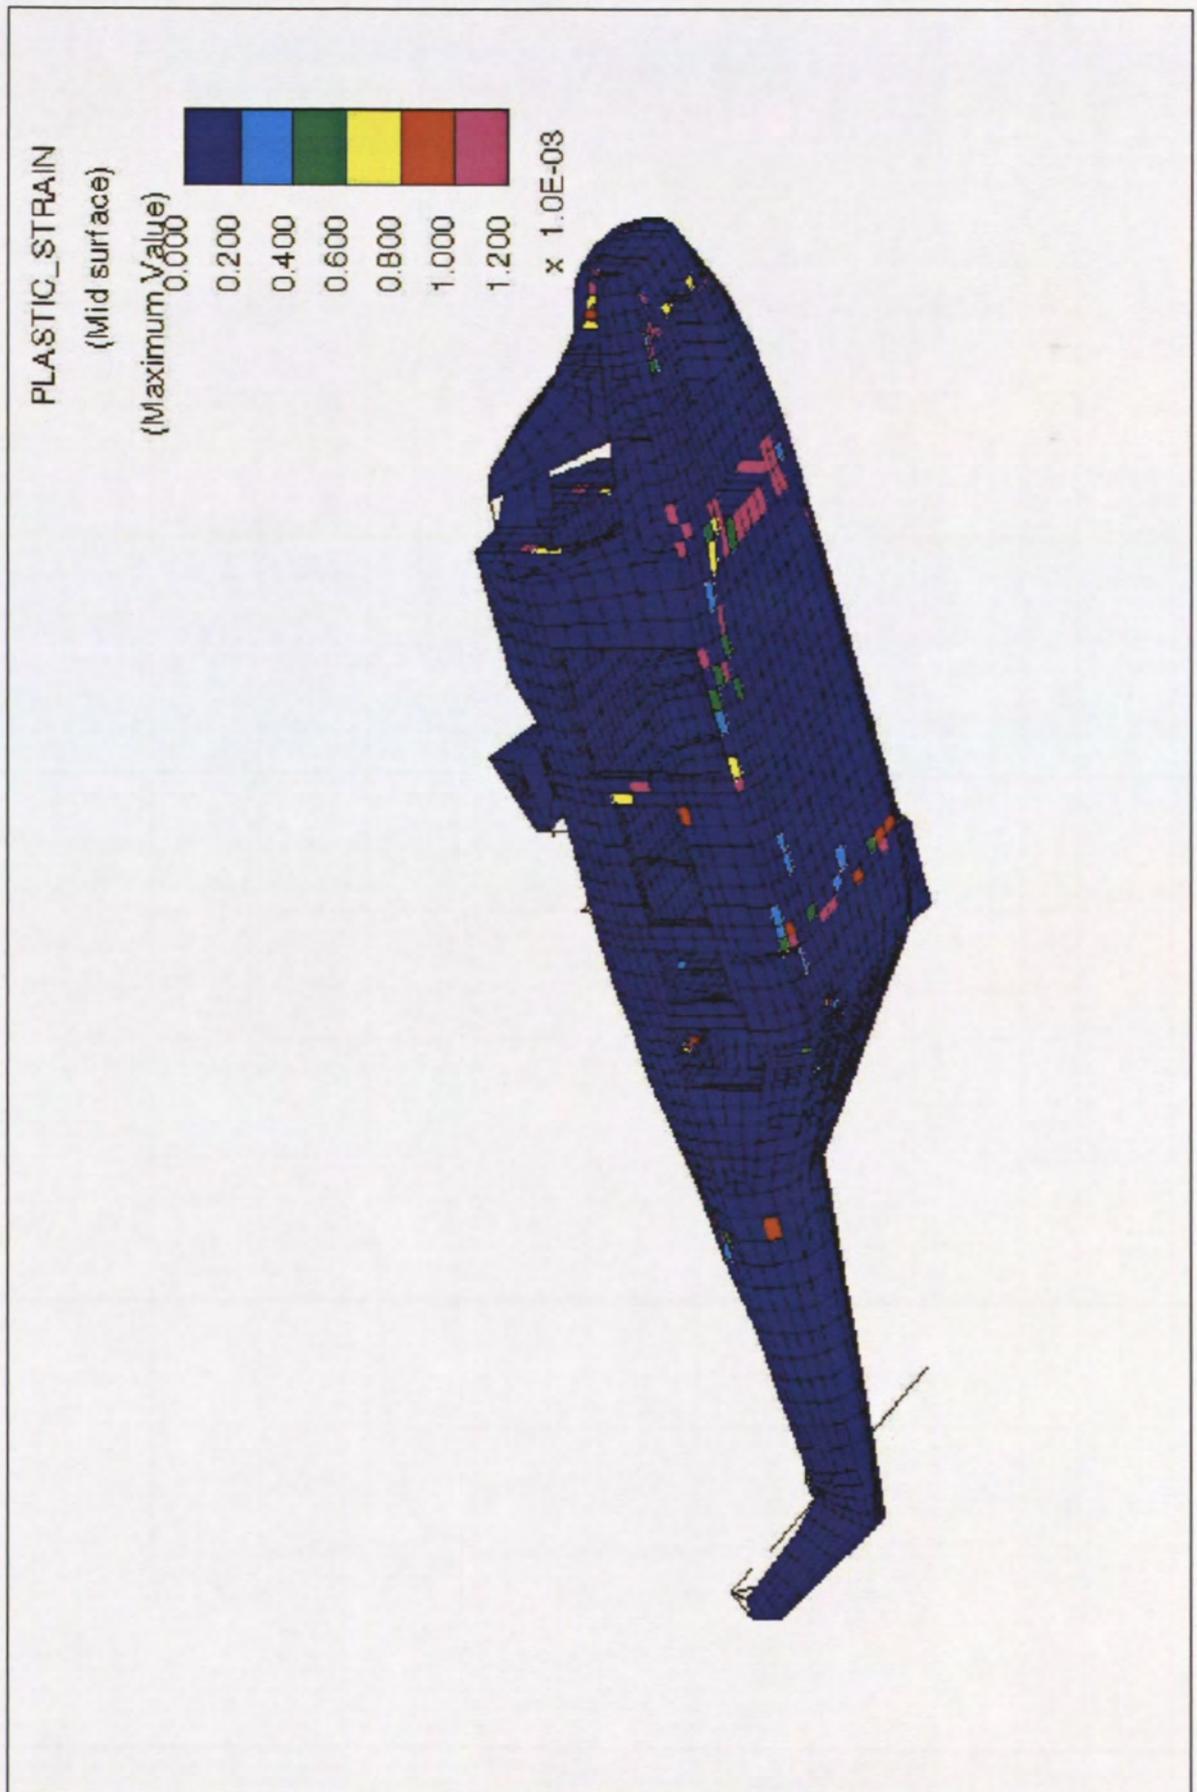
Figure 29: Isles of Scilly – Half Speed: Maximum Plastic Strain Throughout Time Period

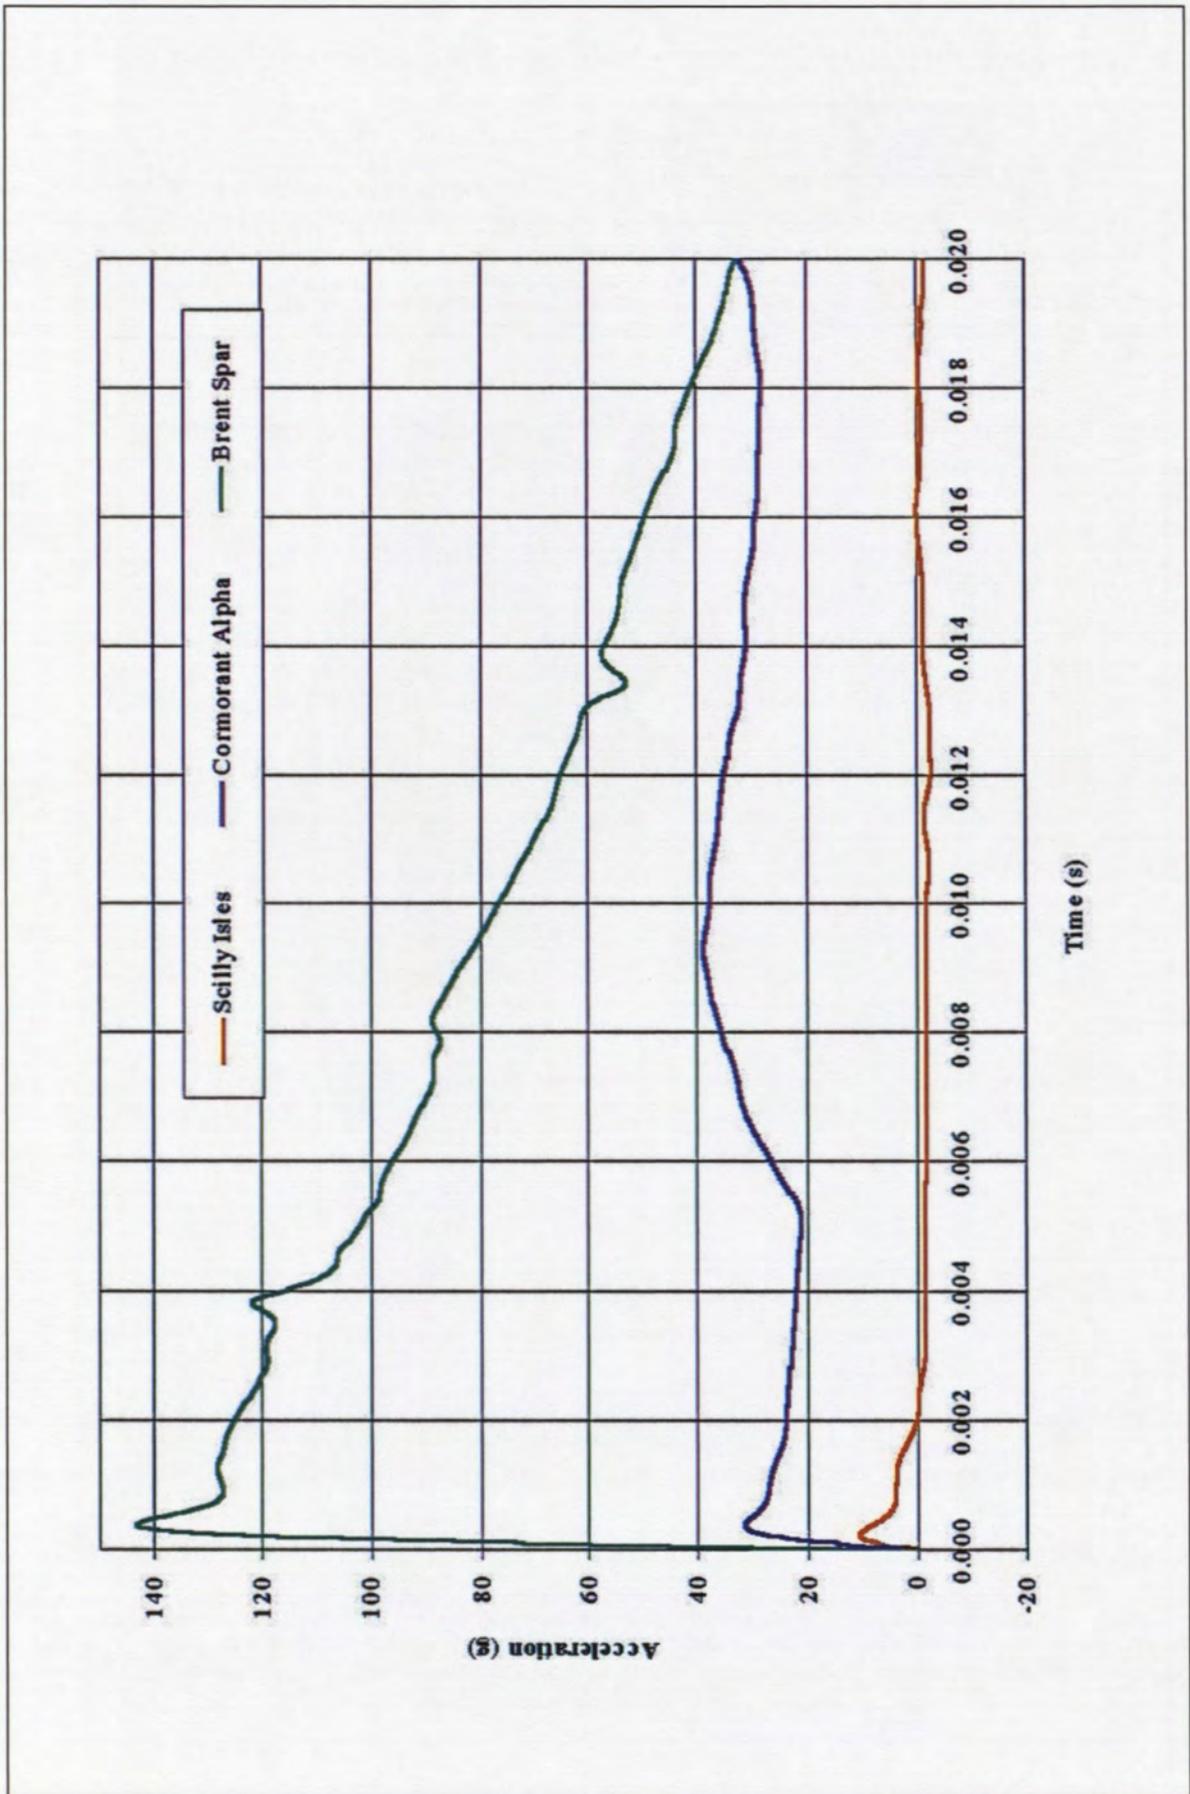
Figure 30: Global Accelerations For Full Speed Scenarios Eulerian Water Models

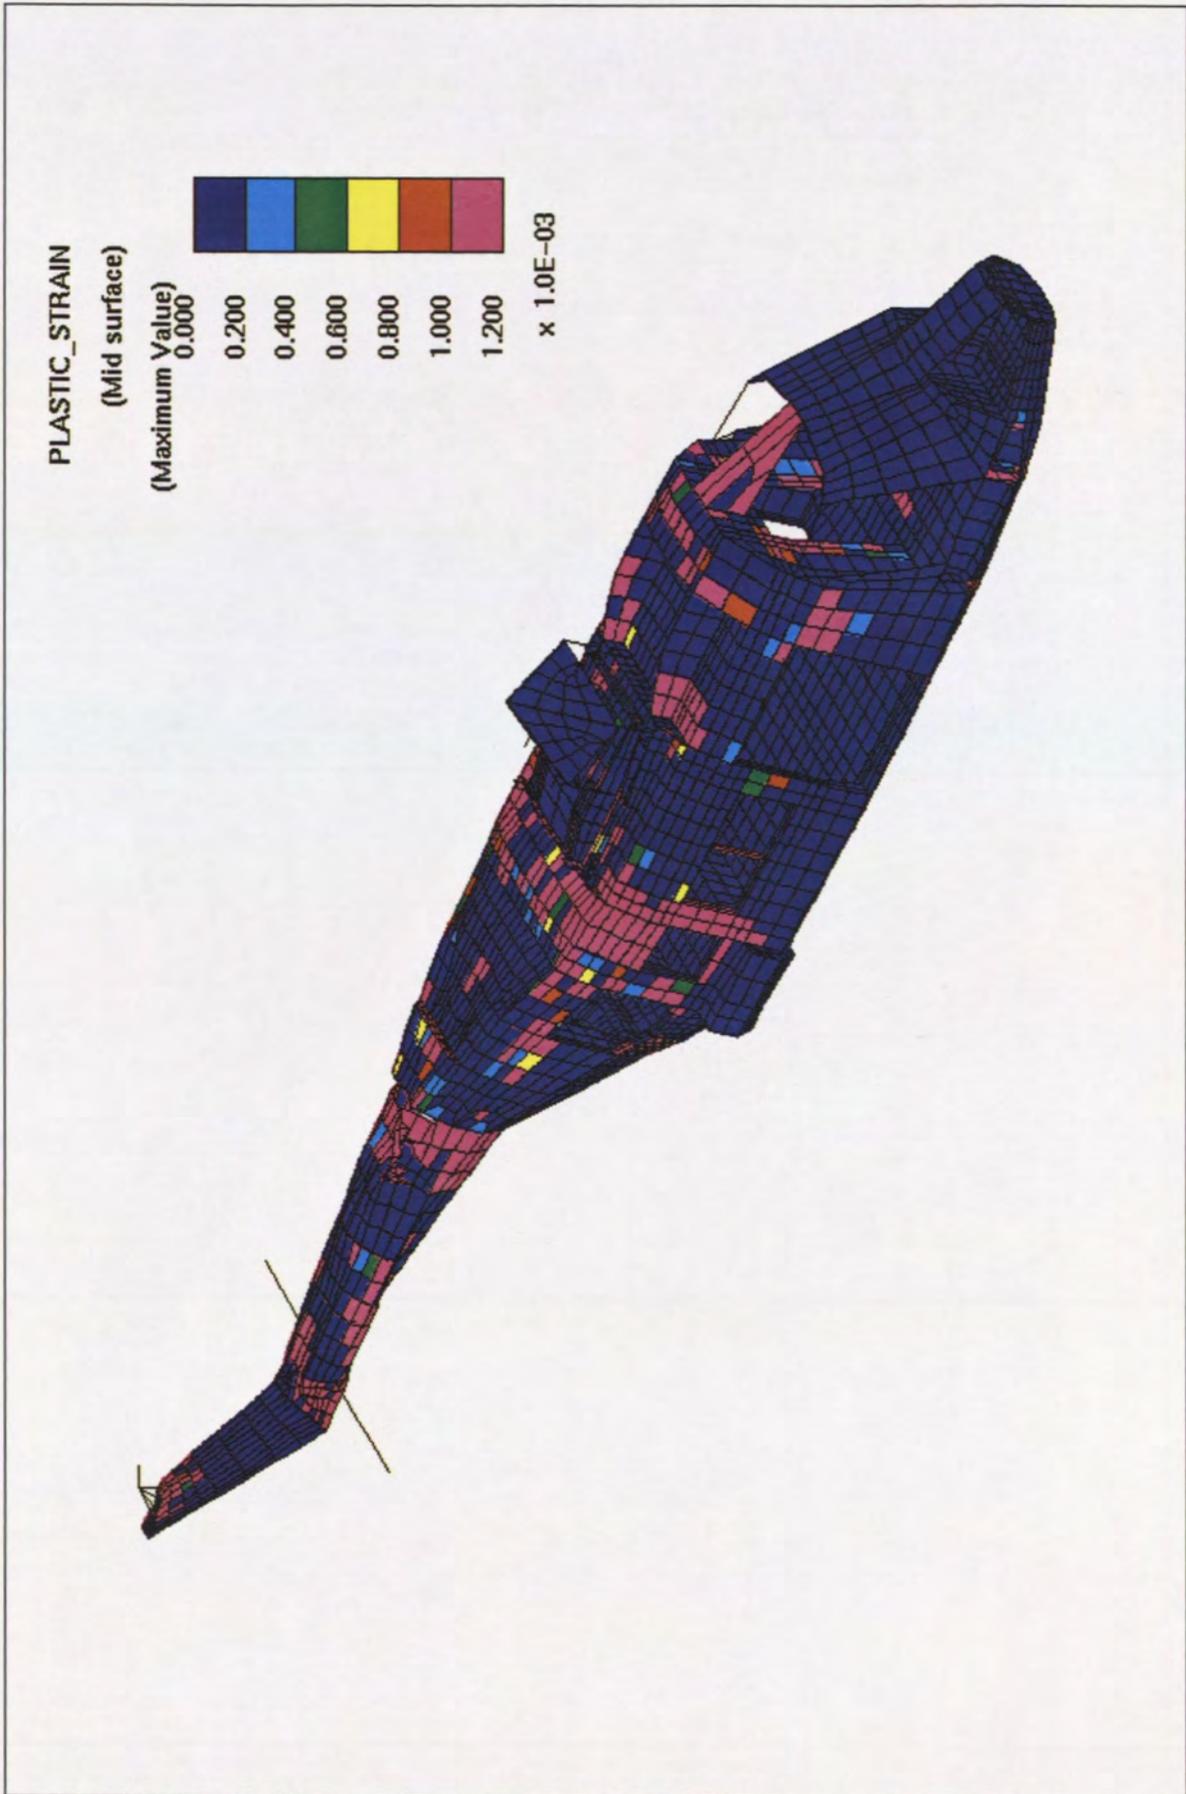
Figure 31: Plastic Strain for Full Speed Brent Spar Scenario Eulerian Water Model

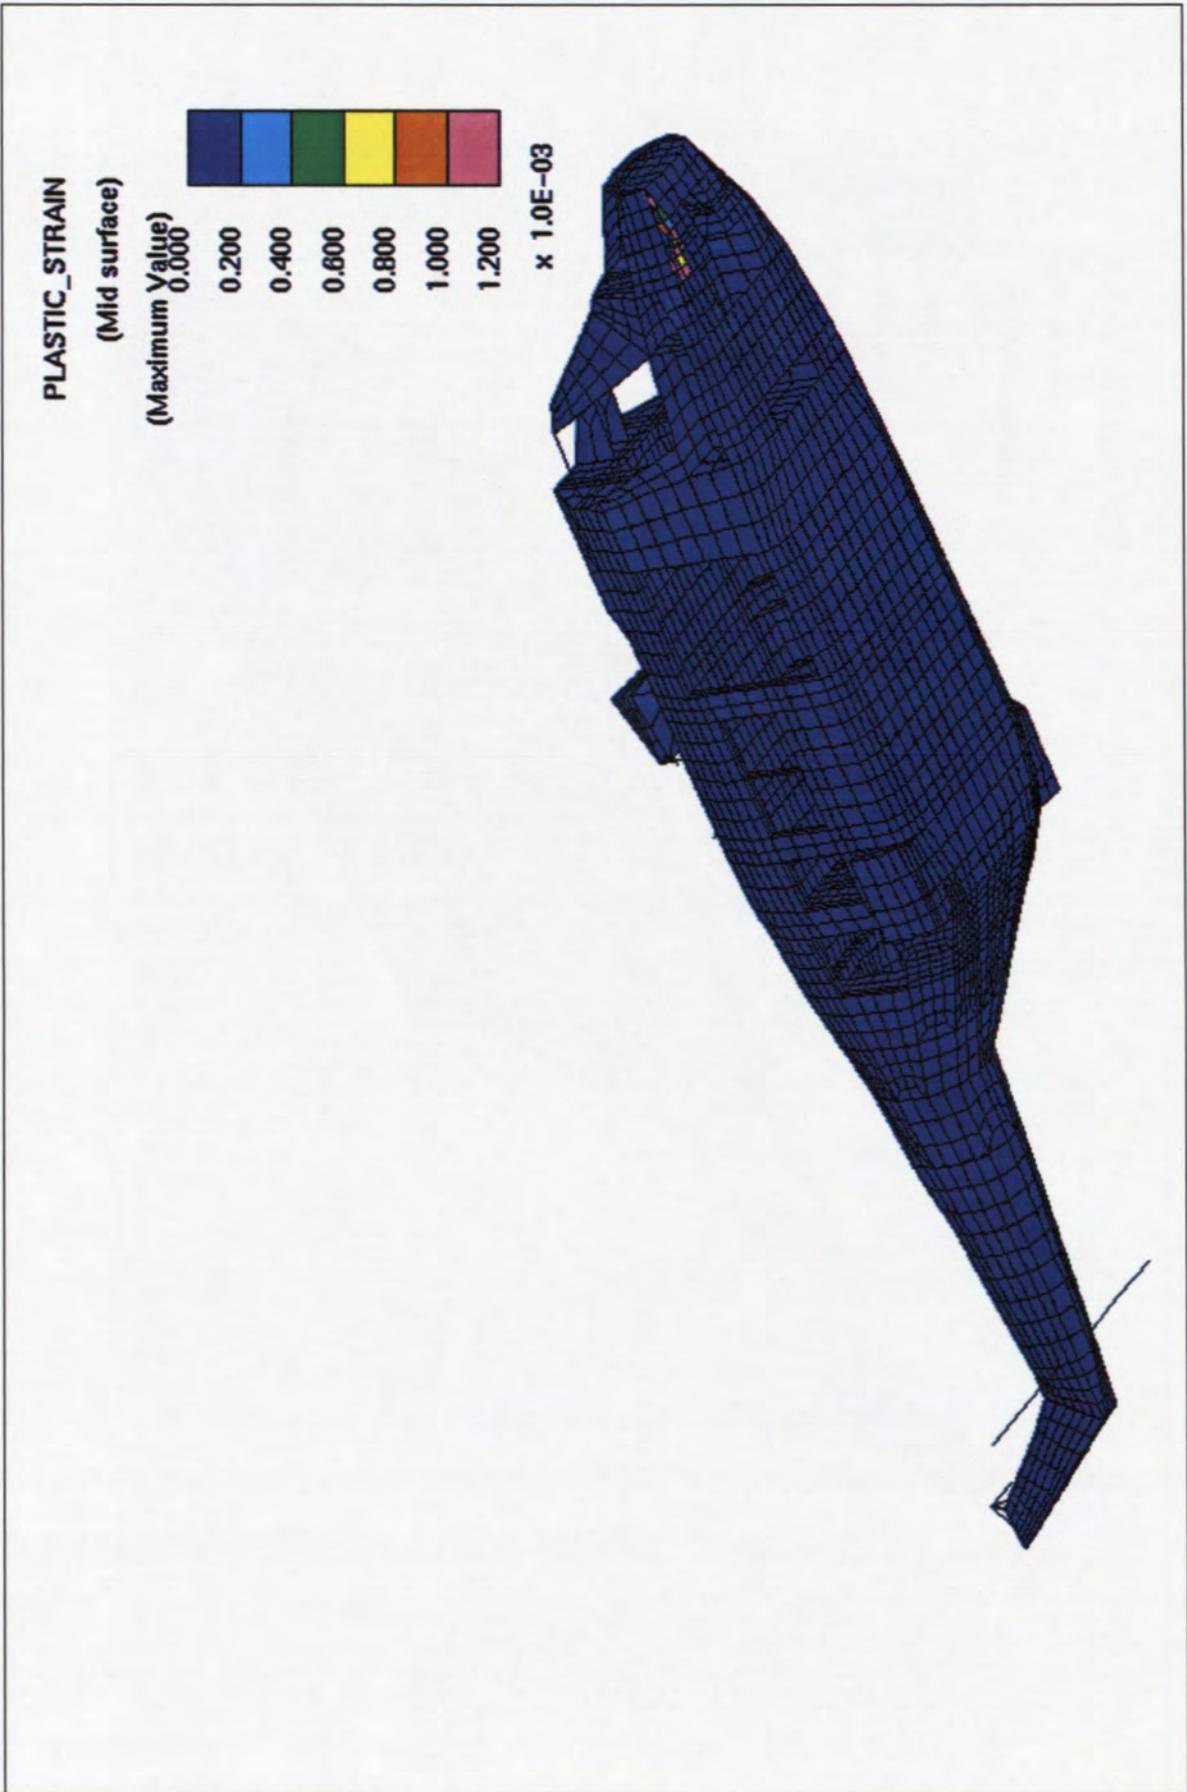
Figure 32: Plastic Strain for Full Speed Scilly Isles Scenario Eulerian Water Model

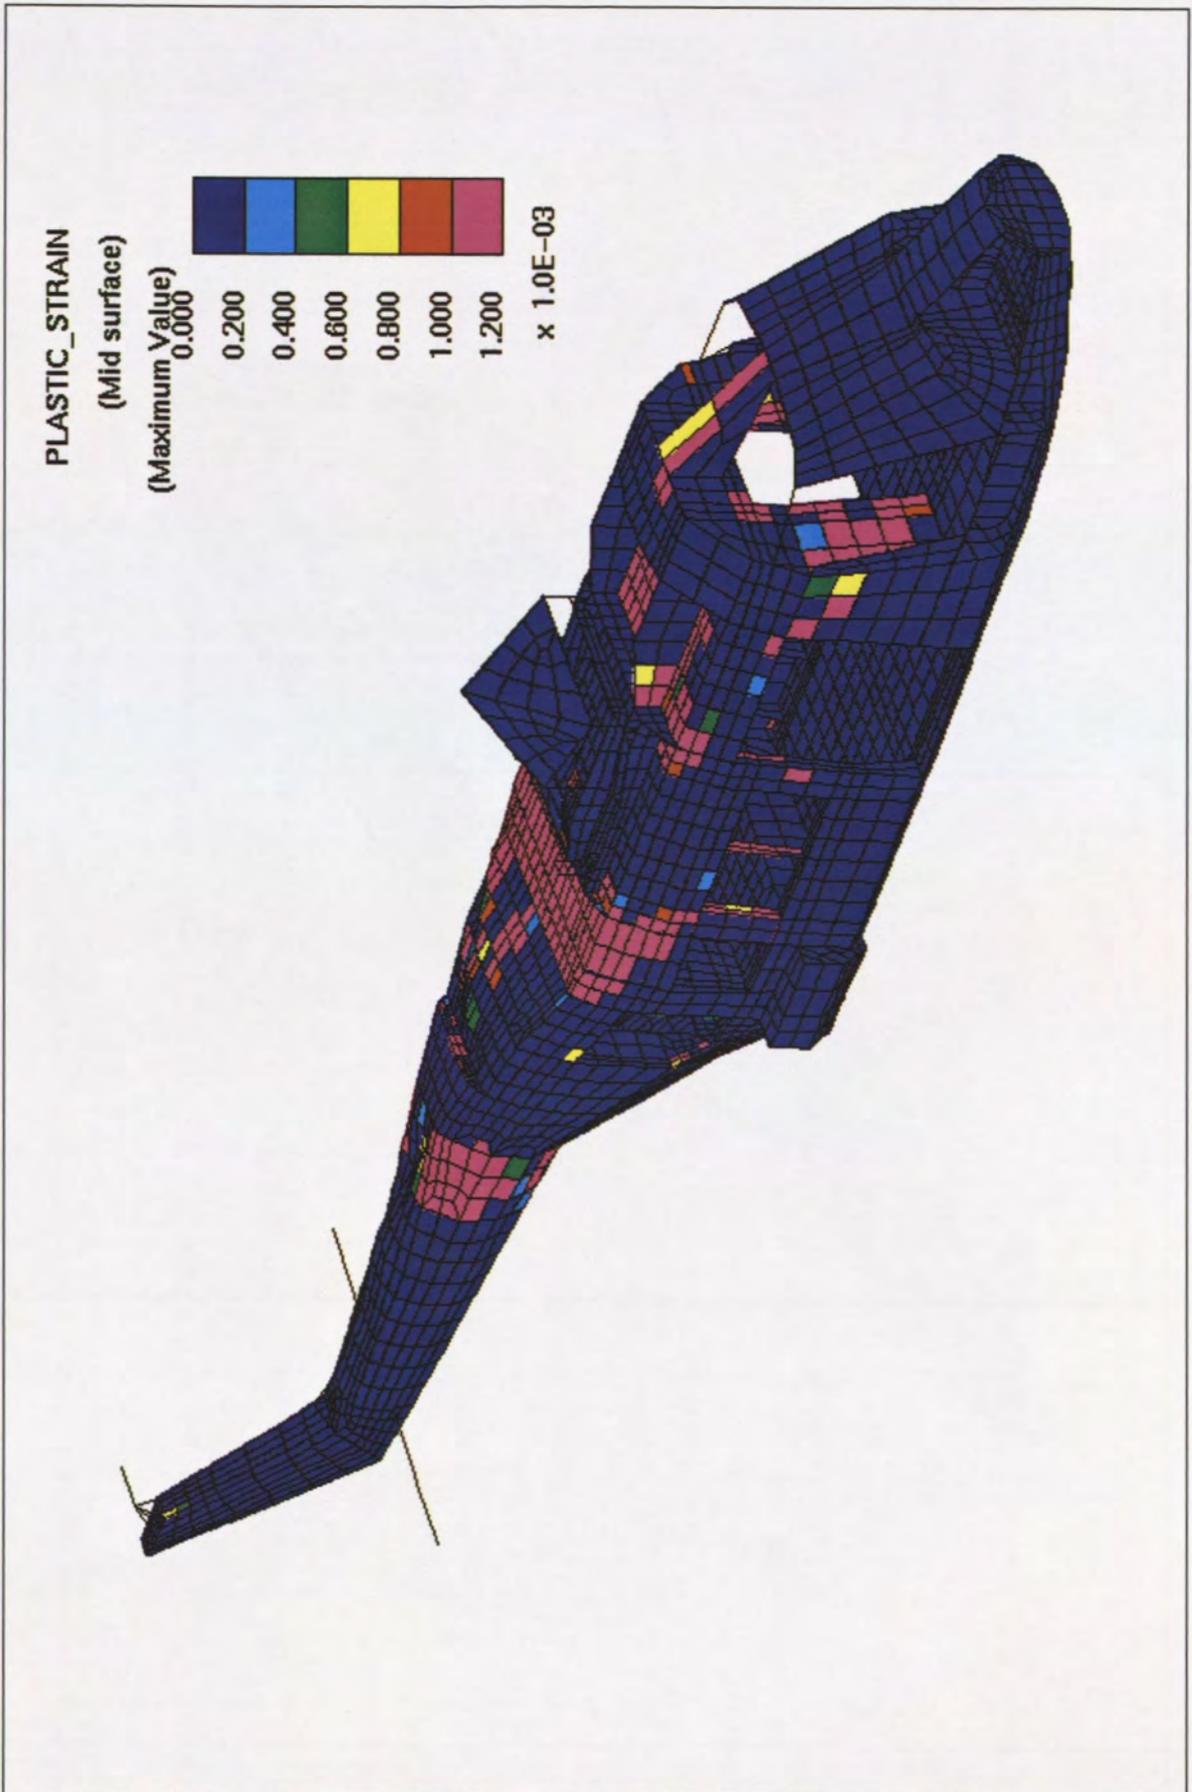
Figure 33: Plastic Strain for Full Speed Cormorant Alpha Scenario Eulerian Water Model

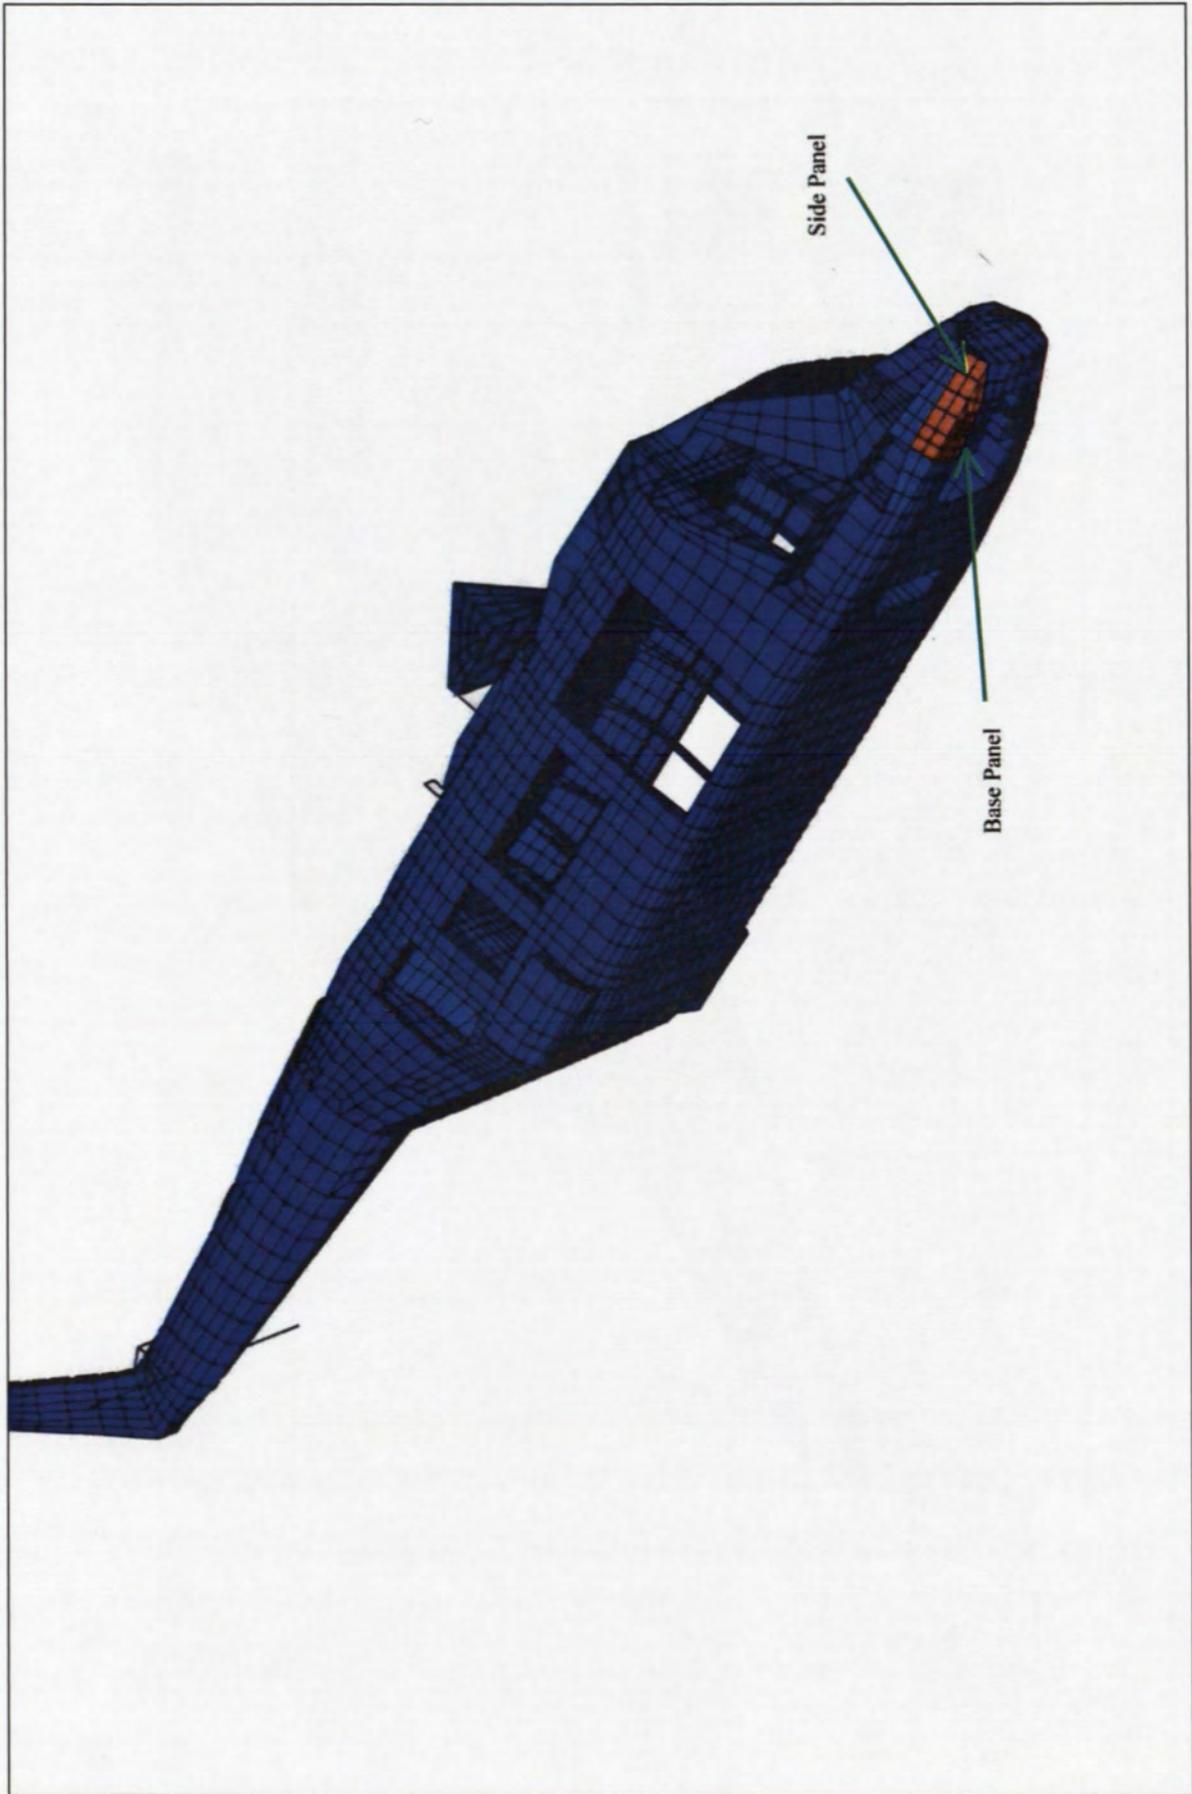
Figure 34: Location of Side Panels Under Consideration
