CAA PAPER 2001/2

**CRASHWORTHINESS OF HELICOPTER
EMERGENCY FLOTATION SYSTEMS**

Study I (Main Study)

Study II (Supplementary Study)

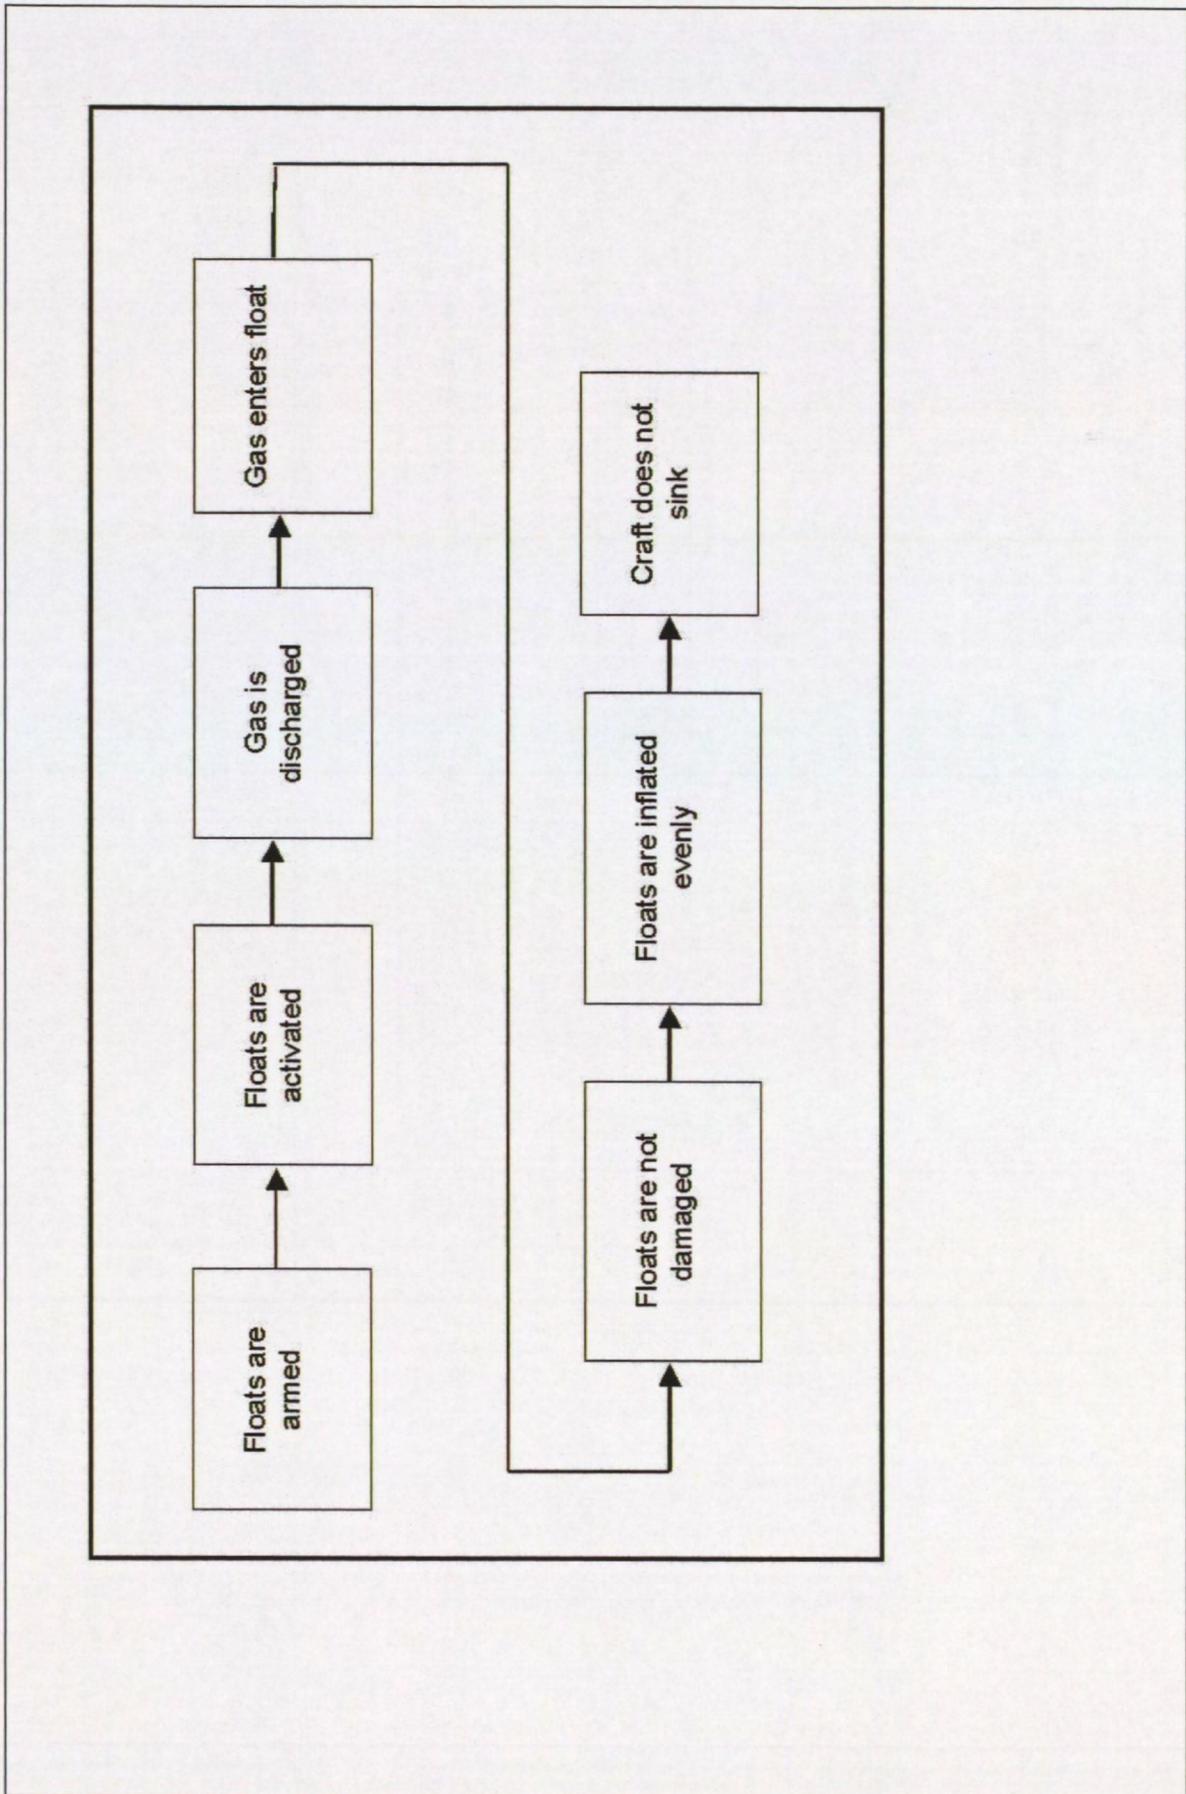
Figure 35: Sequence of Events in Successful Float Deployment

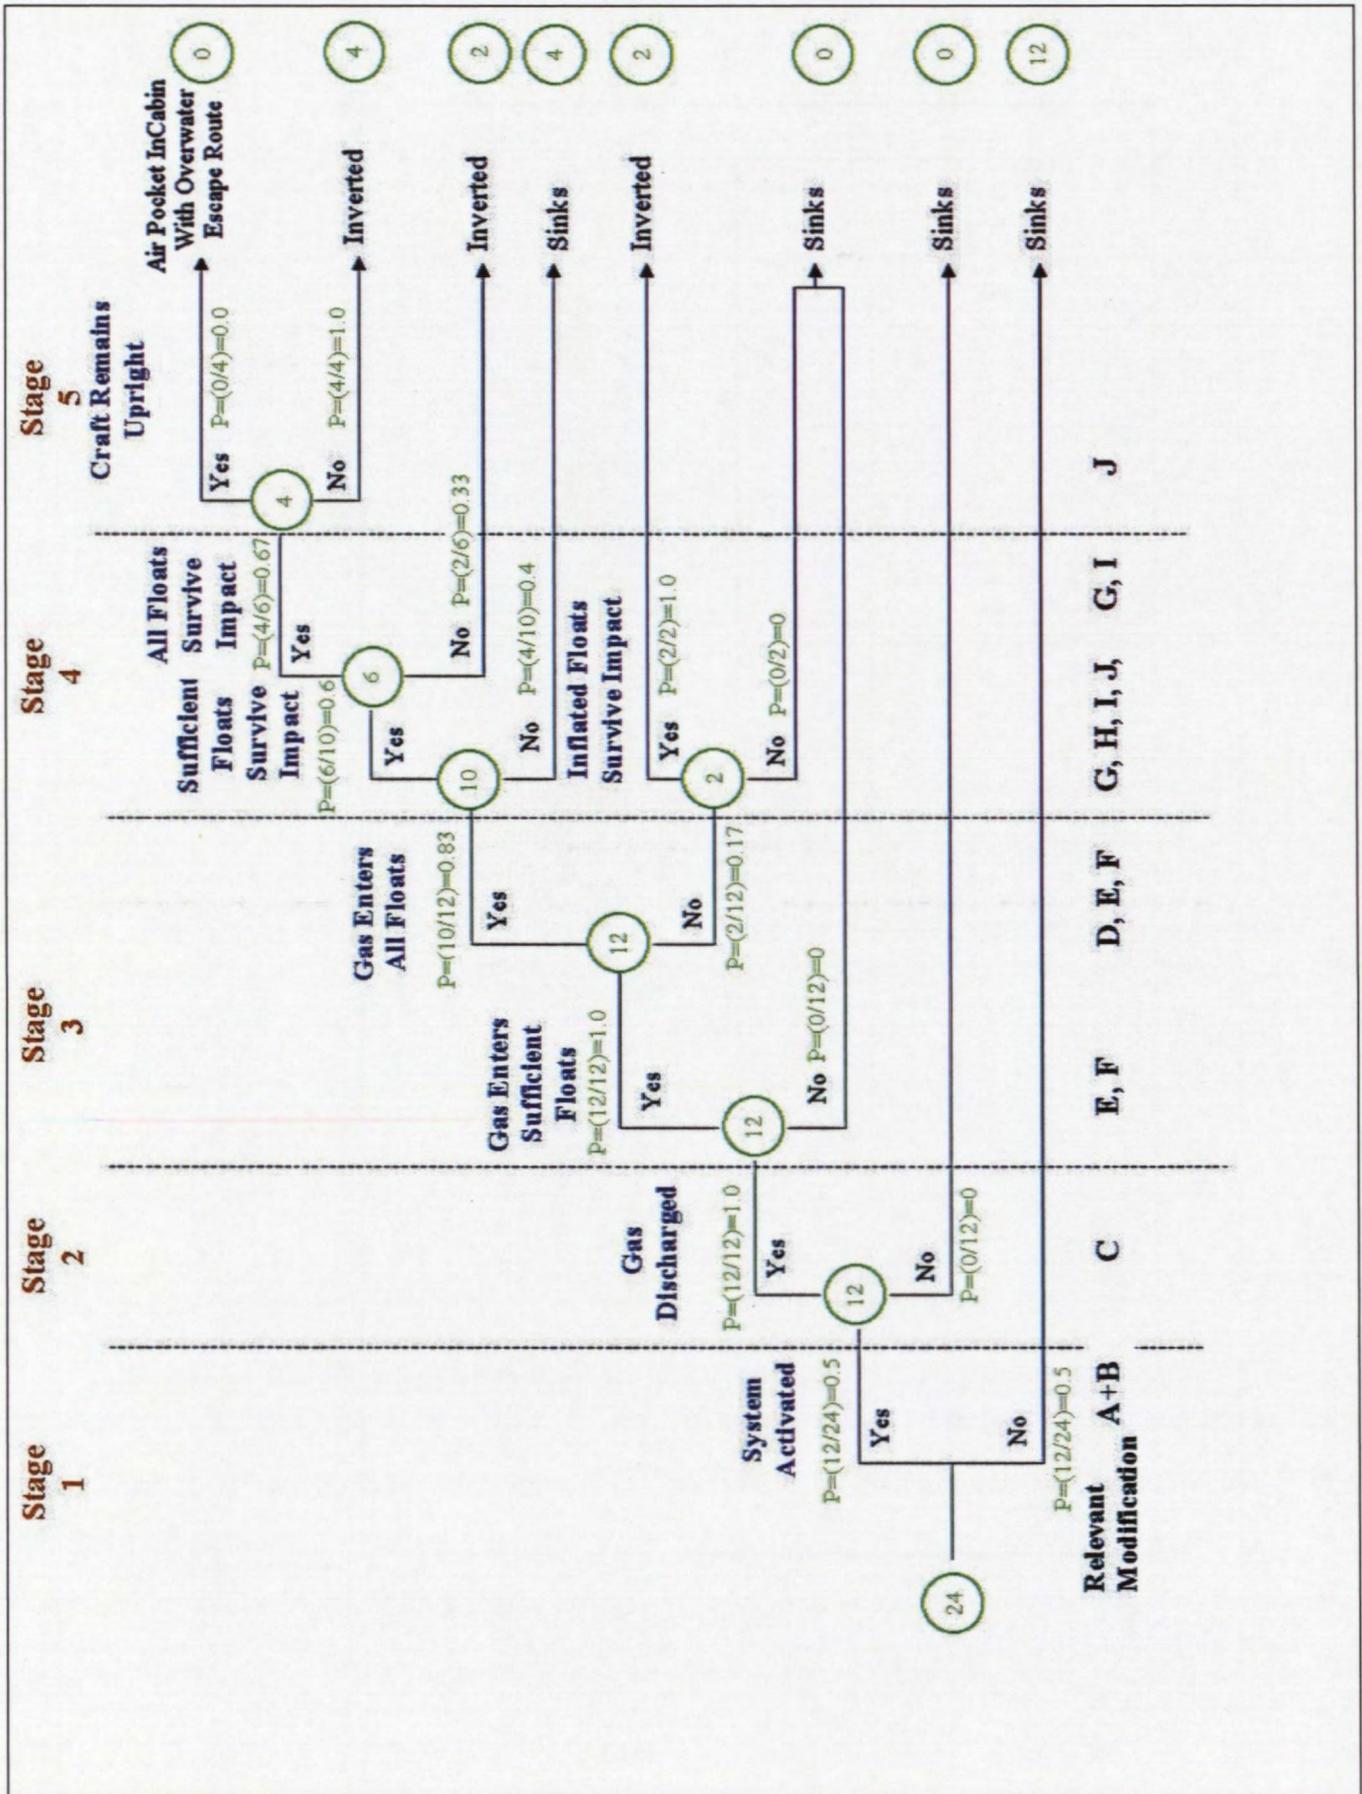
Figure 36: Probability Tree for Deployment of EFS

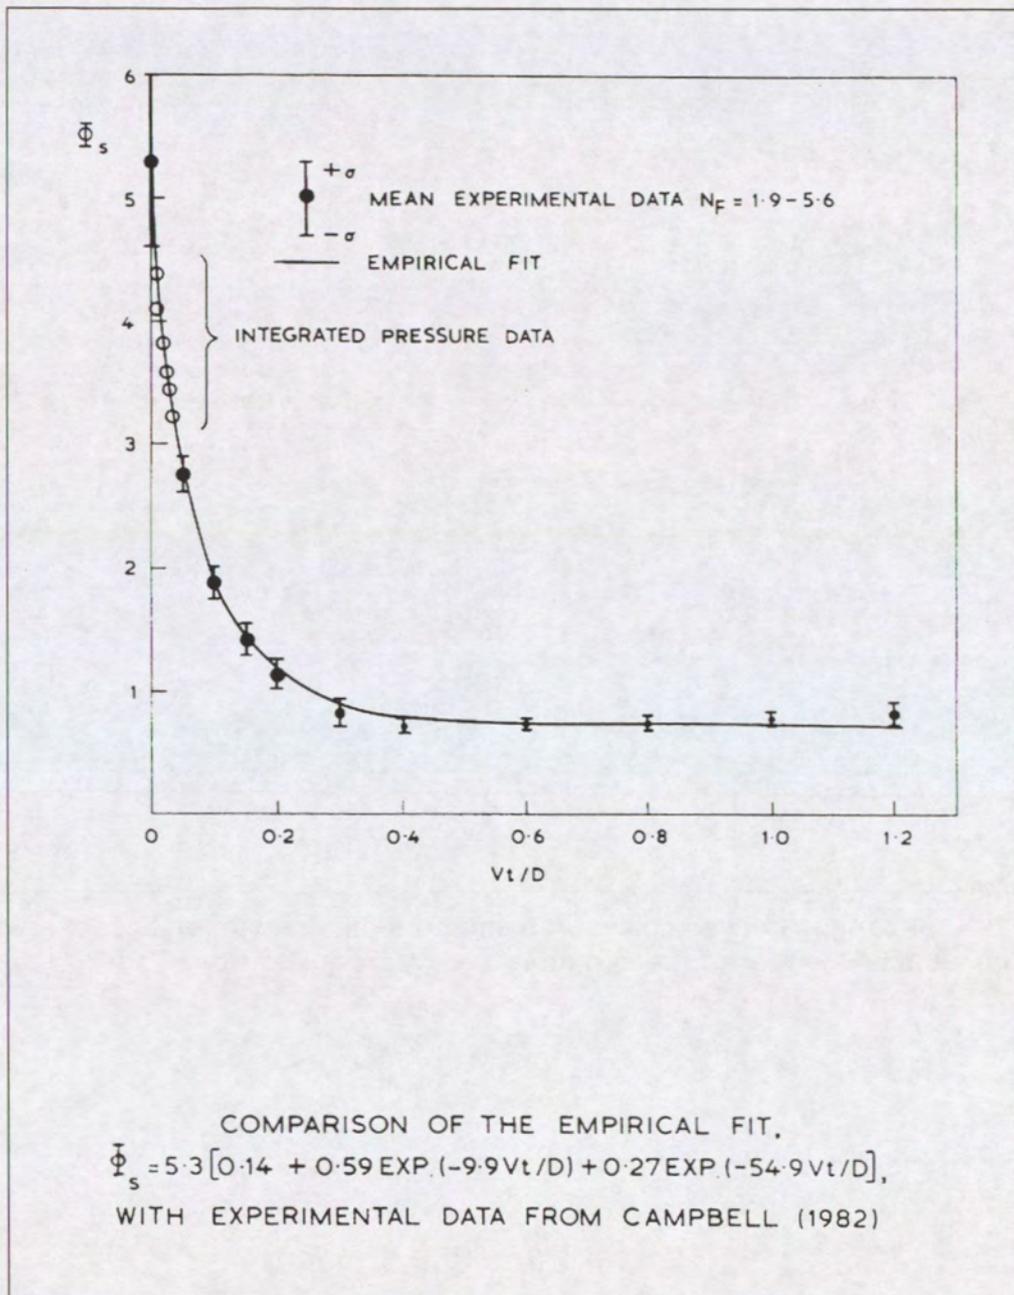
Figure 1: Comparison between the theoretical force history and measured data for horizontal cylinder impacts on smooth water (reproduced from Ridley [20]).

Ridley [20] proposed an alternative formula for predicting the impact force time history, which also fitted the measured data well (see Figure 1). Ridley's formula has since become the basis of a widely-used procedure [19] for estimating wave slamming forces on tubular members of offshore structures. This formula is therefore well-established in offshore design, and seemed to offer a reasonable basis for estimating water impact loads on a helicopter sponson. BMT therefore developed a procedure for estimating loads on the sponson based on Ridley's impact force formula combined with Campbell's 'strip theory' approach.

- (a) When a perfectly horizontal cylinder impacted onto perfectly still water the measured impact force time histories could all be collapsed onto a single curve, as illustrated in Figure 1. The vertical bars in this Figure show the low level of variability between different tests, and represent one standard deviation either side of the mean value at each point in the time-history.

Figure 1 shows the time history of the force on a smooth horizontal circular cylinder, of diameter D , falling with velocity u onto still water of density ρ . The Figure compares Ridley's [20] empirical formula with Campbell's measured data [21]. Ridley expressed the force per unit length of the cylinder, $F(t)$, in terms of a non-dimensional quantity, $\Phi_s(t)$, and as a function of time t :

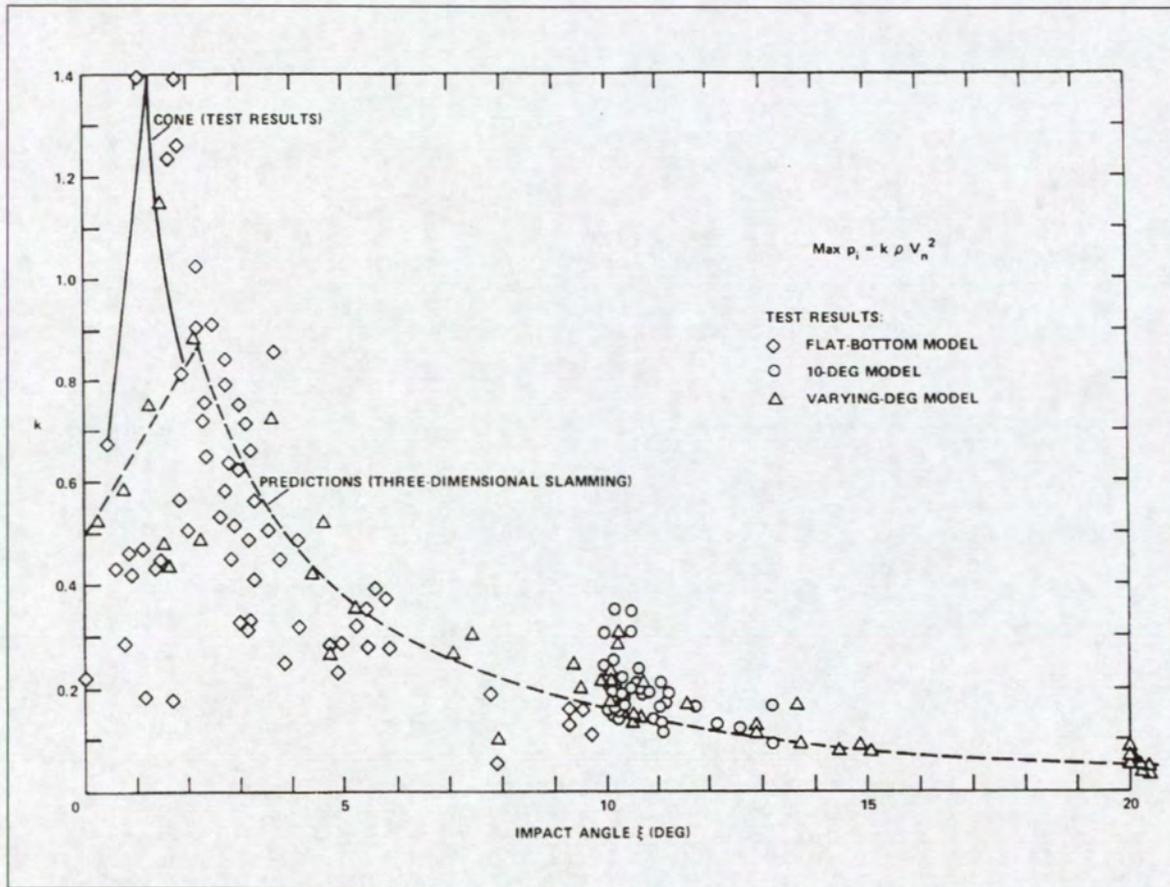
Figure 2: Comparison between measured and predicted maximum impact pressures from tests on wedges dropped onto waves (reproduced from Chuang [26]).

Chuang [26] reported results from an extensive and systematic programme of local impact pressure measurements on wedges and cones dropped onto both calm water and regular waves. The results from the tests in waves are of particular interest because wave slamming forces are known to be very sensitive to the shape of the water surface, its roughness and the amount of air entrapment. Figure 22 of Chuang's report [26], reproduced as Figure 2, summarises the results obtained from all of Chuang's tests in regular waves, and compares the results with his own empirical prediction formula (shown as a dashed line). The experimental data show considerable scatter (as is usual in experiments of this type in waves), but the empirical curve lies above the majority of the data.

The coefficient k , shown in Figure 2, is in an unconventional set of units, and is not the same as the usual maximum pressure coefficient, $C_{p \max}$, which may be obtained by setting:

Entrapped air has a pronounced 'cushioning' effect at small angles of impact, and the impact pressure is very sensitive to small changes in the angle between the structure and water surfaces, to local changes in the surface shape and roughness, and to the degree of aeration. This is the reason why Chuang's empirical curve, shown in Figure 2, falls when the impact angle is small, whereas Wagner's theoretical model

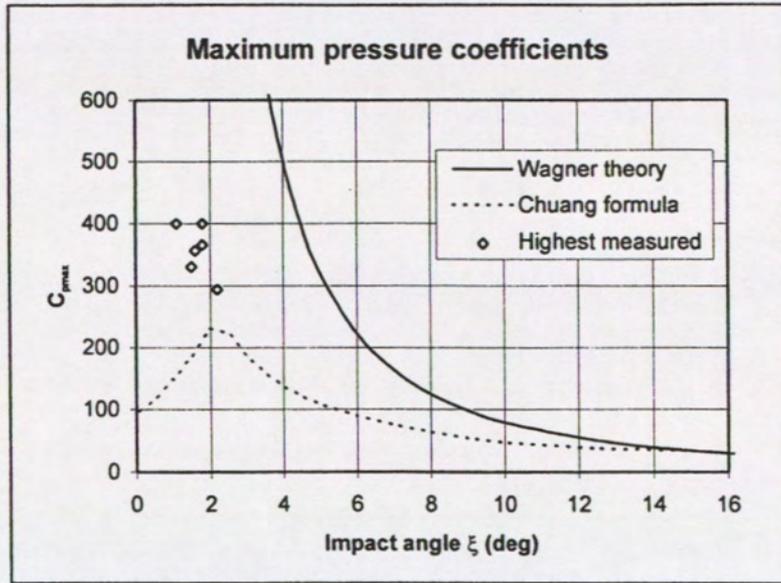
Figure 3: Comparison between Wagner and Chuang formulae for the maximum pressure coefficient.

Figure 3 compares maximum pressure coefficients predicted using Wagner's theoretical model [13] with those predicted using Chuang's empirical formula. The pressure coefficient, C_{pmax} , has been plotted against the impact angle, ξ . The two curves approach each other when ξ is greater than 15° , but behave in a very different manner when the impact angle is small. This Figure also shows the highest values of C_{pmax} obtained during Chuang's experiments. These highest values are very scattered, and are up to twice the values predicted by Chuang's formula.

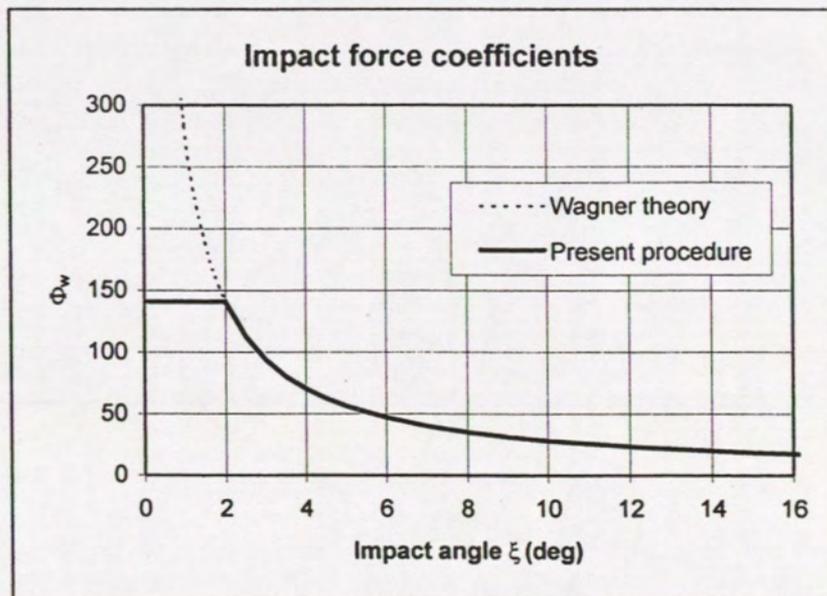
Figure 4: Comparison between the impact force coefficient $\Phi_w(\xi)$ used in the present analysis with that predicted by Wagner's theory.

Figure 4 compares values of $\Phi_w(\xi)$, defined using equations (7), (8) and (15), with the equivalent values obtained using the original Wagner theory.

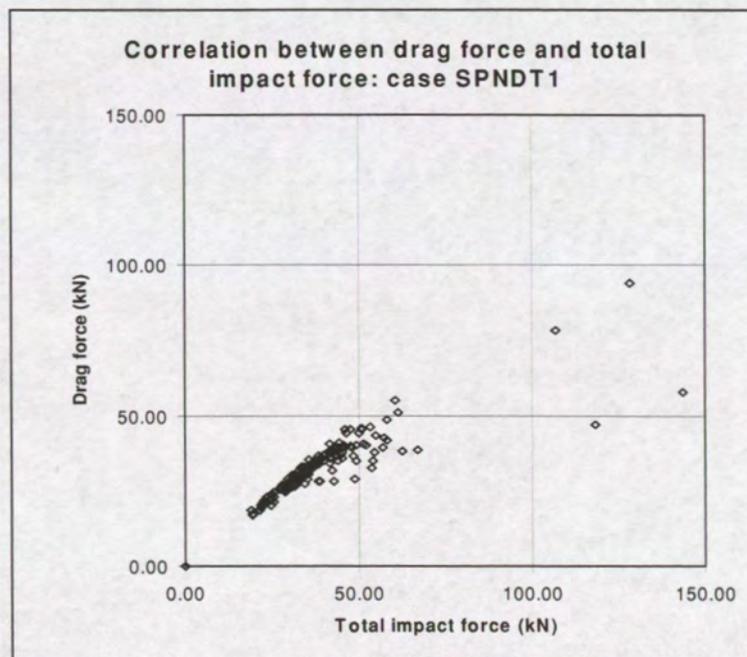
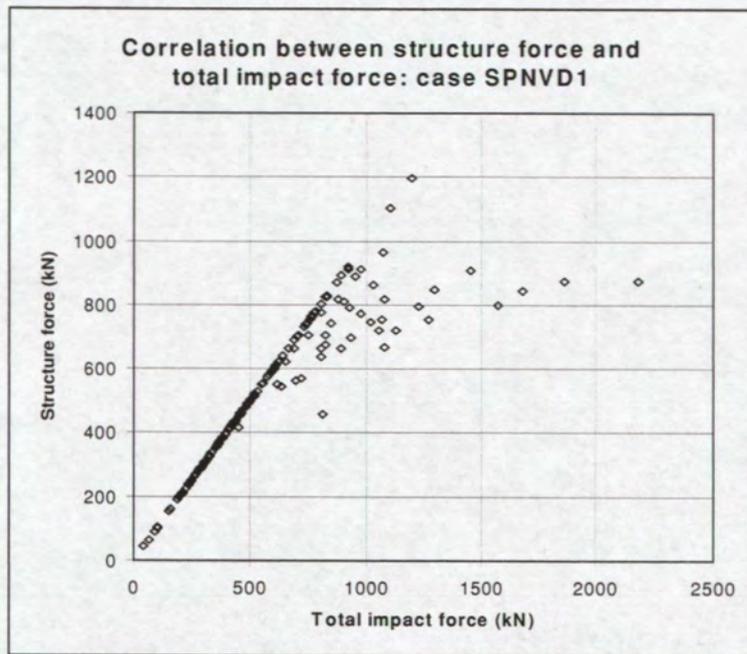
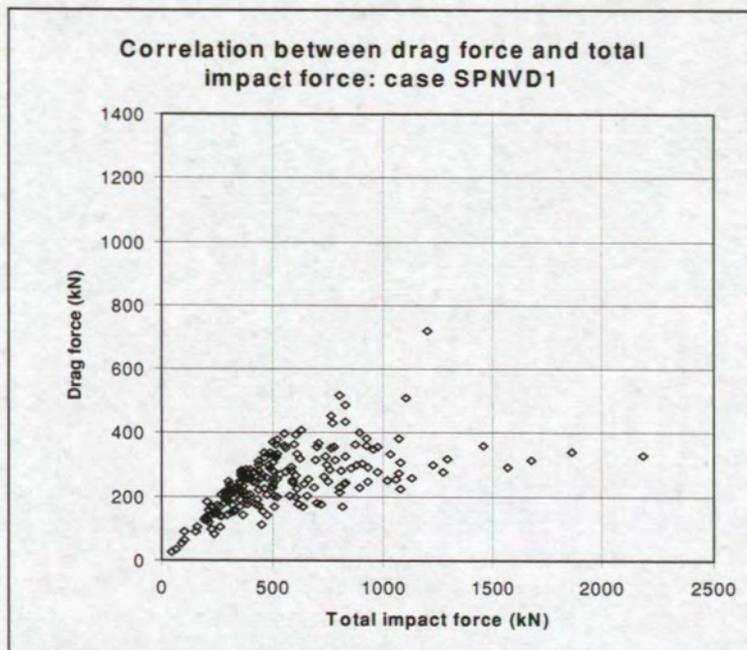
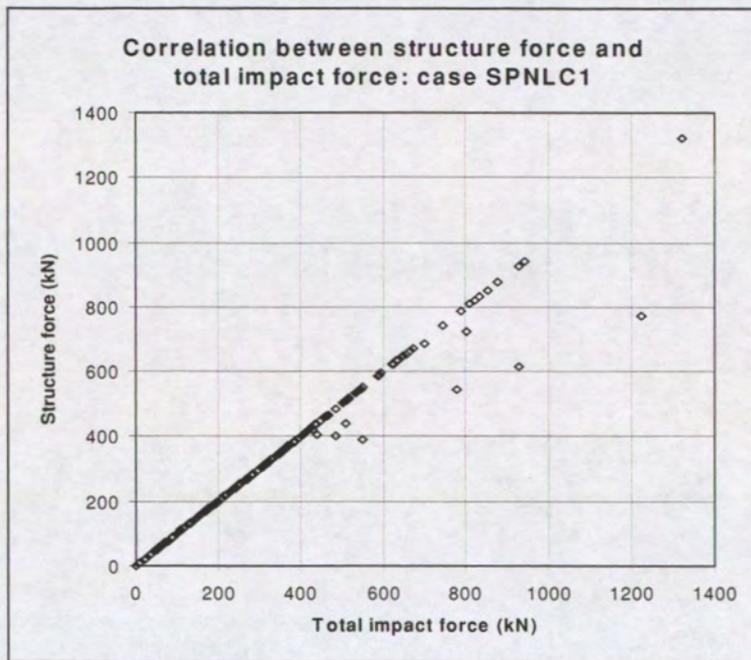
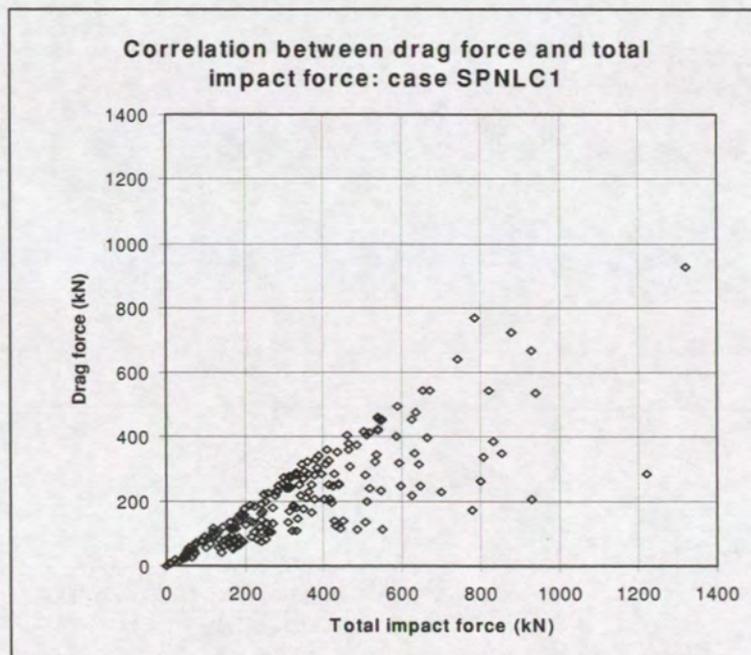
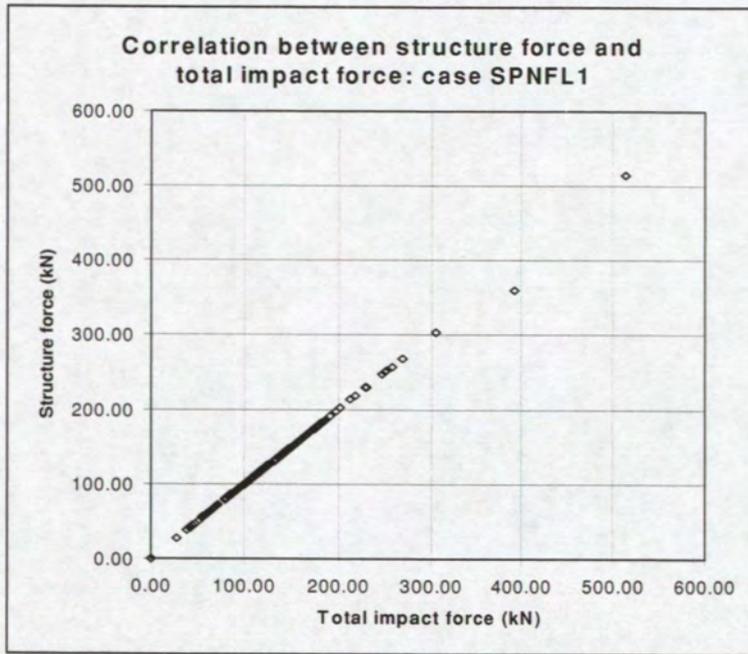
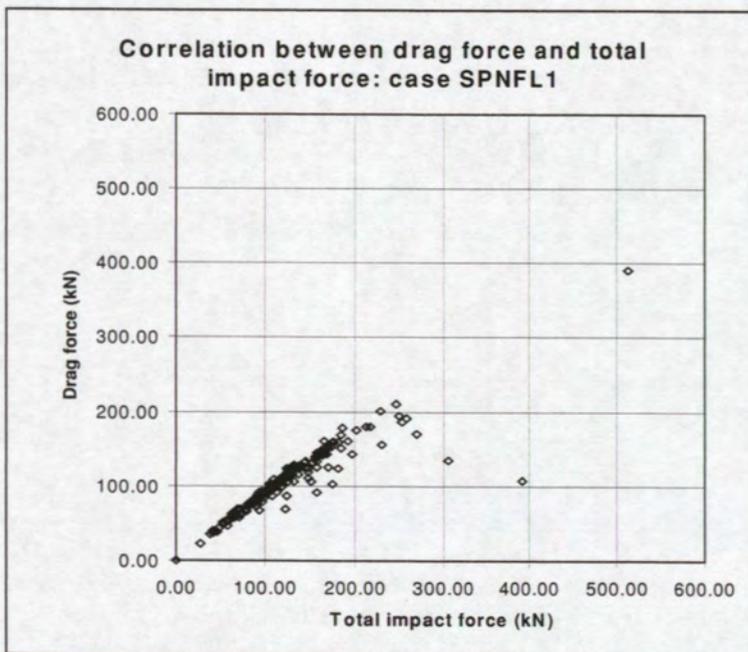
**Correlation plots: maximum structure and drag forces
against the total impact force on the sponson;
all incident scenarios, base case conditions.**

Figure 8: Correlation between maximum structure force and total impact force: sponson in controlled ditching incident, central North Sea waves.

Figure 9: Correlation between the drag force and maximum total impact force: sponson in controlled ditching incident, central North Sea waves.

Figure 10: Correlation between maximum structure force and total impact force: sponson in vertical descent incident, central North Sea waves.

Figure 11: Correlation between the drag force and maximum total impact force: sponson in vertical descent incident, central North Sea waves.

Figure 12: Correlation between maximum structure force and total impact force: sponson in loss of control incident, central North Sea waves.

Figure 13: Correlation between the drag force and maximum total impact force: sponson in loss of control incident, central North Sea waves.

Figure 14: Correlation between maximum structure force and total impact force: sponson in fly-in incident, central North Sea waves.

Figure 15: Correlation between the drag force and maximum total impact force: sponson in fly-in incident, central North Sea waves.

Figures 8 to 15 illustrate relationships between simultaneous estimates of the maximum total hydrodynamic impact force on the sponson and corresponding estimates of the maximum structure force and drag force. These correlation plots are based on the first 200 samples from each 20,000-point simulation run. Each quantity is plotted against the corresponding value of the maximum total impact force.

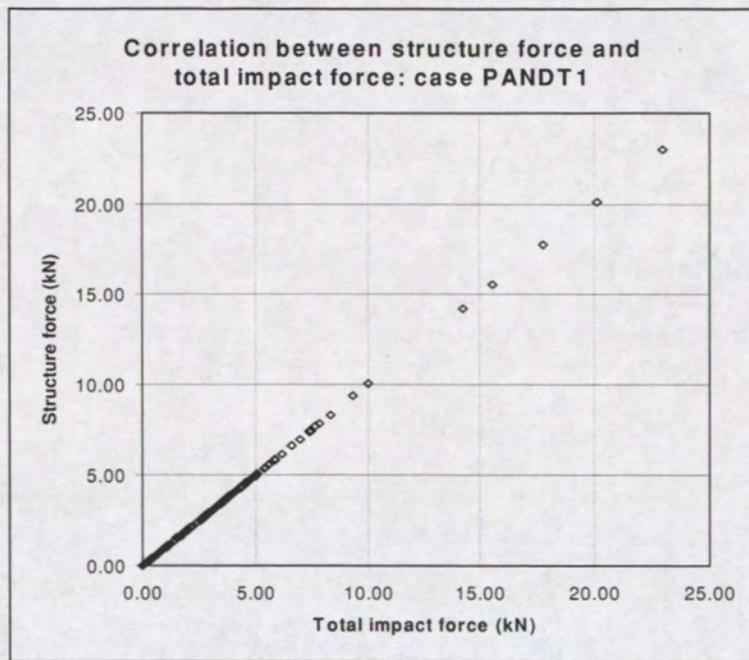
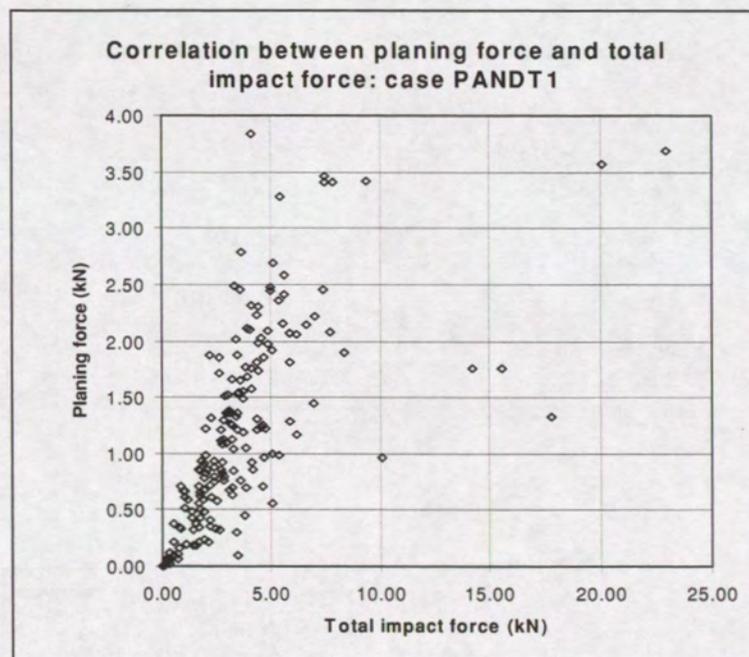
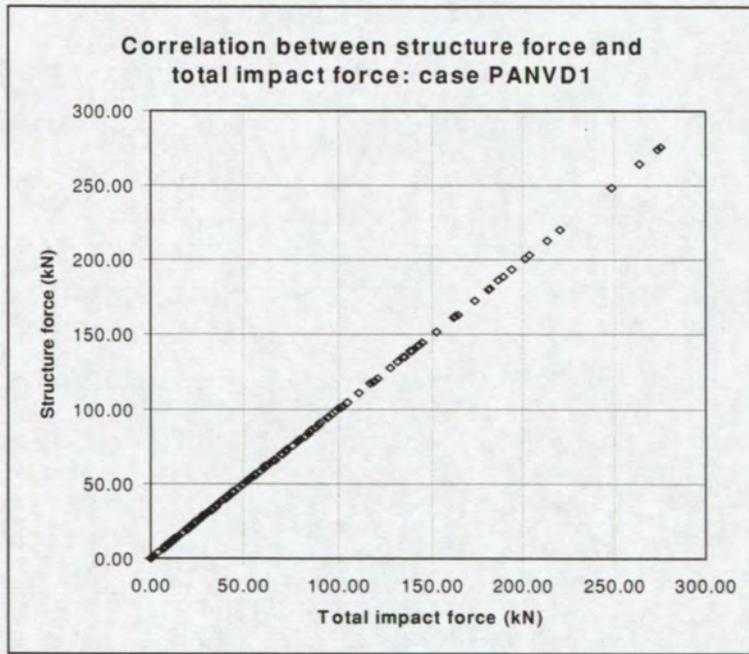
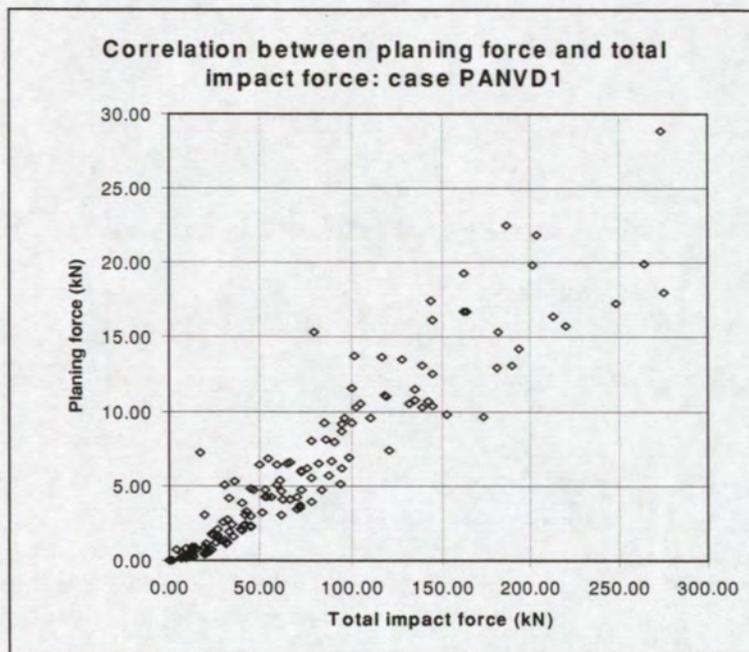
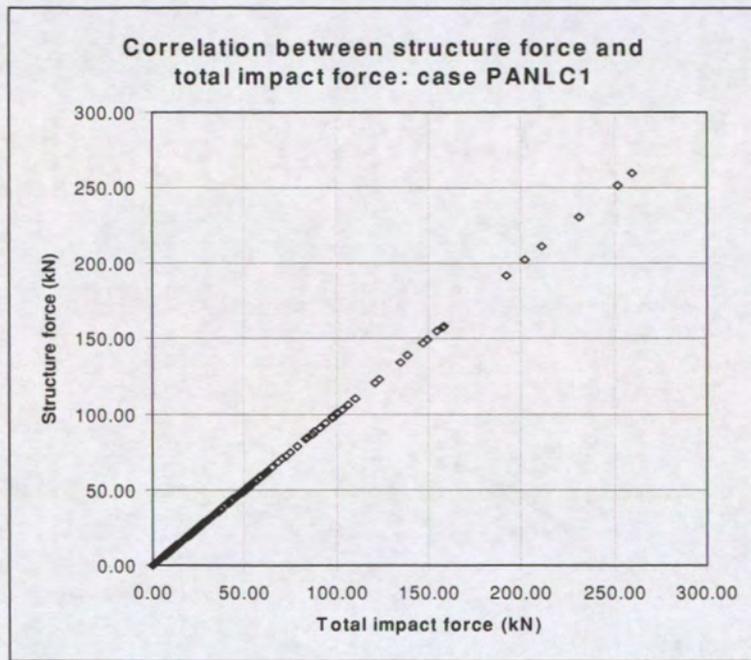
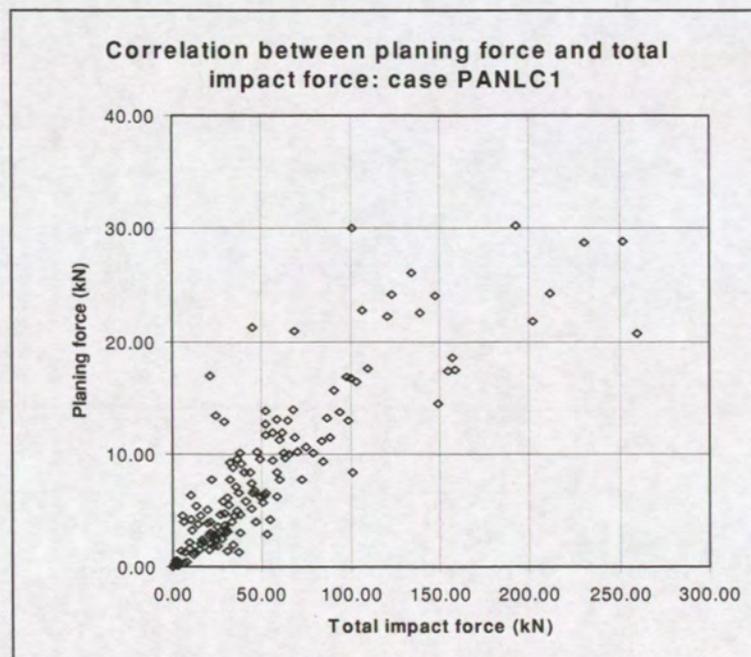
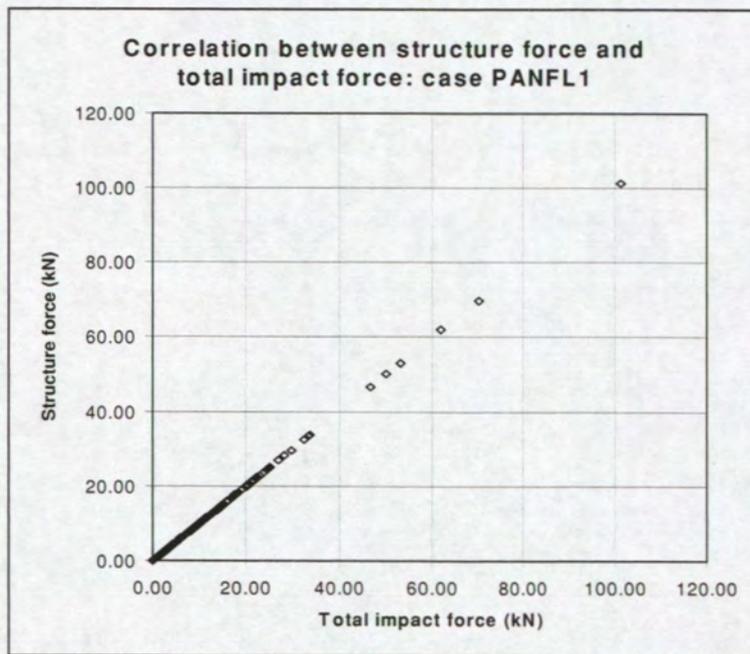
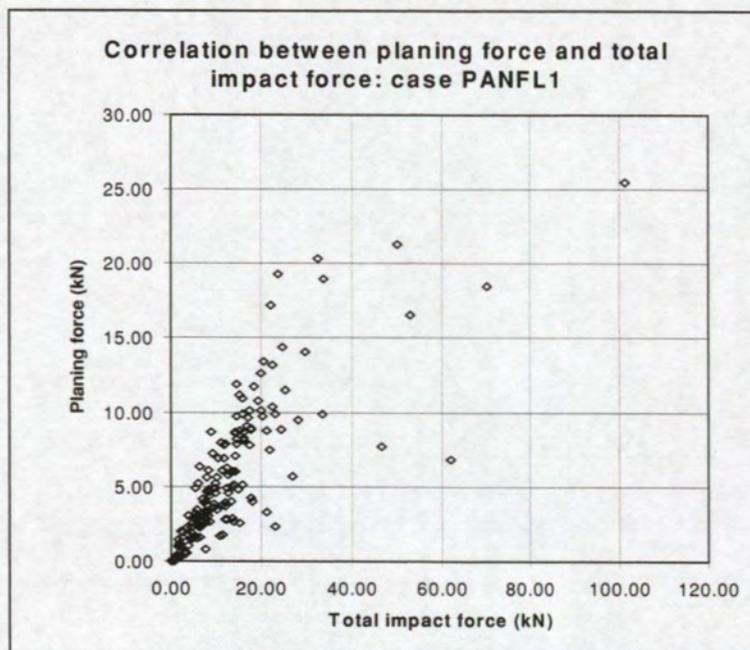
**Correlation plots: maximum structure and planing forces
against the total impact force on the fuselage panel;
all incident scenarios, base case conditions.**

Figure 16: Correlation between maximum structure force and total impact force: panel in controlled ditching incident, central North Sea waves.

Figure 17: Correlation between the planing force and maximum total impact force: panel in controlled ditching incident, central North Sea waves.

Figure 18: Correlation between maximum structure force and total impact force: panel in vertical descent incident, central North Sea waves.

Figure 19: Correlation between the planing force and maximum total impact force: panel in vertical descent incident, central North Sea waves.

Figure 20: Correlation between maximum structure force and total impact force: panel in loss of control incident, central North Sea waves.

Figure 21: Correlation between the planing force and maximum total impact force: panel in loss of control incident, central North Sea waves.

Figure 22: Correlation between maximum structure force and total impact force: panel in fly-in incident, central North Sea waves.

Figure 23: Correlation between the planing force and maximum total impact force: panel in fly-in incident, central North Sea waves.

Corresponding results for the fuselage panel are shown in Figures 16 to 23. These figures show relationships between estimates of the maximum total impact force and corresponding estimates of the structure force and planing force.

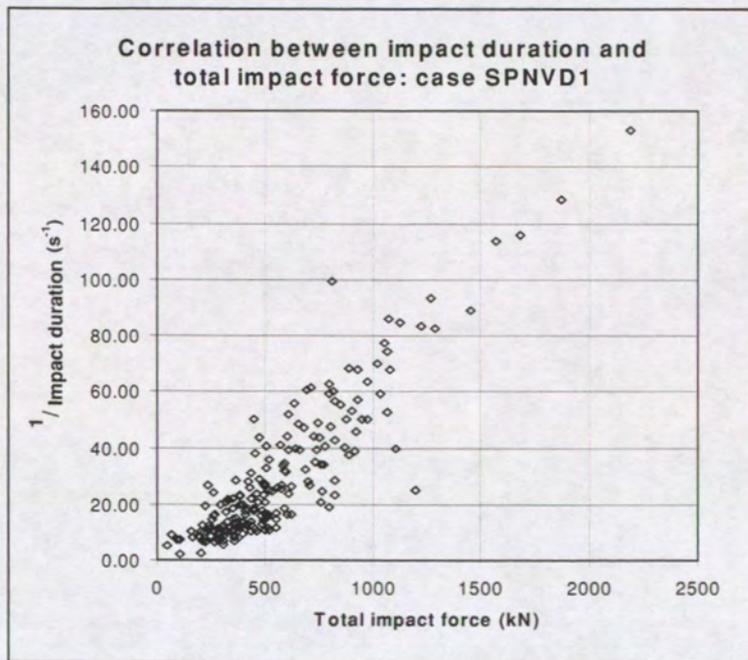
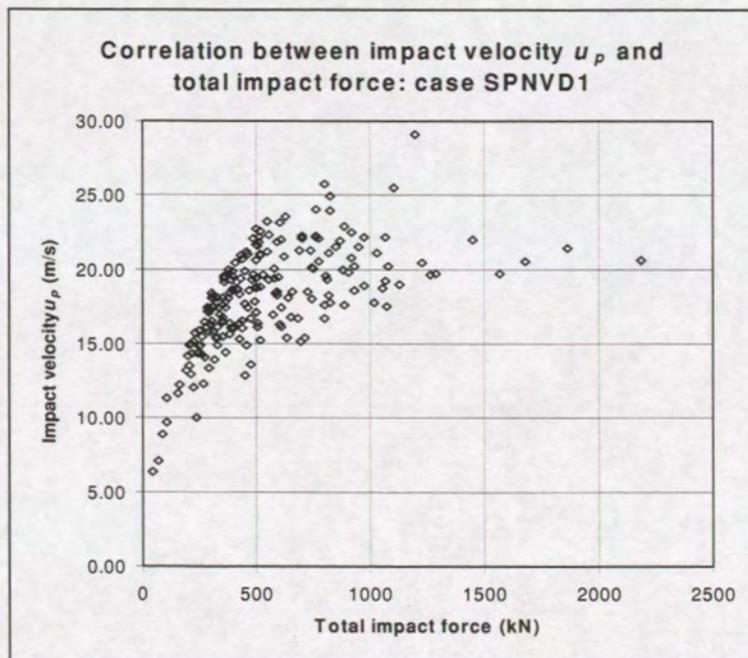
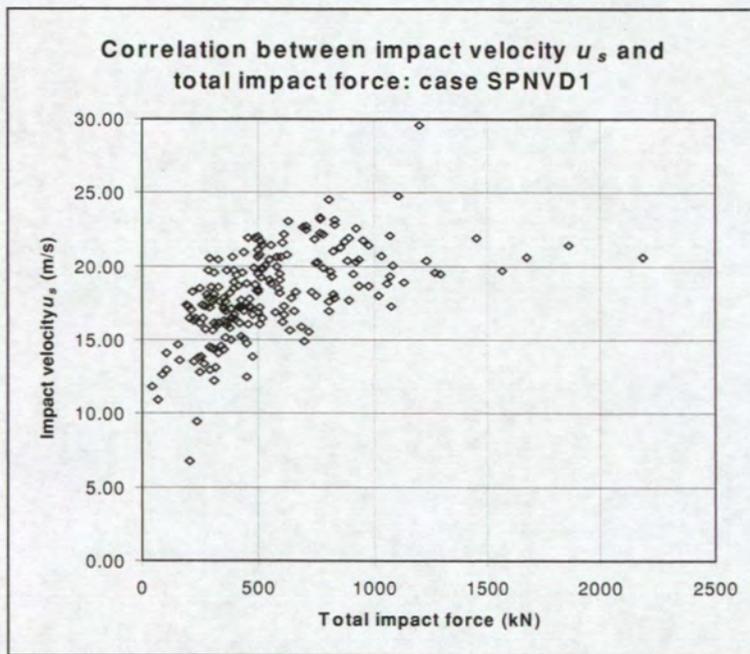
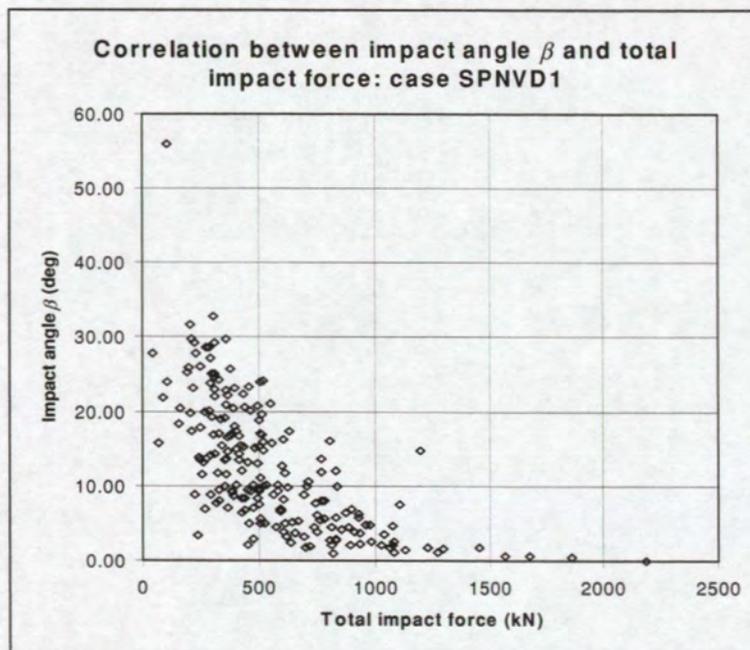
**Correlation plots: impact duration, velocities and angle
against the total impact force on the sponson;
vertical descent scenario, base case conditions.**

Figure 24: Correlation between the impact duration and maximum total impact force: sponson in vertical descent incident, central North Sea waves.

Figure 25: Correlation between the impact velocity u_p and maximum total impact force: sponson in vertical descent incident, central North Sea waves.

Figure 26: Correlation between the impact velocity u_s and maximum total impact force: sponson in vertical descent incident, central North Sea waves.

Figure 27: Correlation between the impact angle β and maximum total impact force: sponson in vertical descent incident, central North Sea waves.

Figures 24 to 27 show sample results illustrating relationships between the maximum total impact force, impact duration, the impact velocities u_p and u_s , and the impact angle β for the sponson in a vertical descent incident. Corresponding results for the fuselage panel are shown in Figures 28 to 31.

Equation (24) suggests an approximately inverse relationship between the duration and severity of an impact. This seems intuitively reasonable. The maximum force on a panel or sponson tends to increase rapidly as its surface becomes more parallel to the water surface on impact, but at the same time it enters the water more quickly, reducing T_{imp} . Figures 24 and 28 therefore show the **inverse** of the impact duration, $1/T_{imp}$, plotted against the maximum impact force, $F_{max\ imp}$.

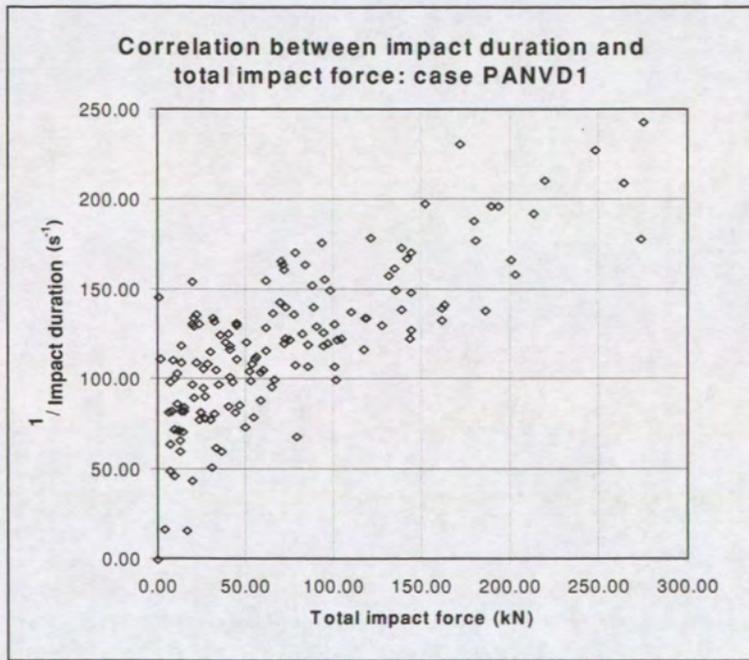
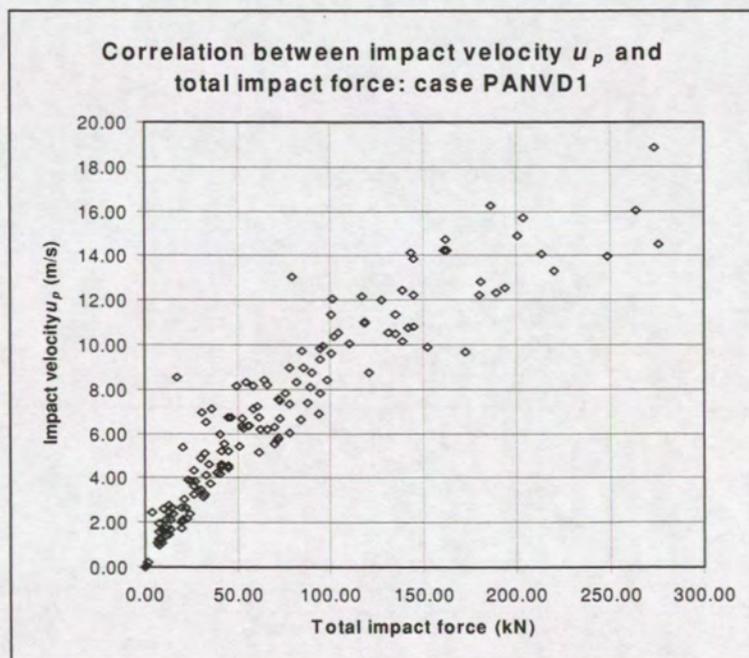
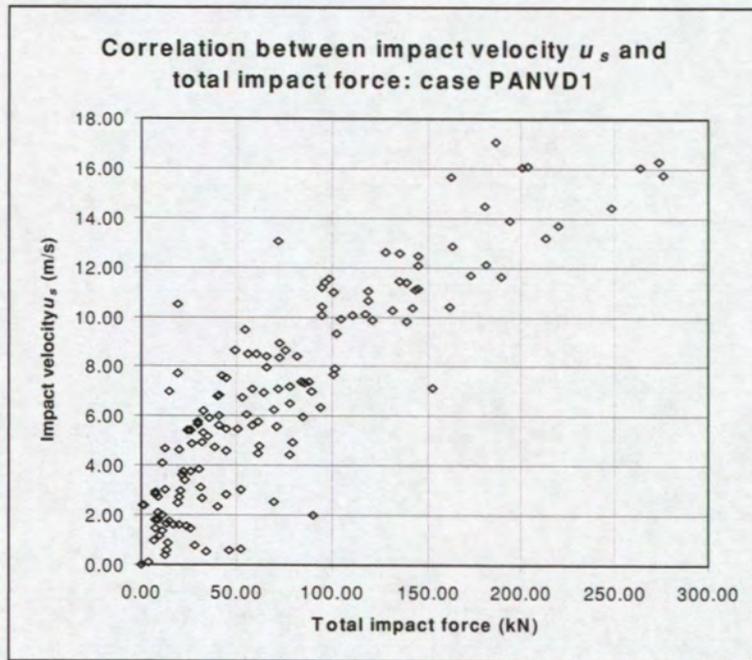
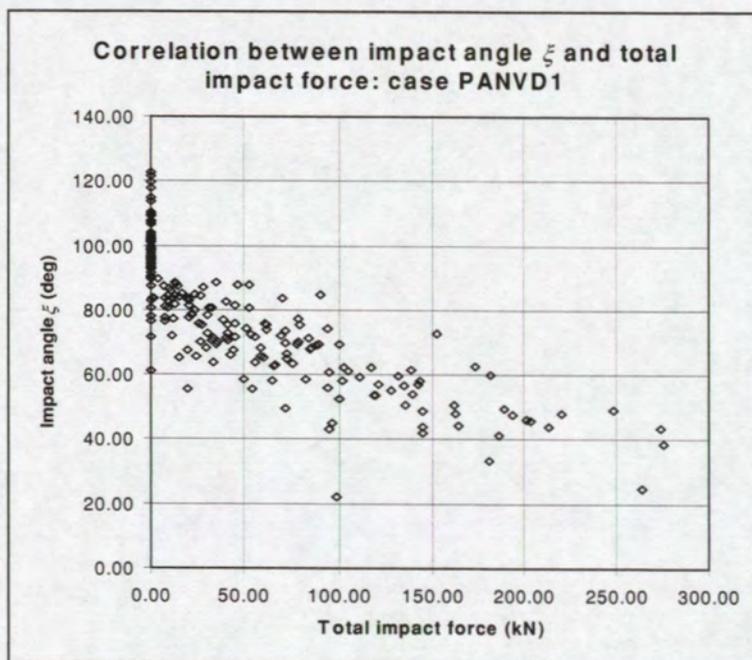
**Correlation plots: impact duration, velocities and angle
against the total impact force on the fuselage panel;
vertical descent scenario, base case conditions.**

Figure 28: Correlation between the impact duration and maximum total impact force: panel in vertical descent incident, central North Sea waves.

Figure 29: Correlation between the impact velocity u_p and maximum total impact force: panel in vertical descent incident, central North Sea waves.

Figure 30: Correlation between the impact velocity u_s and maximum total impact force: panel in vertical descent incident, central North Sea waves.

Figure 31: Correlation between the impact angle ξ and maximum total impact force: panel in vertical descent incident, central North Sea waves.
