CAA PAPER 2001/2

**CRASHWORTHINESS OF HELICOPTER
EMERGENCY FLOTATION SYSTEMS**

Study I (Main Study)

Study II (Supplementary Study)

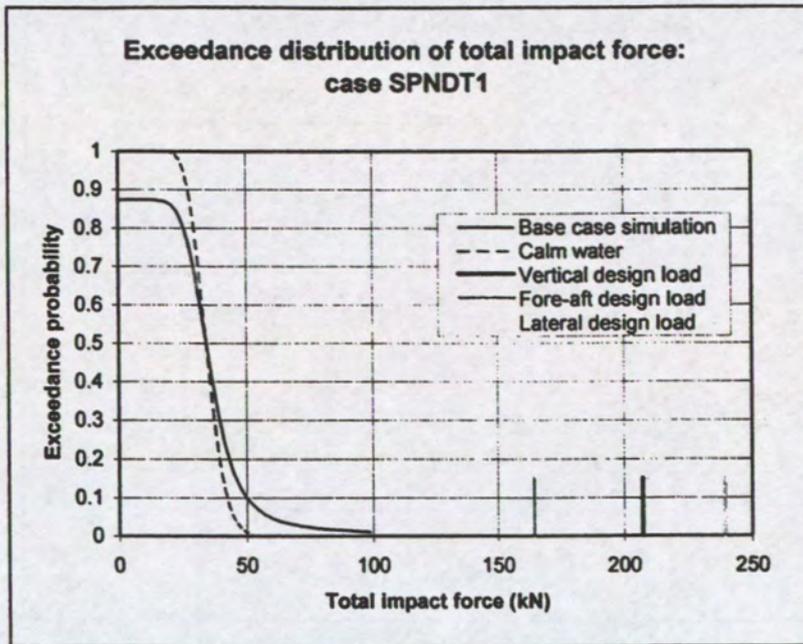
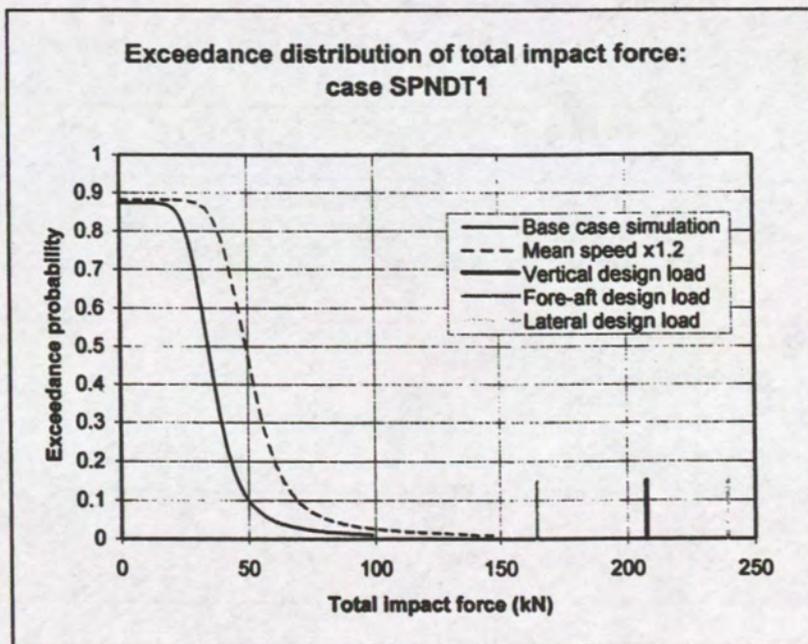
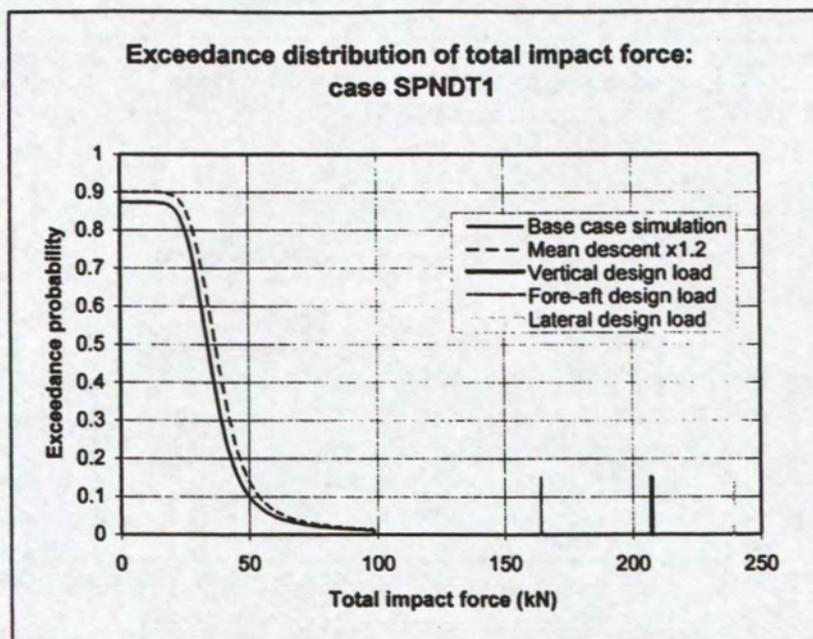
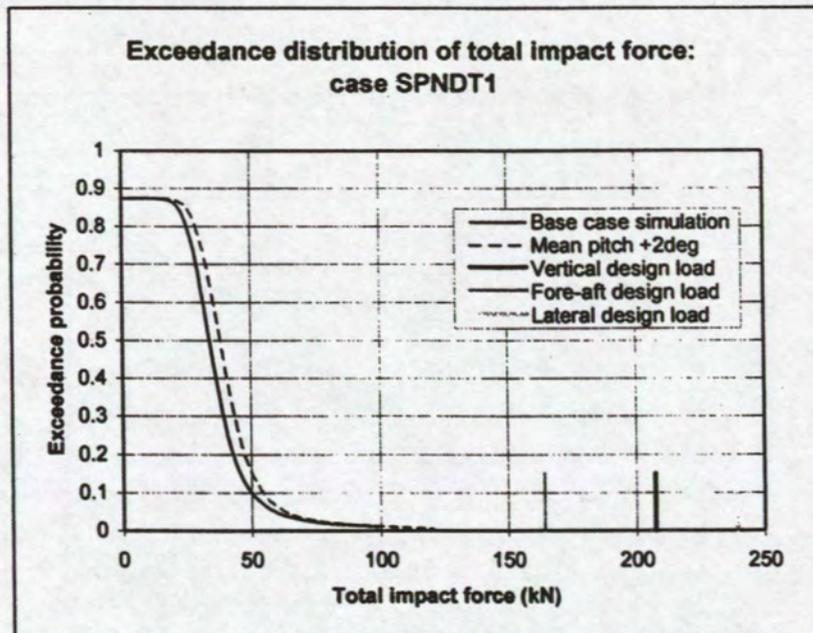
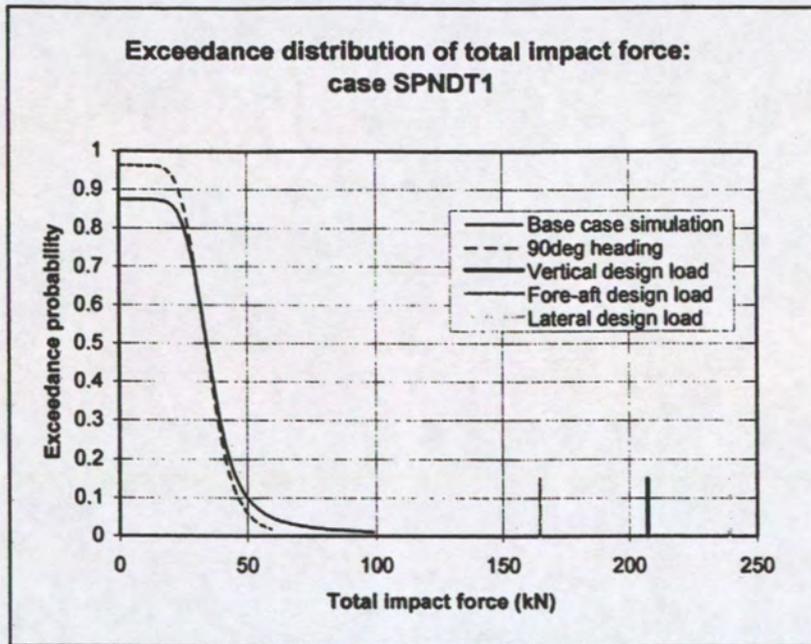
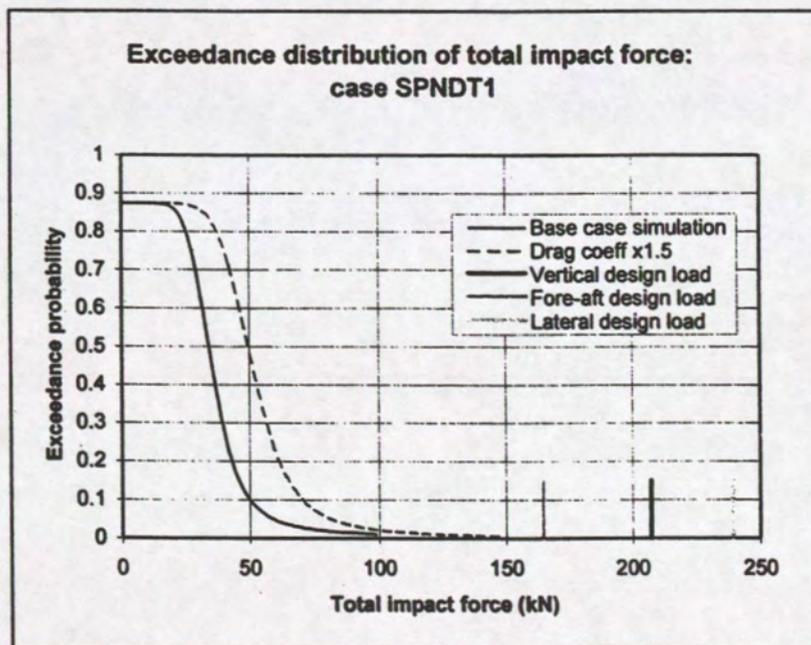
**Exceedance distributions of the maximum
total impact force on the sponson:**

1. Controlled ditching incident

Figure 32: Exceedance distribution of the maximum total impact force: sponson in controlled ditching incident, effect of calm water.

Figure 33: Exceedance distribution of the maximum total impact force: sponson in controlled ditching incident, effect of increased mean speed.

Figure 34: Exceedance distribution of the maximum total impact force: sponson in controlled ditching incident, effect of increased mean descent angle.

Figure 35: Exceedance distribution of the maximum total impact force: sponson in controlled ditching incident, effect of increased mean pitch angle.

Figure 36: Exceedance distribution of the maximum total impact force: sponson in controlled ditching incident, effect of landing beam-on to waves.

Figure 37: Exceedance distribution of the maximum total impact force: sponson in controlled ditching incident, effect of increased drag coefficient.

Figures 32 to 55 show exceedance distributions of the total impact force on the sponson in each of the above incident scenarios. Figures 56 to 81 show corresponding results for the fuselage panel. The exceedance distribution shows the range of variability of the total impact load within each incident scenario.

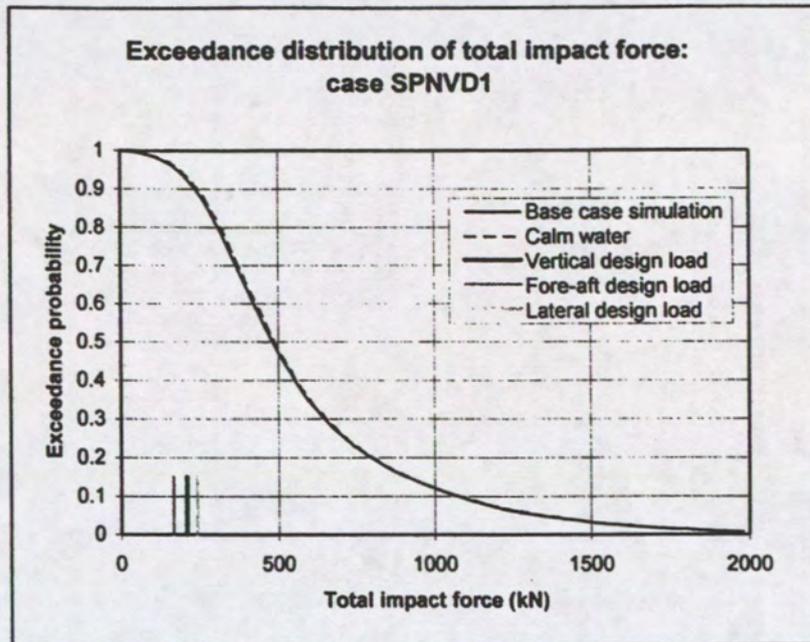
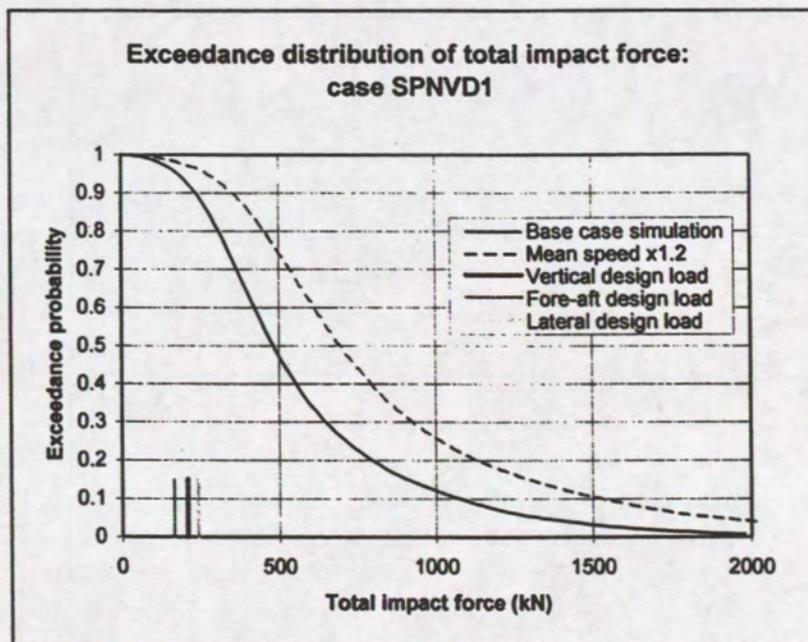
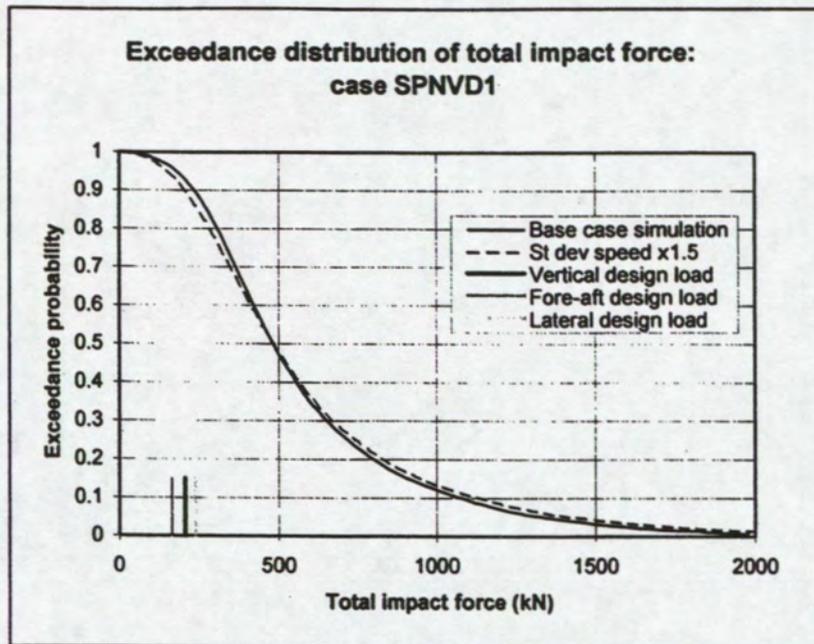
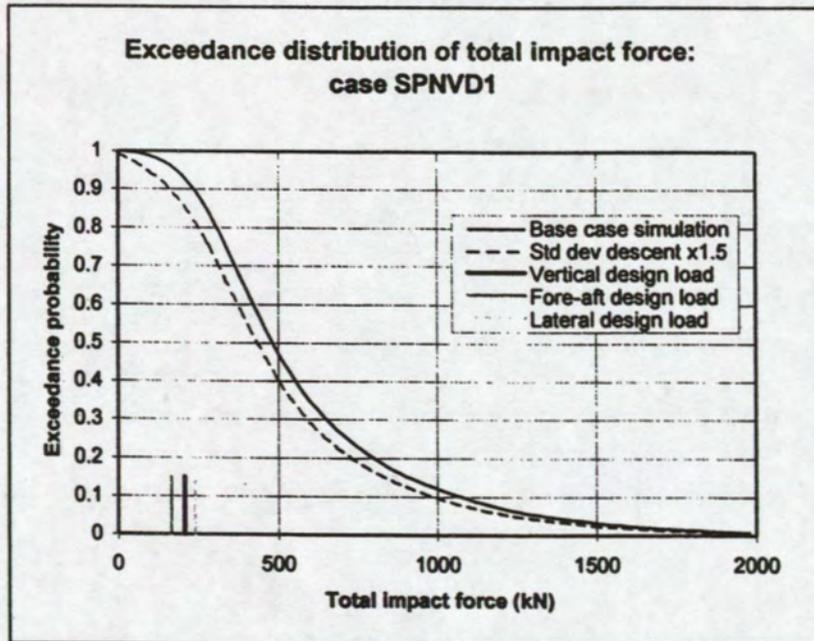
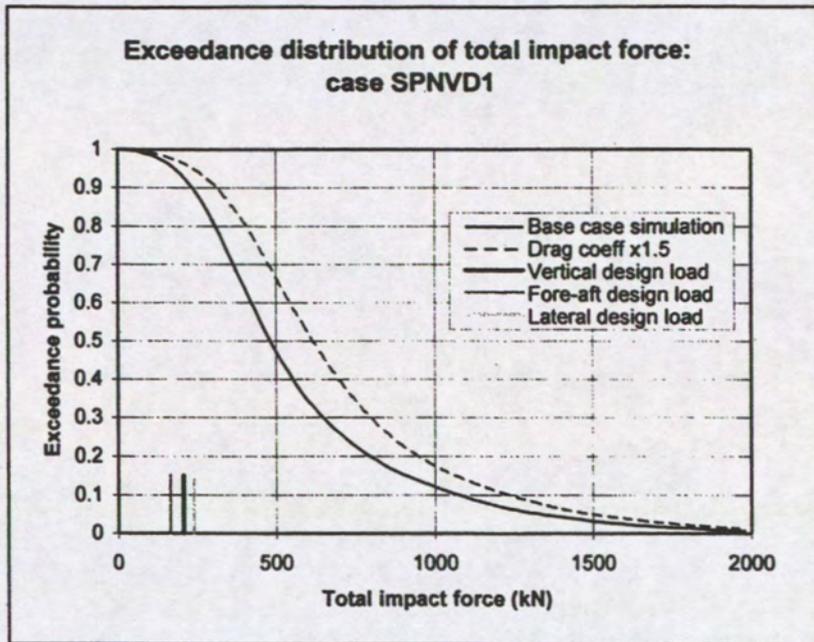
**Exceedance distributions of the maximum
total impact force on the sponson:**

2. Vertical descent incident

Figure 38: Exceedance distribution of the maximum total impact force: sponson in vertical descent incident, effect of calm water.

Figure 39: Exceedance distribution of the maximum total impact force: sponson in vertical descent incident, effect of increased mean speed.

Figure 40: Exceedance distribution of the maximum total impact force: sponson in vertical descent incident, effect of increased speed range.

Figure 41: Exceedance distribution of the maximum total impact force: sponson in vertical descent incident, effect of increased descent angle range.

Figure 42: Exceedance distribution of the maximum total impact force: sponson in vertical descent incident, effect of increased drag coefficient.

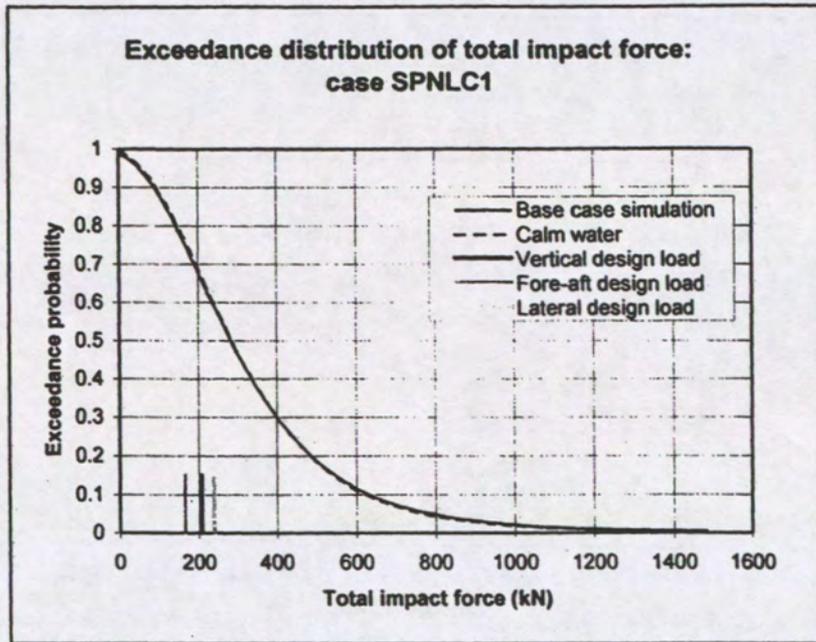
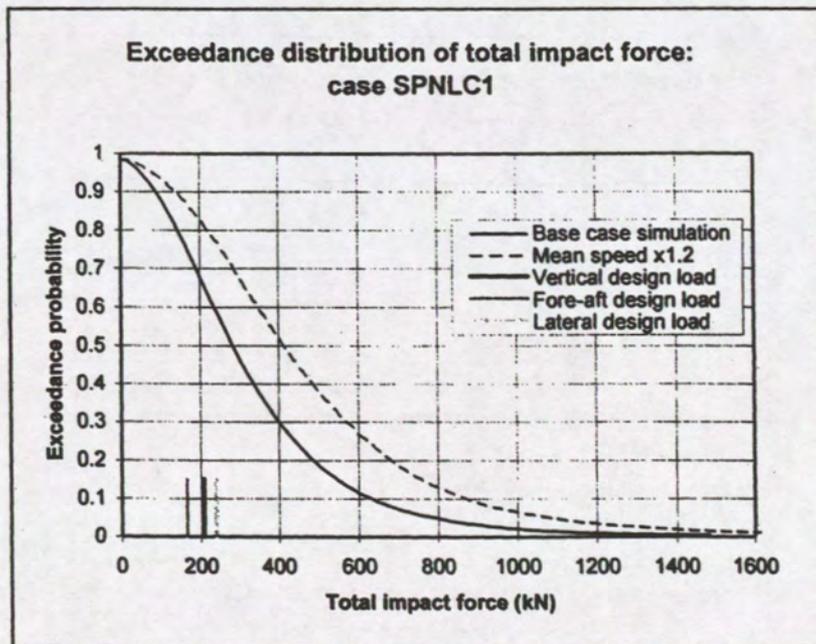
**Exceedance distributions of the maximum
total impact force on the sponson:**

3. Loss of control incident

Figure 43: Exceedance distribution of the maximum total impact force: sponson in loss of control incident, effect of calm water.

Figure 44: Exceedance distribution of the maximum total impact force: sponson in loss of control incident, effect of increased mean speed.

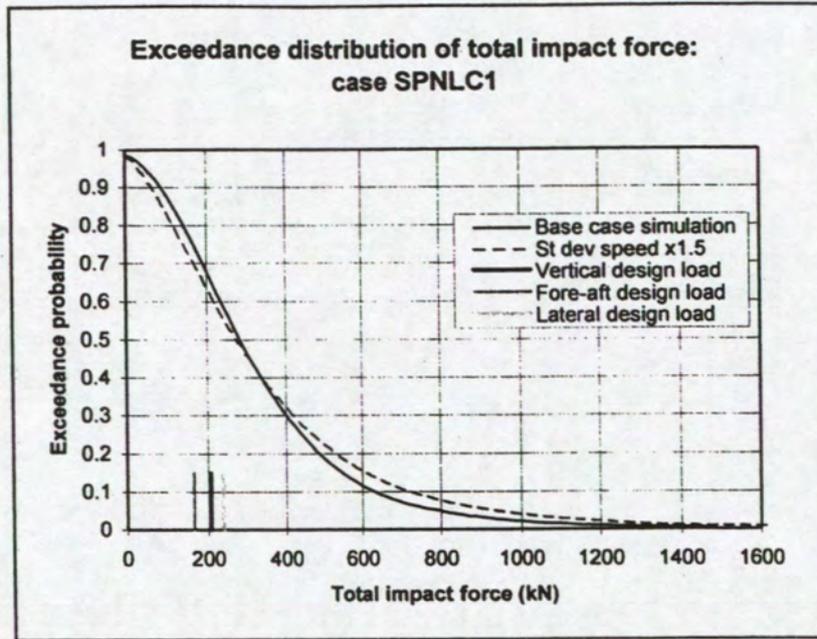
Figure 45: Exceedance distribution of the maximum total impact force: sponson in loss of control incident, effect of increased speed range.

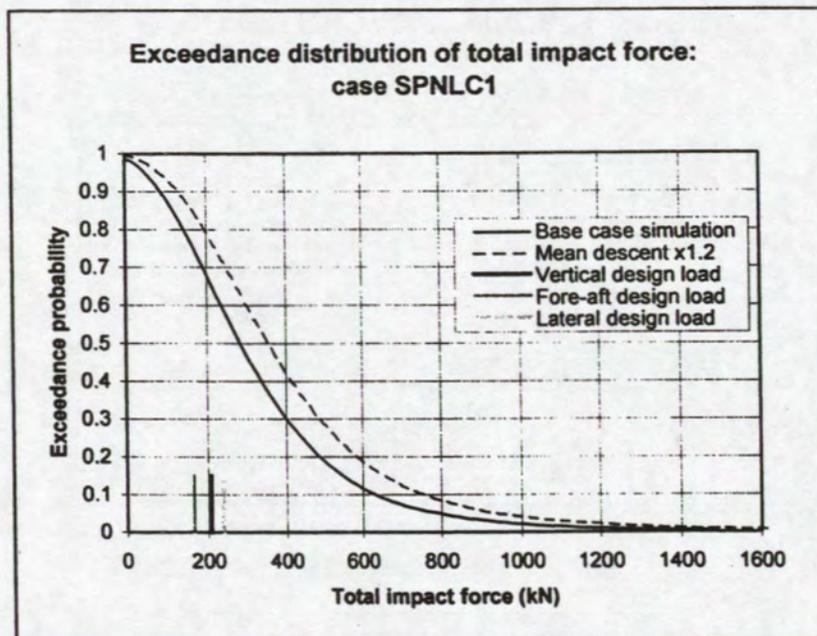
Figure 46: Exceedance distribution of the maximum total impact force: sponson in loss of control incident, effect of increased mean descent angle.

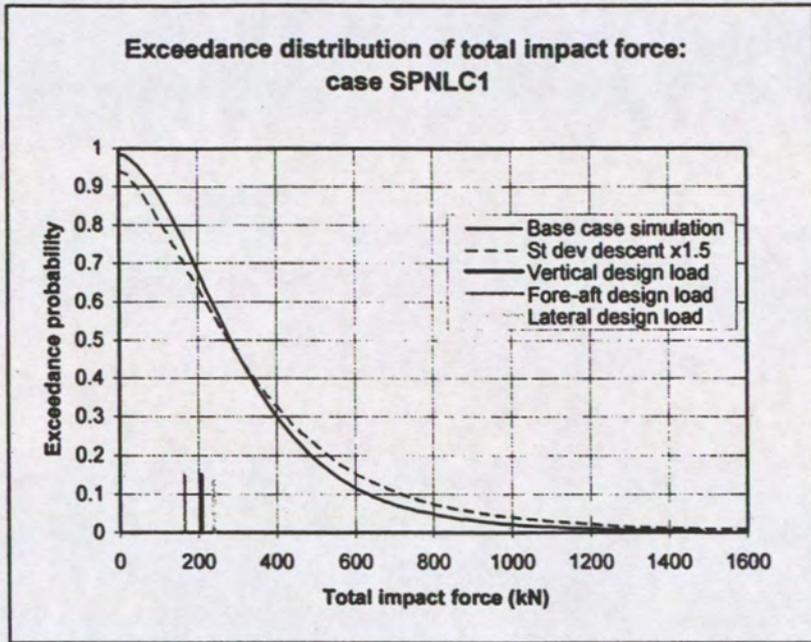
Figure 47: Exceedance distribution of the maximum total impact force: sponson in loss of control incident, effect of increased descent angle range.

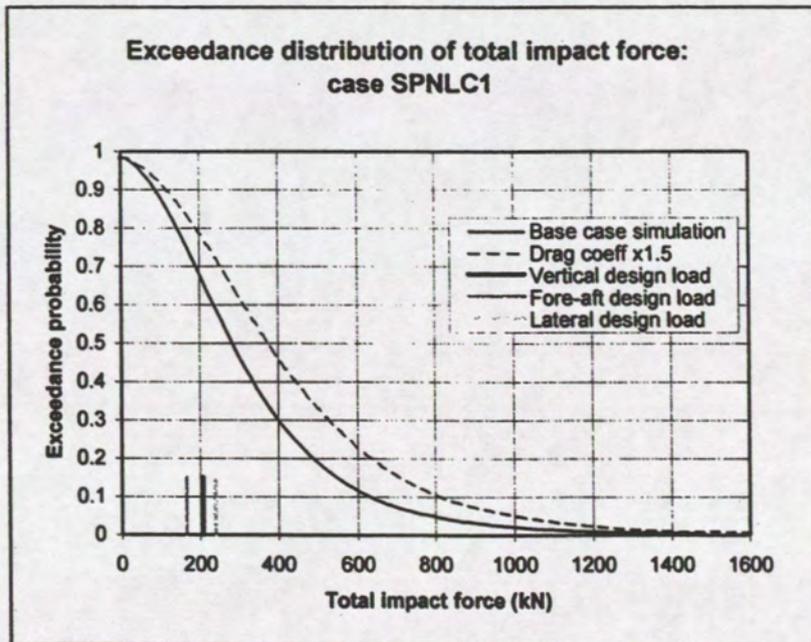
Figure 48: Exceedance distribution of the maximum total impact force: sponson in loss of control incident, effect of increased drag coefficient.

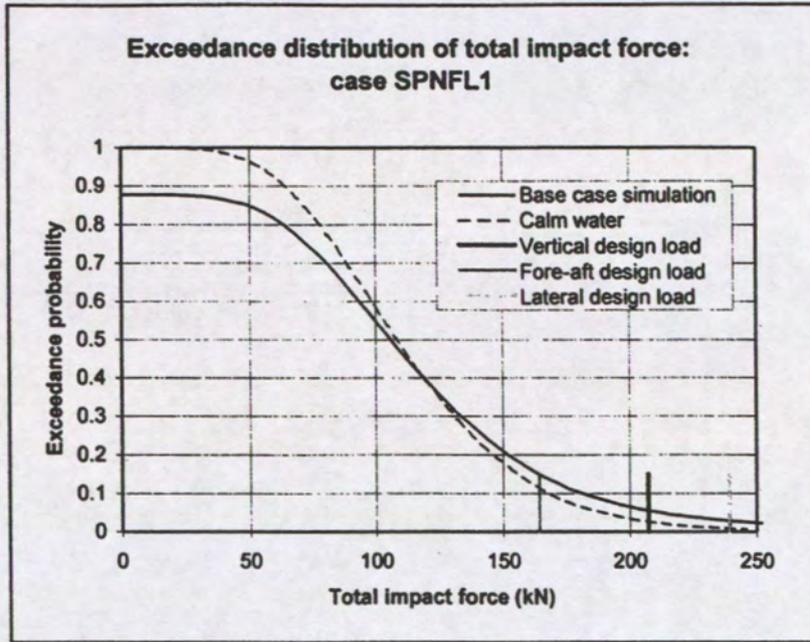
Figure 49: Exceedance distribution of the maximum total impact force: sponson in fly-in incident, effect of calm water.

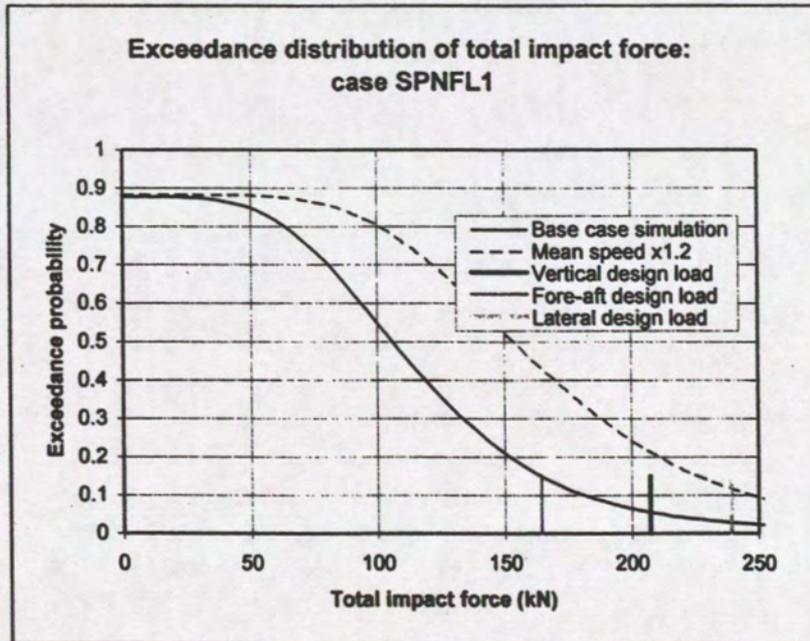
Figure 50: Exceedance distribution of the maximum total impact force: sponson in fly-in incident, effect of increased mean speed.

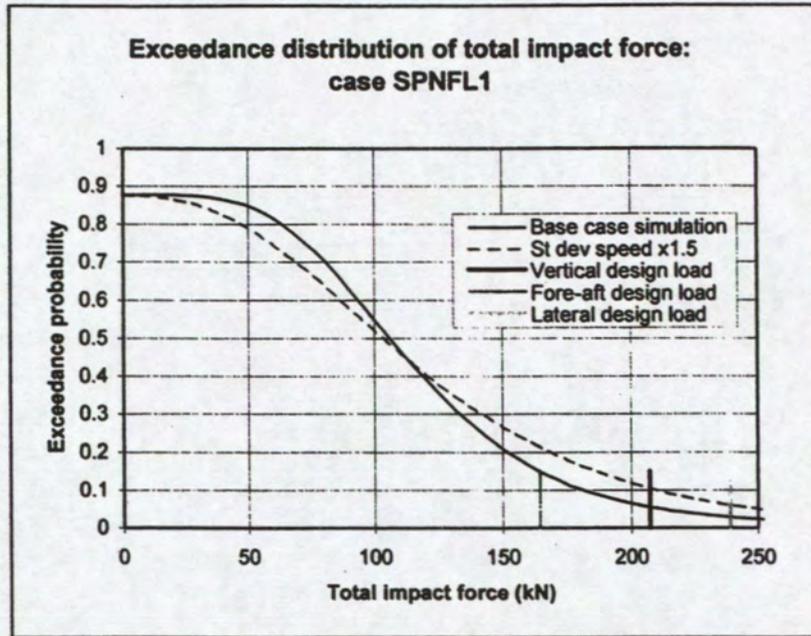
Figure 51: Exceedance distribution of the maximum total impact force: sponson in fly-in incident, effect of increased speed range.

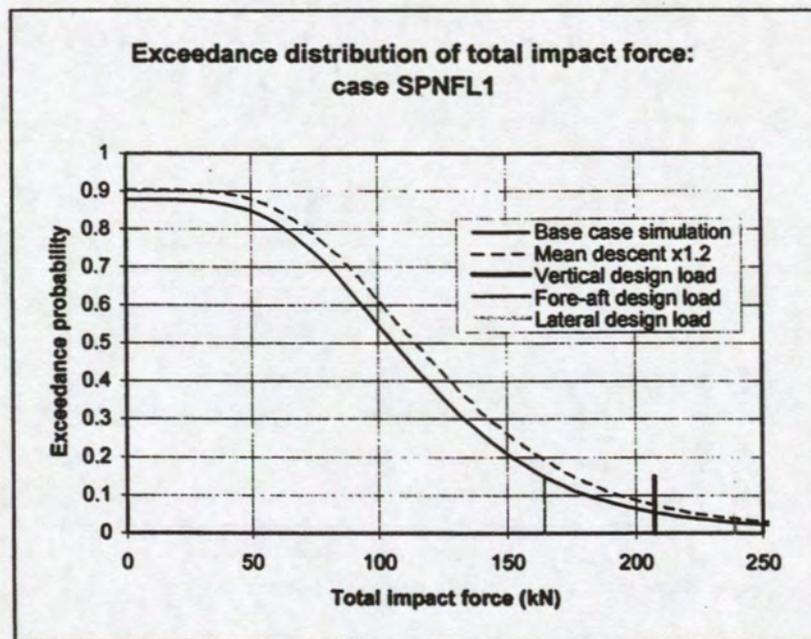
Figure 52: Exceedance distribution of the maximum total impact force: sponson in fly-in incident, effect of increased mean descent angle.

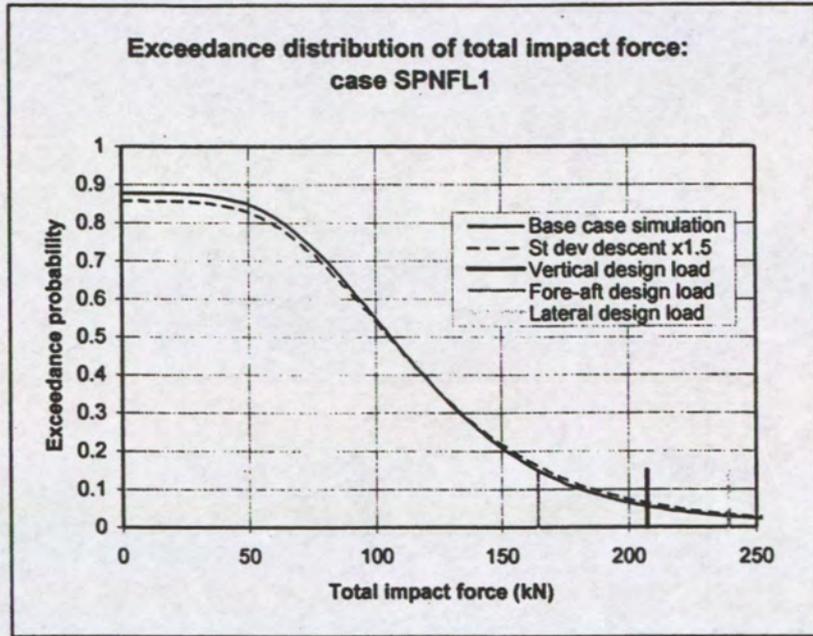
Figure 53: Exceedance distribution of the maximum total impact force: sponson in fly-in incident, effect of increased descent angle range.

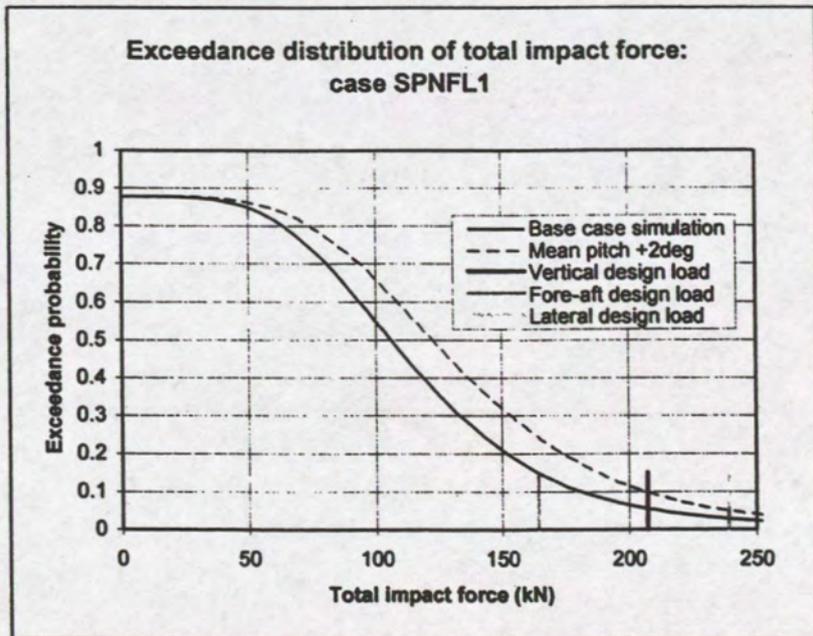
Figure 54: Exceedance distribution of the maximum total impact force: sponson in fly-in incident, effect of increased mean pitch angle.

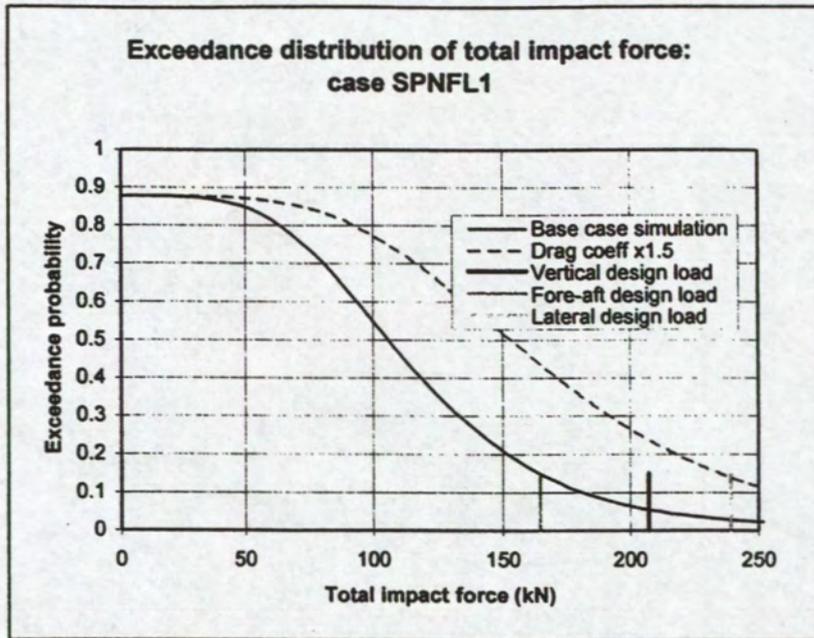
Figure 55: Exceedance distribution of the maximum total impact force: sponson in fly-in incident, effect of increased drag coefficient.

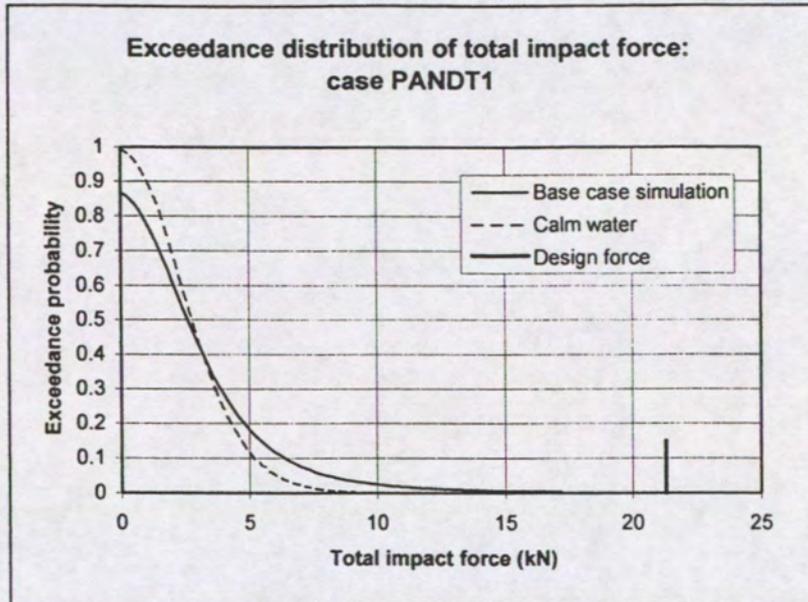
Figure 56: Exceedance distribution of the maximum total impact force: panel in controlled ditching incident, effect of calm water.

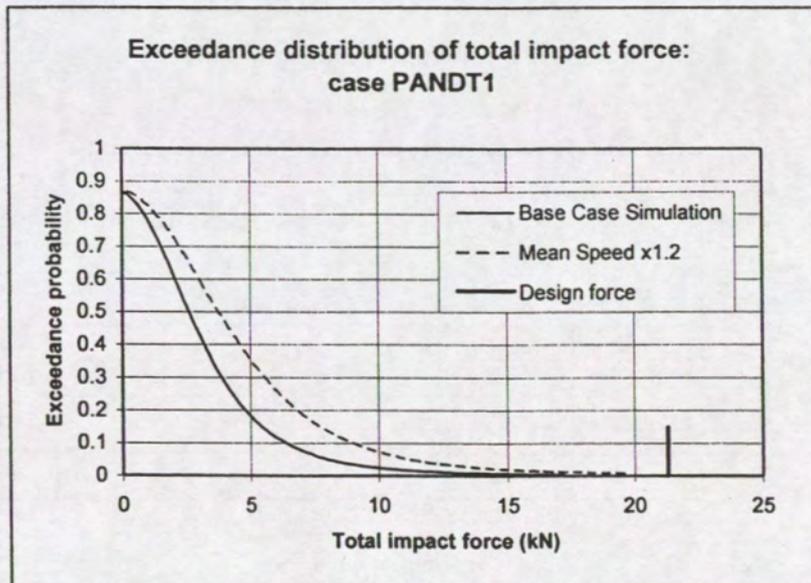
Figure 57: Exceedance distribution of the maximum total impact force: panel in controlled ditching incident, effect of increased mean speed.

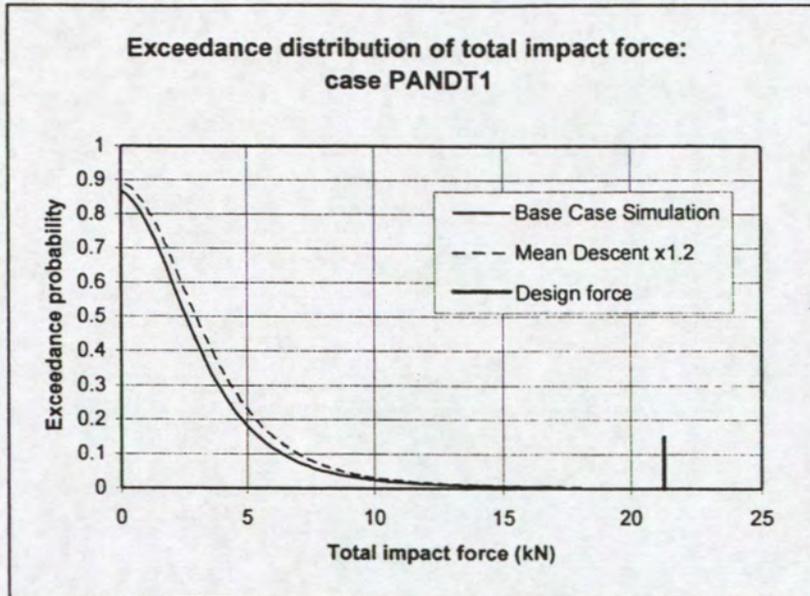
Figure 58: Exceedance distribution of the maximum total impact force: panel in controlled ditching incident, effect of increased mean descent angle.

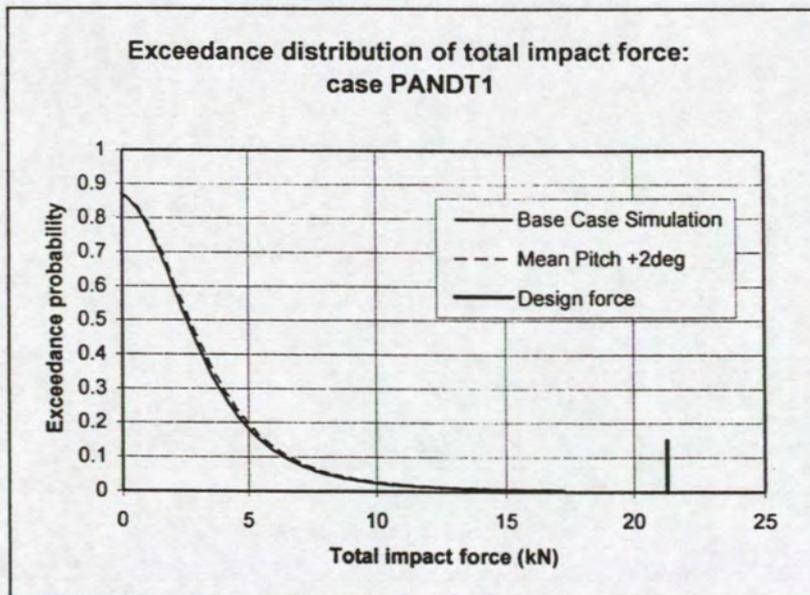
Figure 59: Exceedance distribution of the maximum total impact force: panel in controlled ditching incident, effect of increased mean pitch angle.

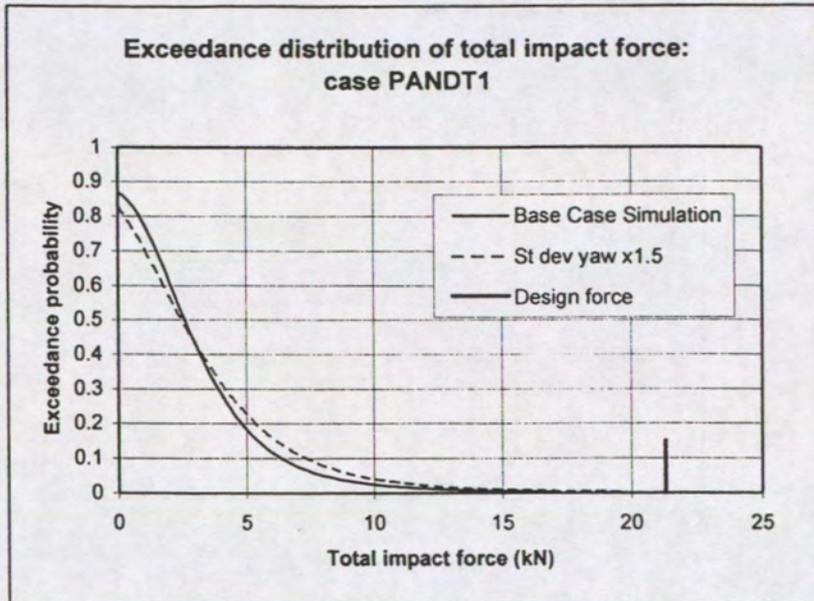
Figure 60: Exceedance distribution of the maximum total impact force: panel in controlled ditching incident, effect of increased yaw angle range.

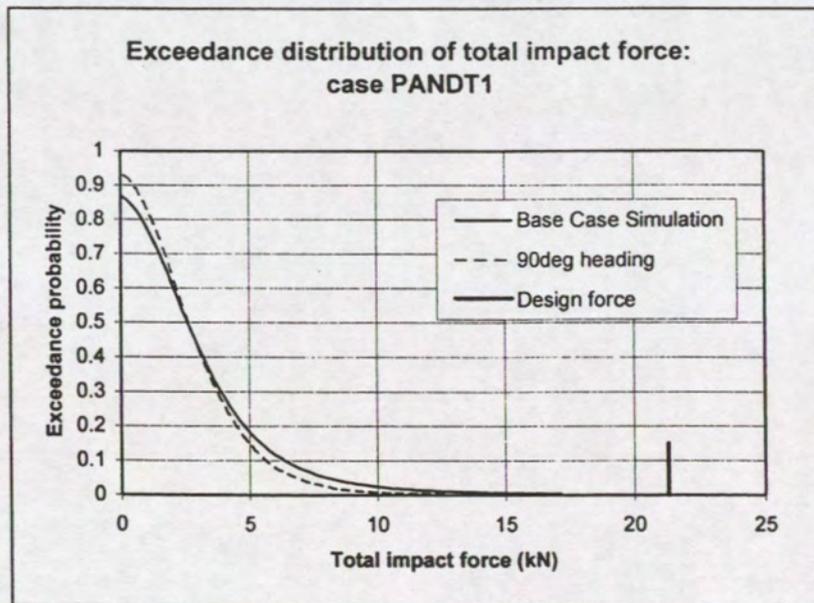
Figure 61: Exceedance distribution of the maximum total impact force: panel in controlled ditching incident, effect of landing beam-on to waves.

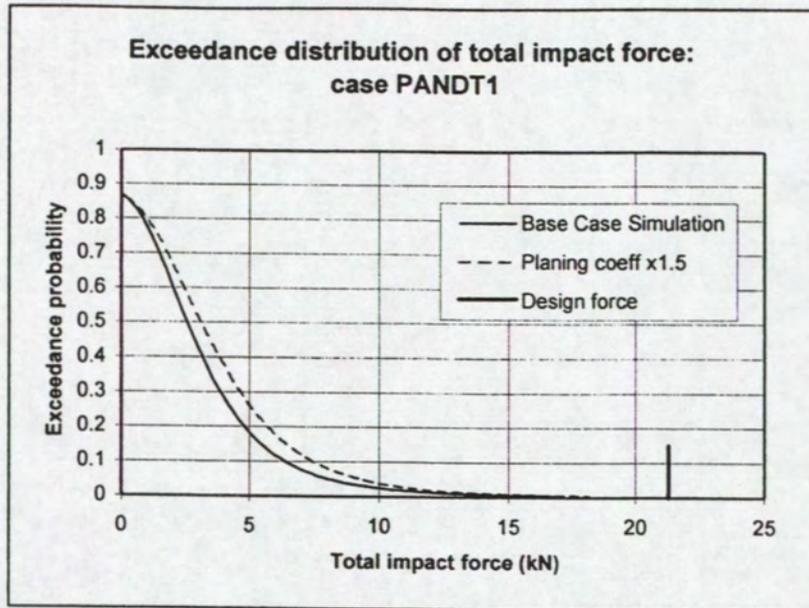
Figure 62: Exceedance distribution of the maximum total impact force: panel in controlled ditching incident, effect of increased planing force coefficient.

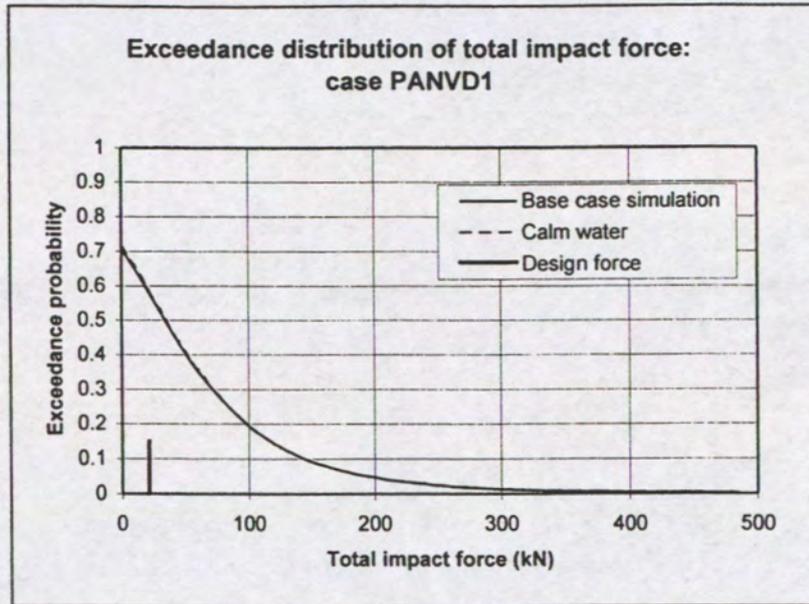
Figure 63: Exceedance distribution of the maximum total impact force: panel in vertical descent incident, effect of calm water.

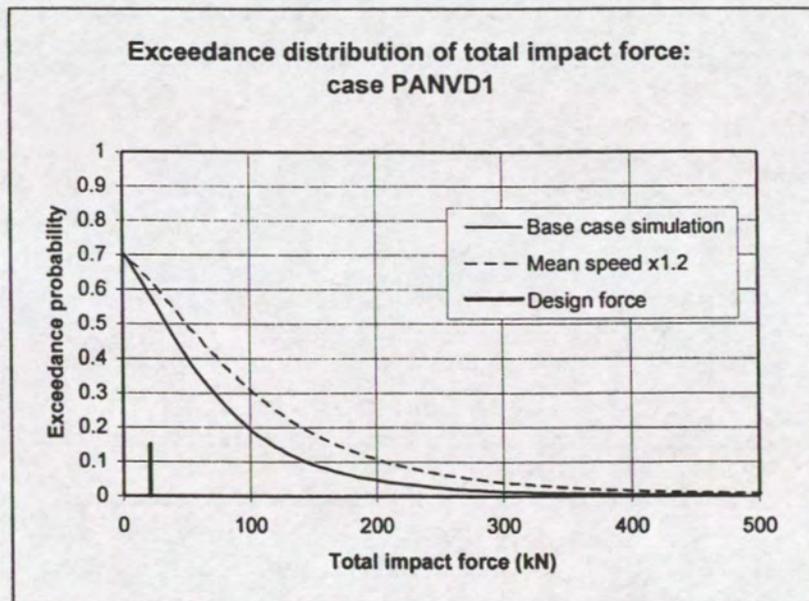
Figure 64: Exceedance distribution of the maximum total impact force: panel in vertical descent incident, effect of increased mean speed.

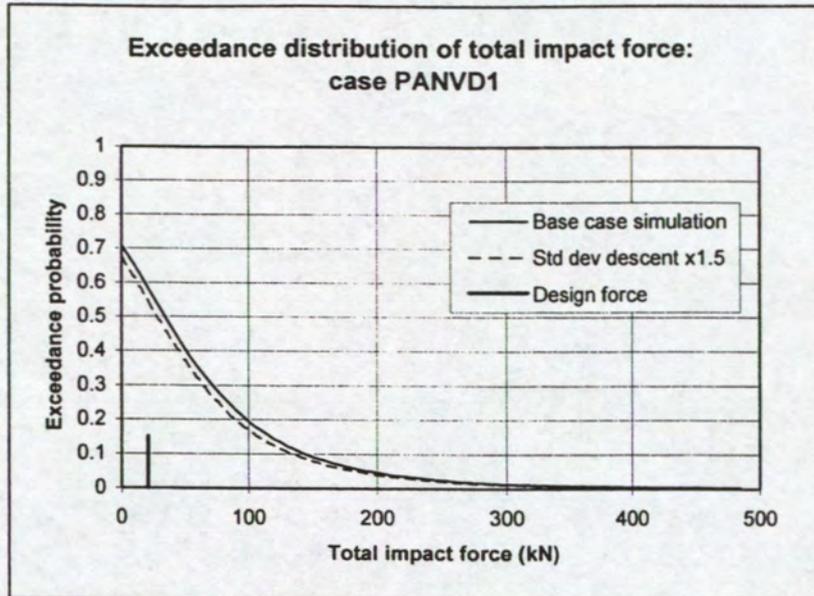
Figure 65: Exceedance distribution of the maximum total impact force: panel in vertical descent incident, effect of increased descent angle range.

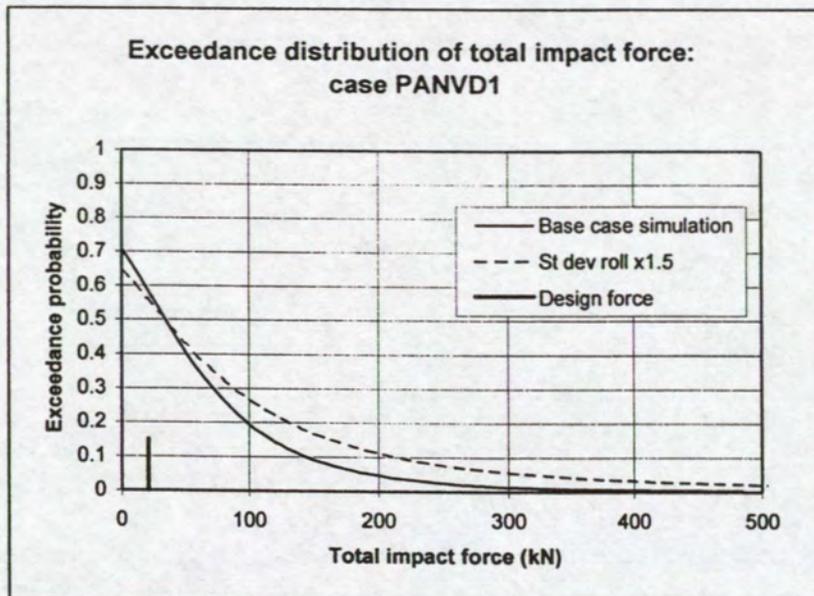
Figure 66: Exceedance distribution of the maximum total impact force: panel in vertical descent incident, effect of increased roll angle range.

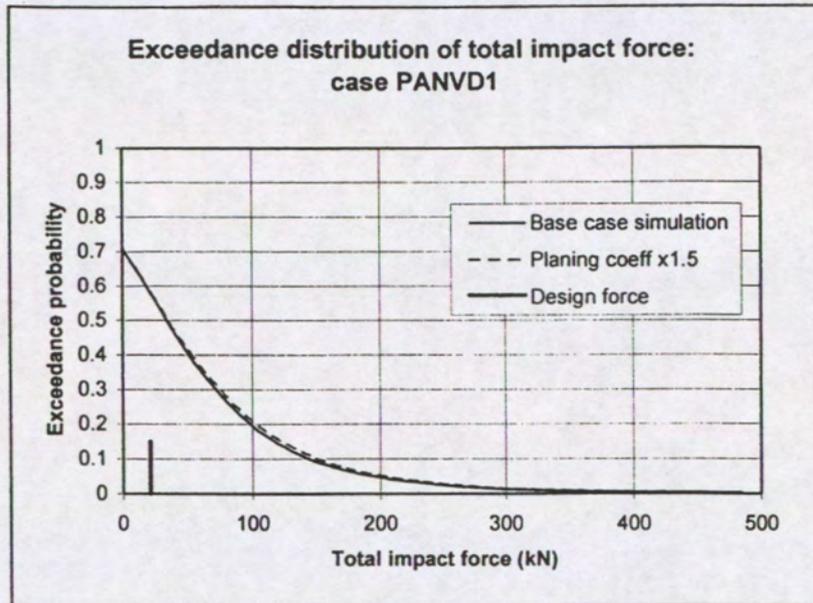
Figure 67: Exceedance distribution of the maximum total impact force: panel in vertical descent incident, effect of increased planing force coefficient.

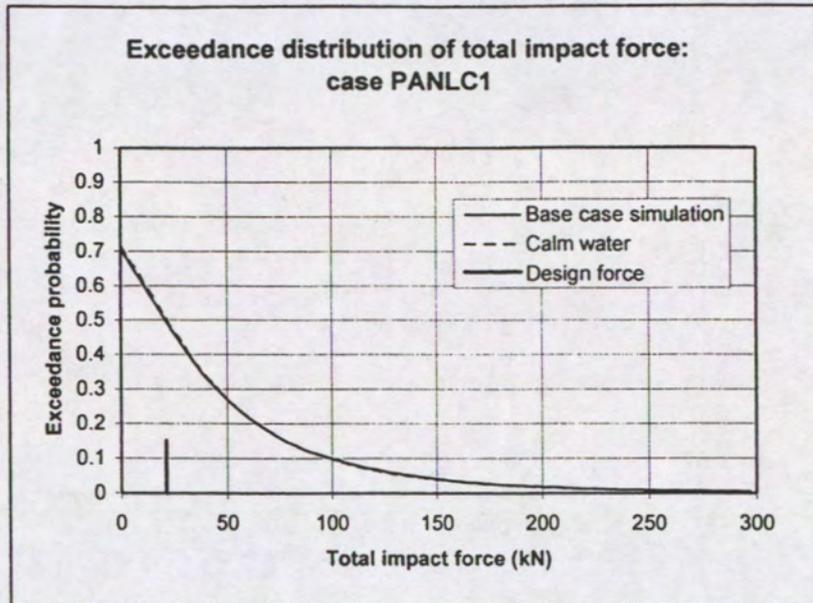
Figure 68: Exceedance distribution of the maximum total impact force: panel in loss of control incident, effect of calm water.

of this report and Figure 68), where wave conditions were found to have no noticeable effect on the impact load distribution corresponding to a loss of control incident. The key difference is that the sensitivity study was intended to be generic, covering a range of possible loss of control incidents, occurring randomly throughout the year. The majority of these simulated incidents occurred in fairly calm sea conditions. The *Cormorant Alpha* scenario was based on one particular incident, which occurred during rough sea conditions. The high sea state at the time of the *Cormorant Alpha* accident therefore gave the wave parameters more significance than they had during the generic study.

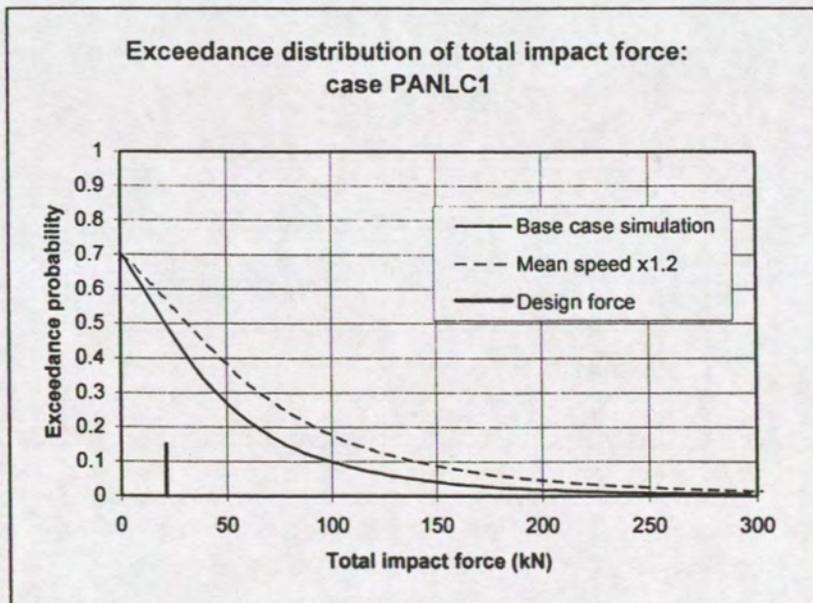
Figure 69: Exceedance distribution of the maximum total impact force: panel in loss of control incident, effect of increased mean speed.

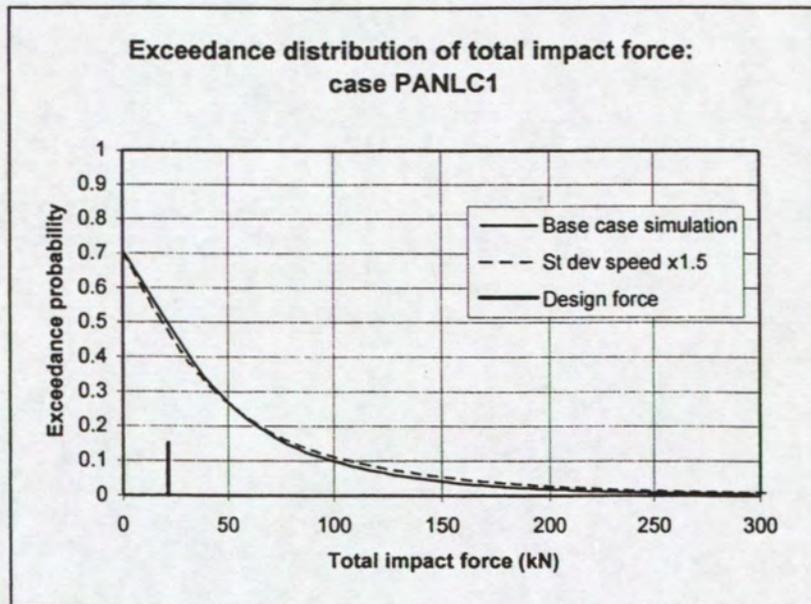
Figure 70: Exceedance distribution of the maximum total impact force: panel in loss of control incident, effect of increased speed range.

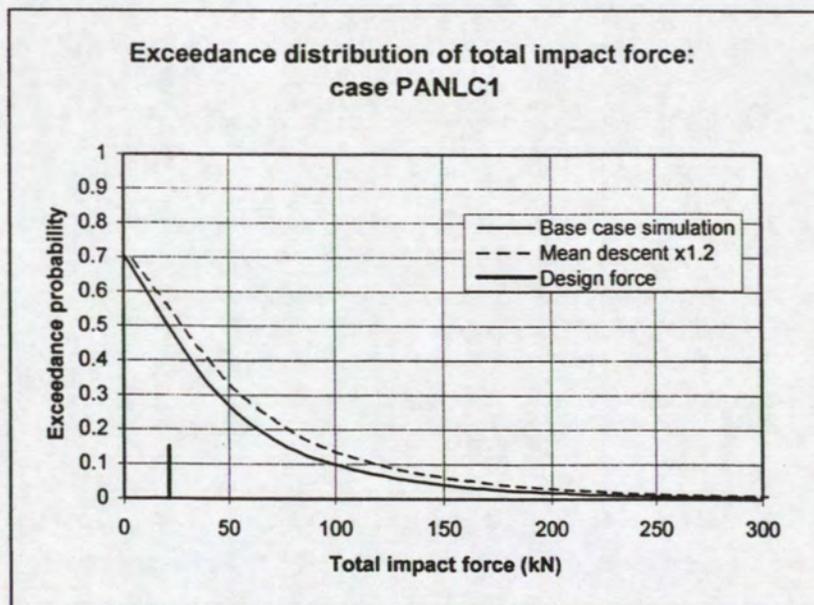
Figure 71: Exceedance distribution of the maximum total impact force: panel in loss of control incident, effect of increased mean descent angle.

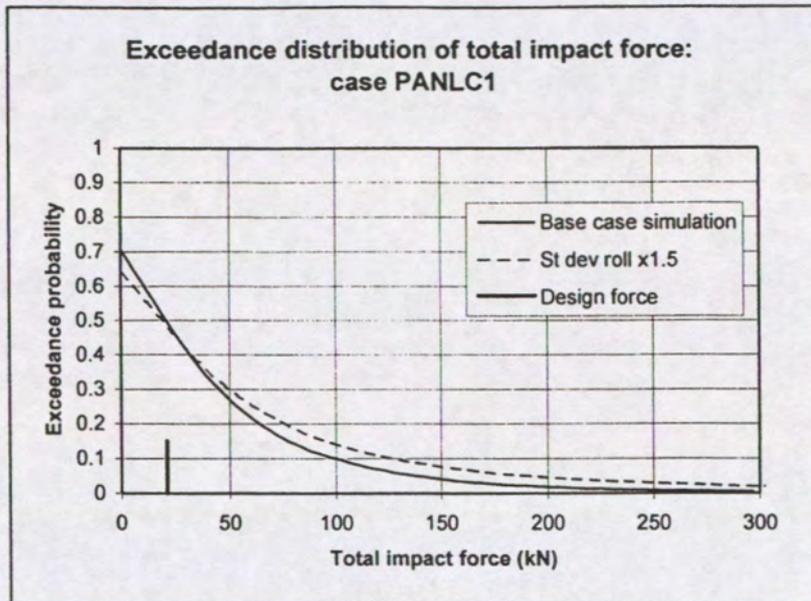
Figure 72: Exceedance distribution of the maximum total impact force: panel in loss of control incident, effect of increased roll angle range.
