CAA PAPER 2001/2

**CRASHWORTHINESS OF HELICOPTER
EMERGENCY FLOTATION SYSTEMS**

Study I (Main Study)

Study II (Supplementary Study)

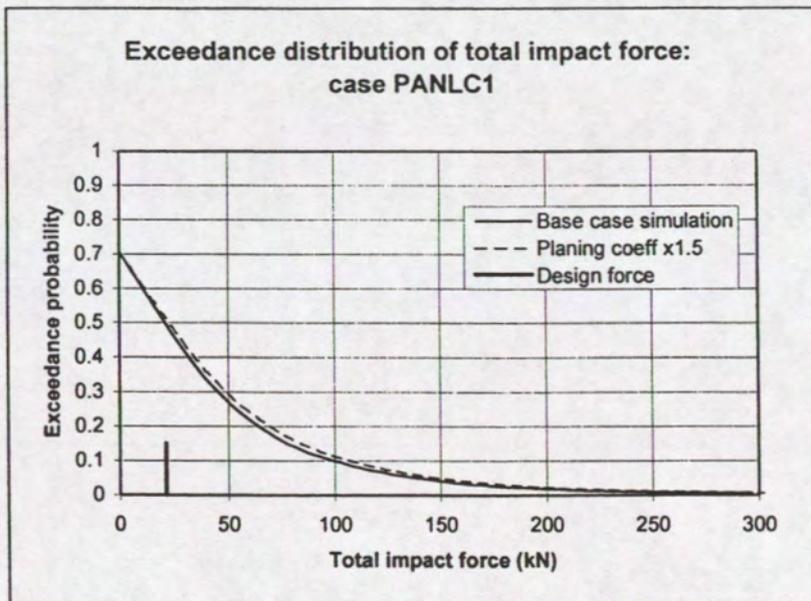
Figure 73: Exceedance distribution of the maximum total impact force: panel in loss of control incident, effect of increased planing force coefficient.

Figures 32 to 55 show exceedance distributions of the total impact force on the sponson in each of the above incident scenarios. Figures 56 to 81 show corresponding results for the fuselage panel. The exceedance distribution shows the range of variability of the total impact load within each incident scenario.

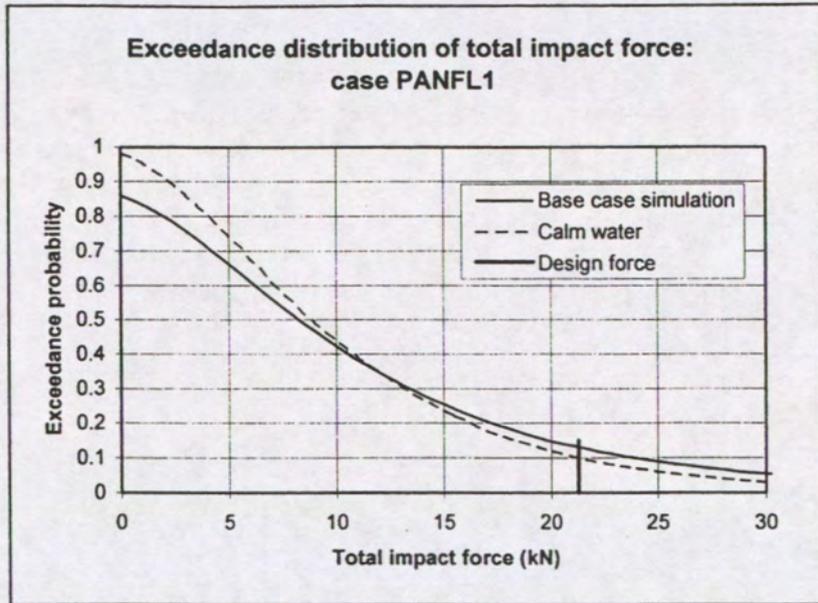
Figure 74: Exceedance distribution of the maximum total impact force: panel in fly-in incident, effect of calm water.

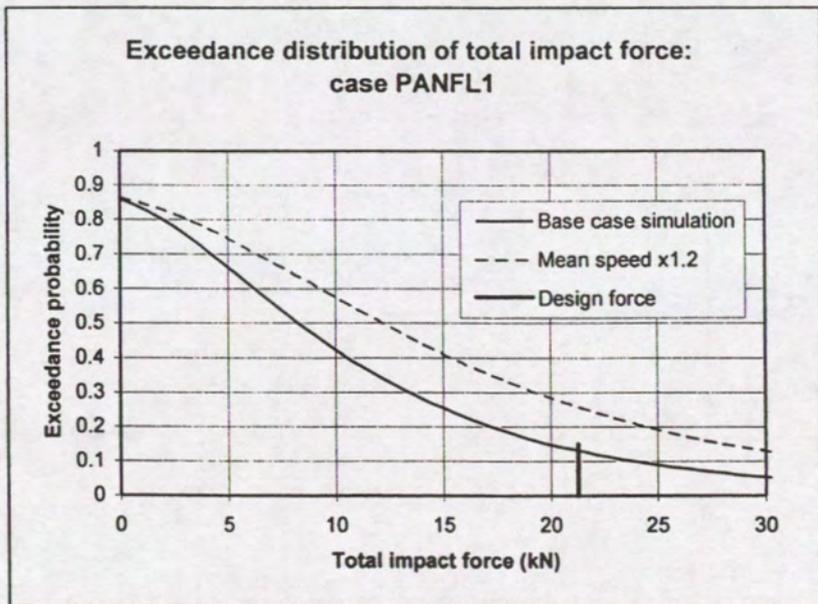
Figure 75: Exceedance distribution of the maximum total impact force: panel in fly-in incident, effect of increased mean speed.

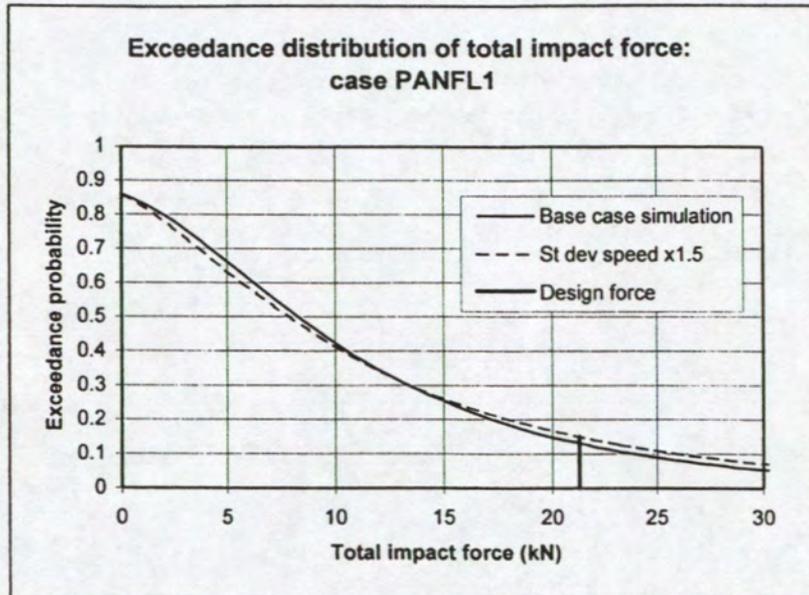
Figure 76: Exceedance distribution of the maximum total impact force: panel in fly-in incident, effect of increased speed range.

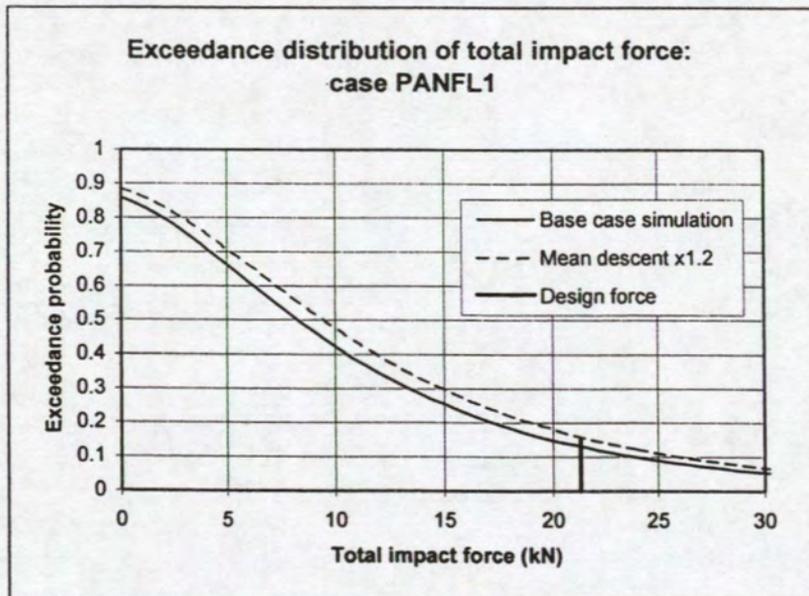
Figure 77: Exceedance distribution of the maximum total impact force: panel in fly-in incident, effect of increased mean descent angle.

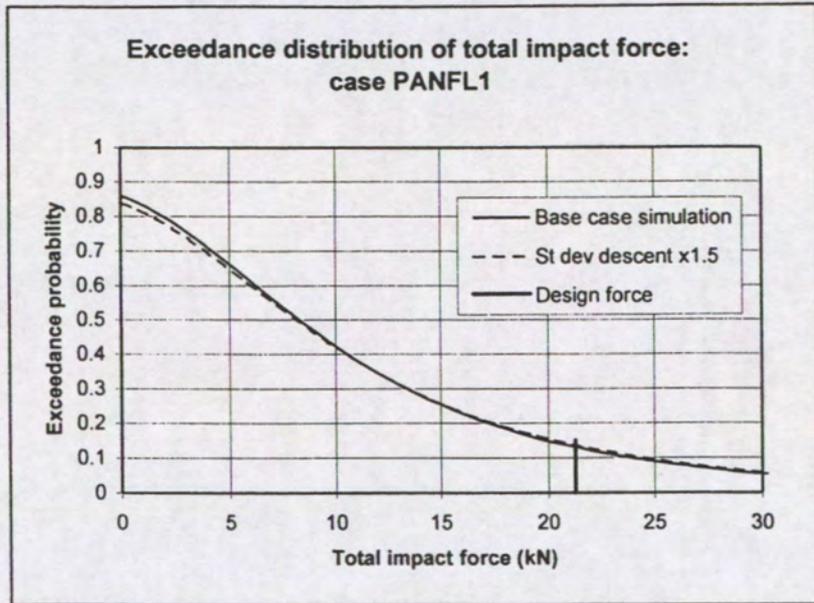
Figure 78: Exceedance distribution of the maximum total impact force: panel in fly-in incident, effect of increased descent angle range.

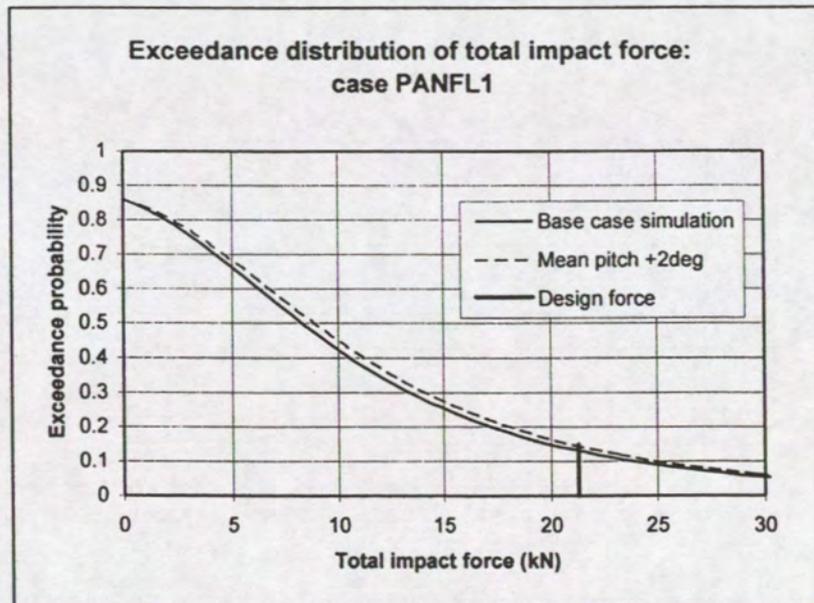
Figure 79: Exceedance distribution of the maximum total impact force: panel in fly-in incident, effect of increased mean pitch angle.

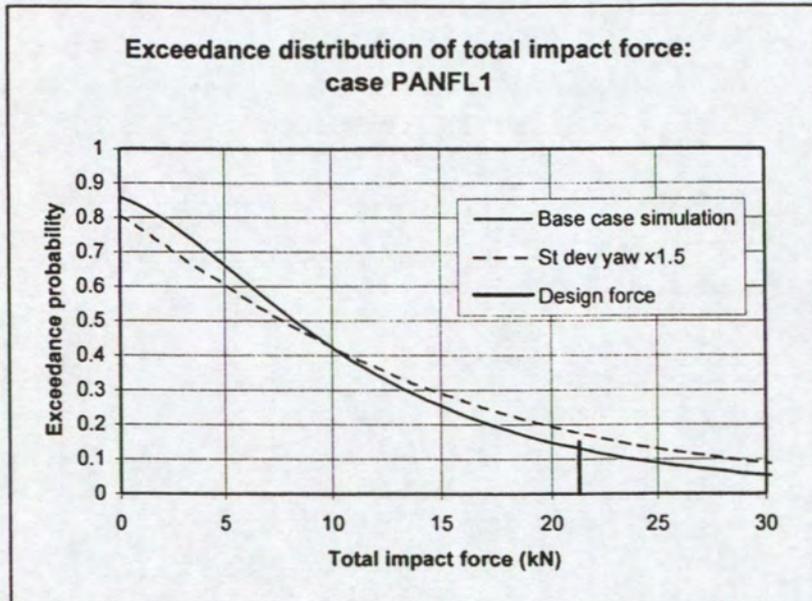
Figure 80: Exceedance distribution of the maximum total impact force: panel in fly-in incident, effect of increased yaw angle range.

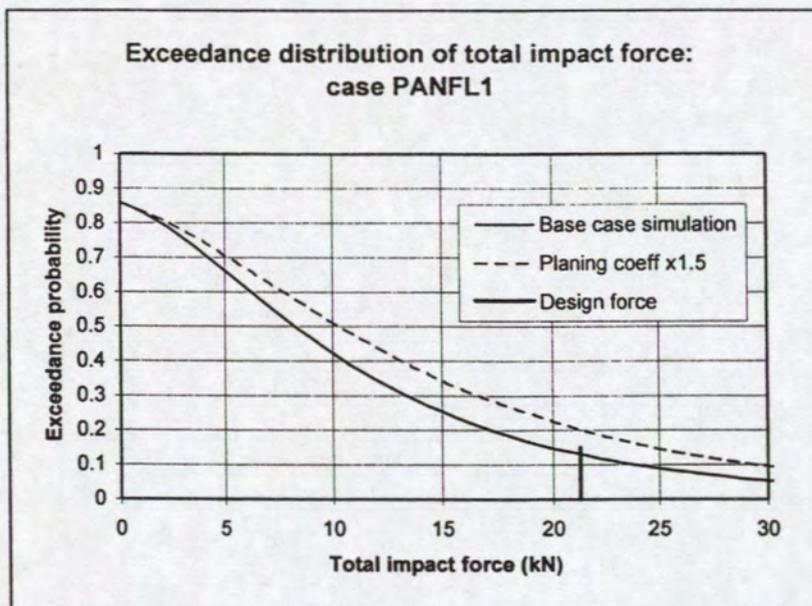
Figure 81: Exceedance distribution of the maximum total impact force: panel in fly-in incident, effect of increased planing force coefficient.

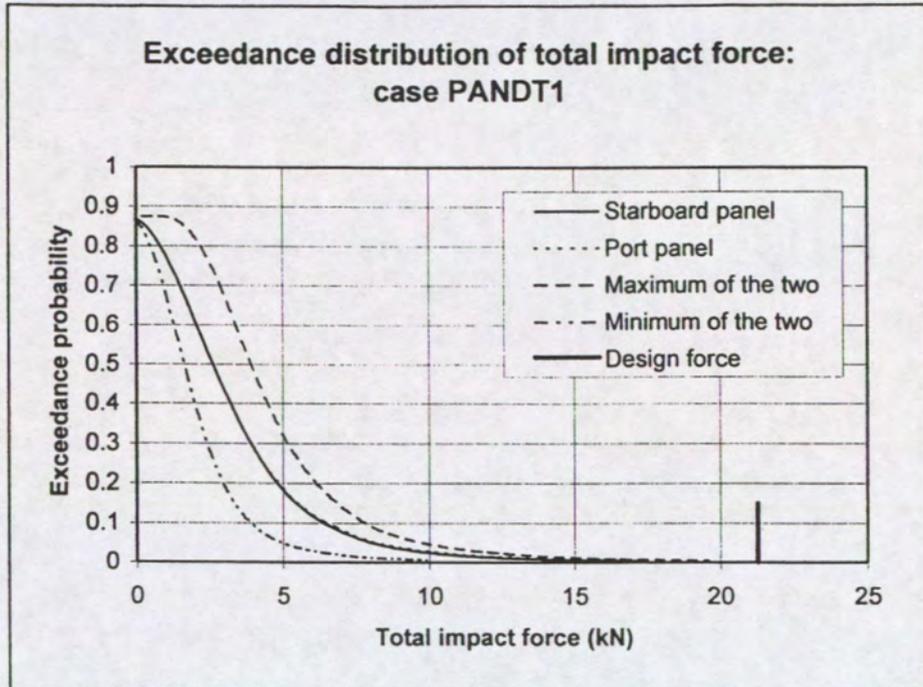
Figure 82: Exceedance distribution of the maximum total impact force on fuselage panels in a controlled ditching incident; individually and together.

Figure 82 compares the four resulting exceedance distributions of maximum impact loads in the controlled ditching scenario. The load distribution for the 'starboard panel' alone is identical to that obtained during the base case study. As expected, the results for the 'starboard panel' and 'port panel' alone are almost indistinguishable.

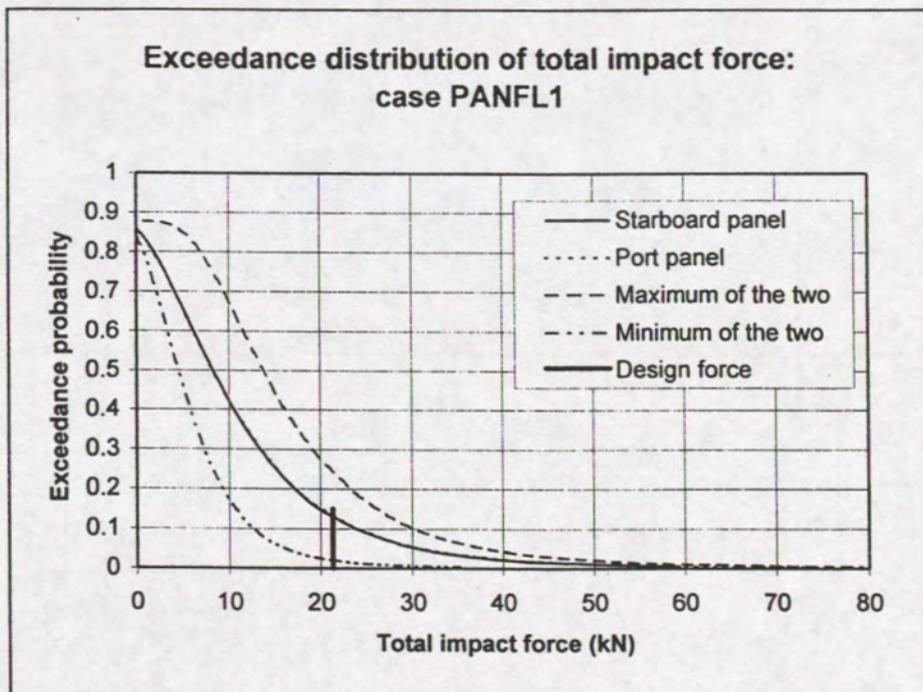
Figure 83: Exceedance distribution of the maximum total impact force on fuselage panels in a fly-in incident; individually and together.

Figures 83, 84 and 85 show similar sets of results obtained in scenarios representing fly-in, loss of control and vertical descent incidents respectively.

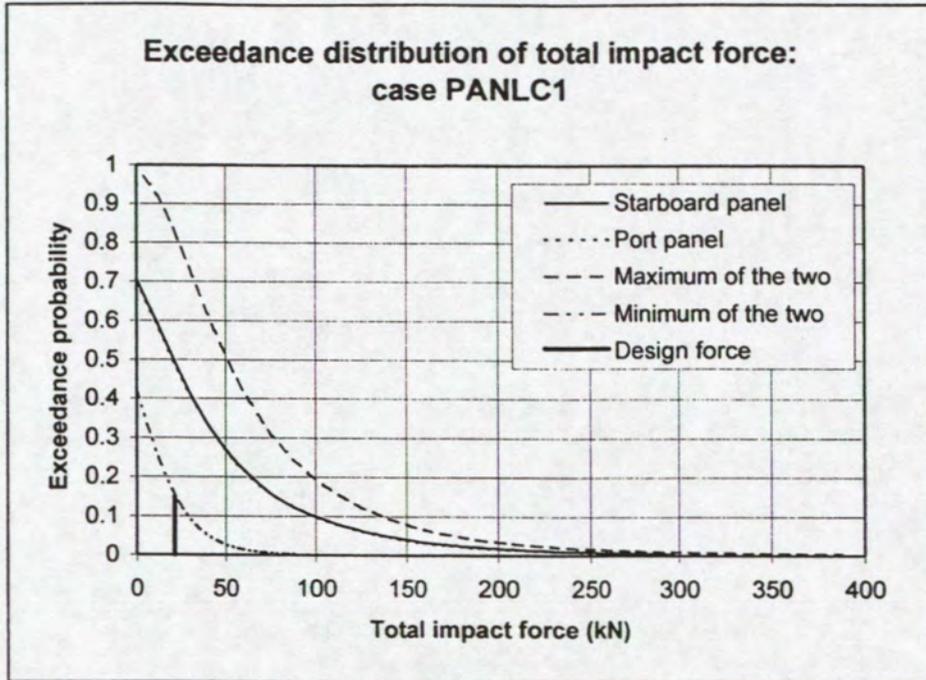
Figure 84: Exceedance distribution of the maximum total impact force on fuselage panels in a loss of control incident; individually and together.

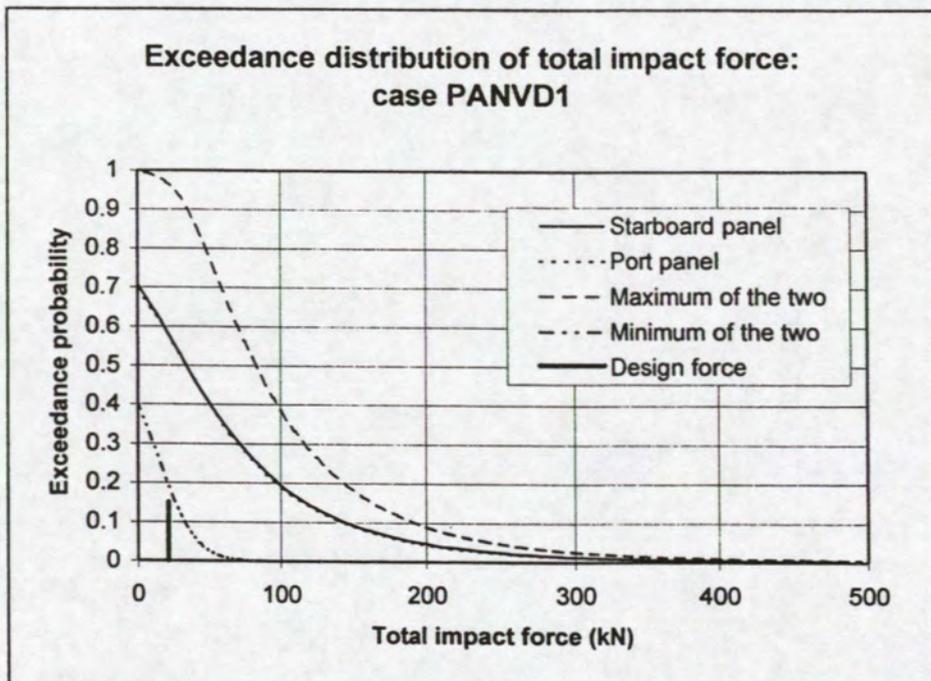
Figure 85: Exceedance distribution of the maximum total impact force on fuselage panels in a vertical descent incident; individually and together.

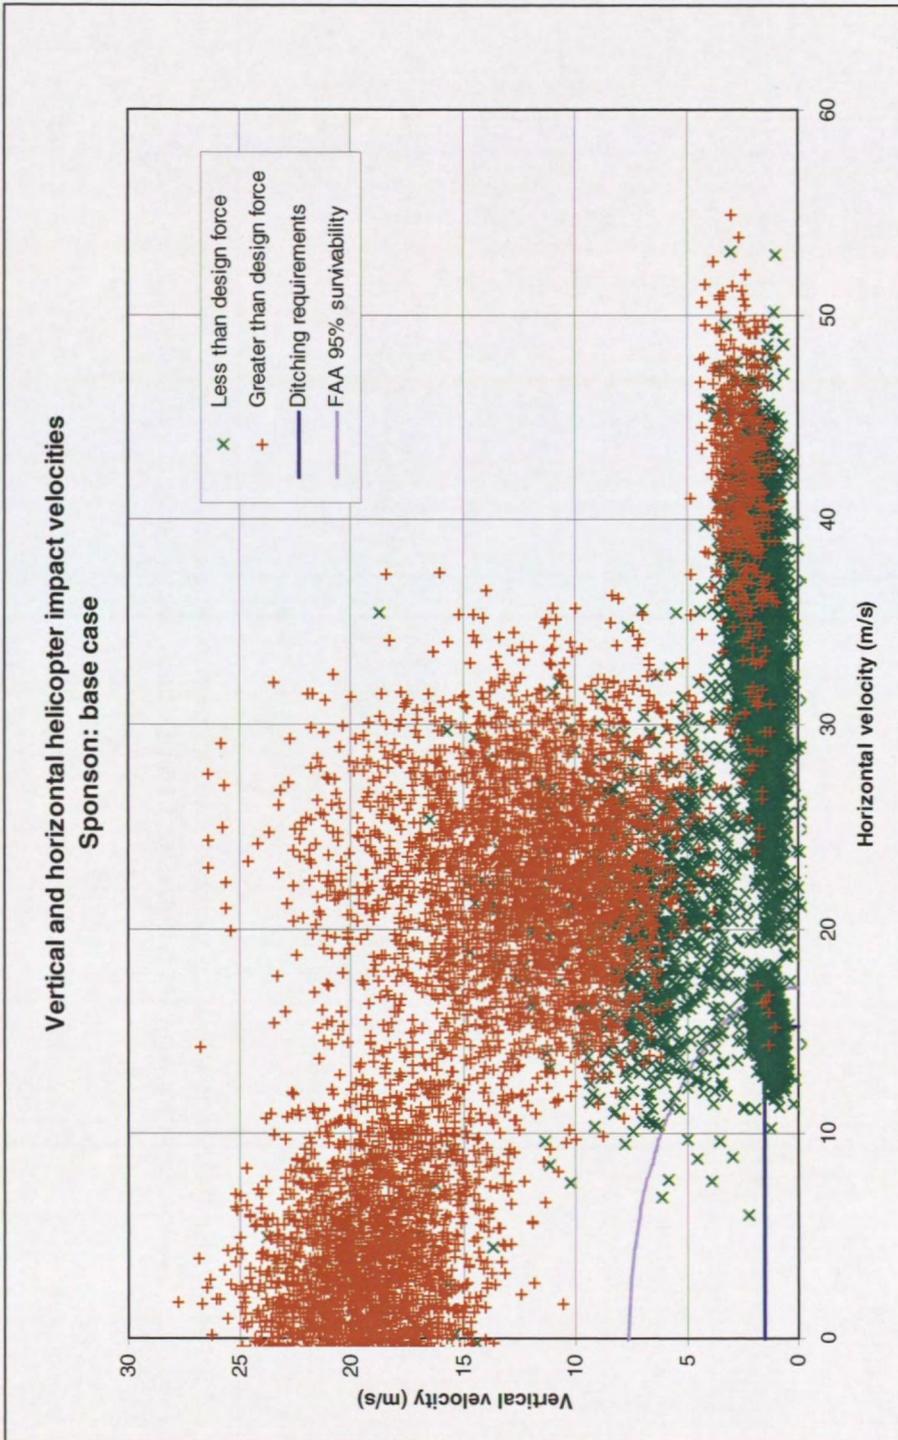
Figure 86: Scatter plot showing vertical and horizontal impact velocities of helicopter: loads on sponson greater than and less than the design load: base case conditions.

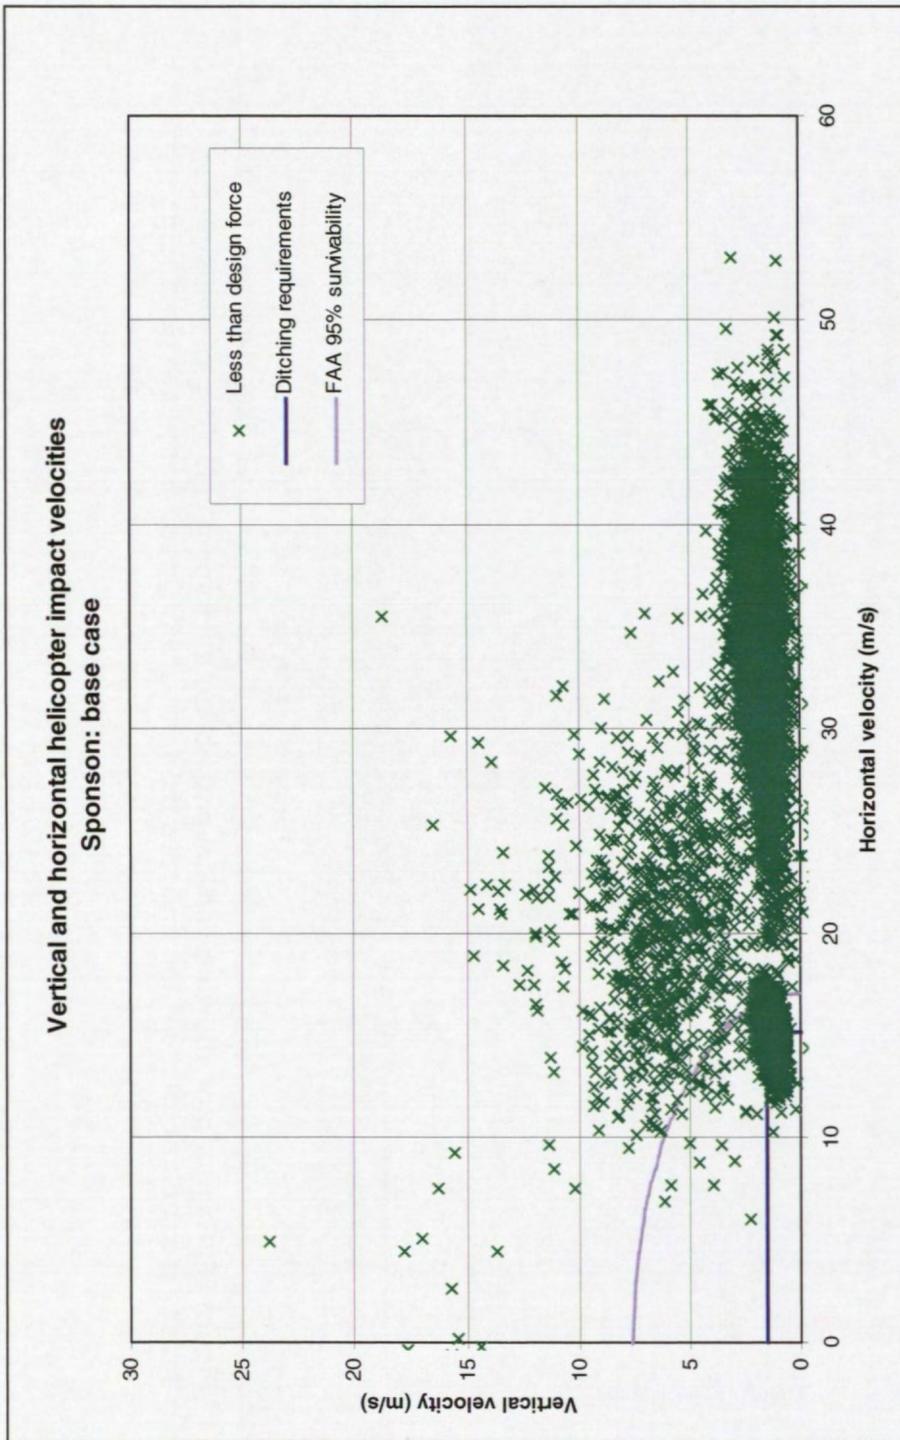
Figure 87: Scatter plot showing vertical and horizontal impact velocities of helicopter: loads on sponson less than the design load: base case conditions.

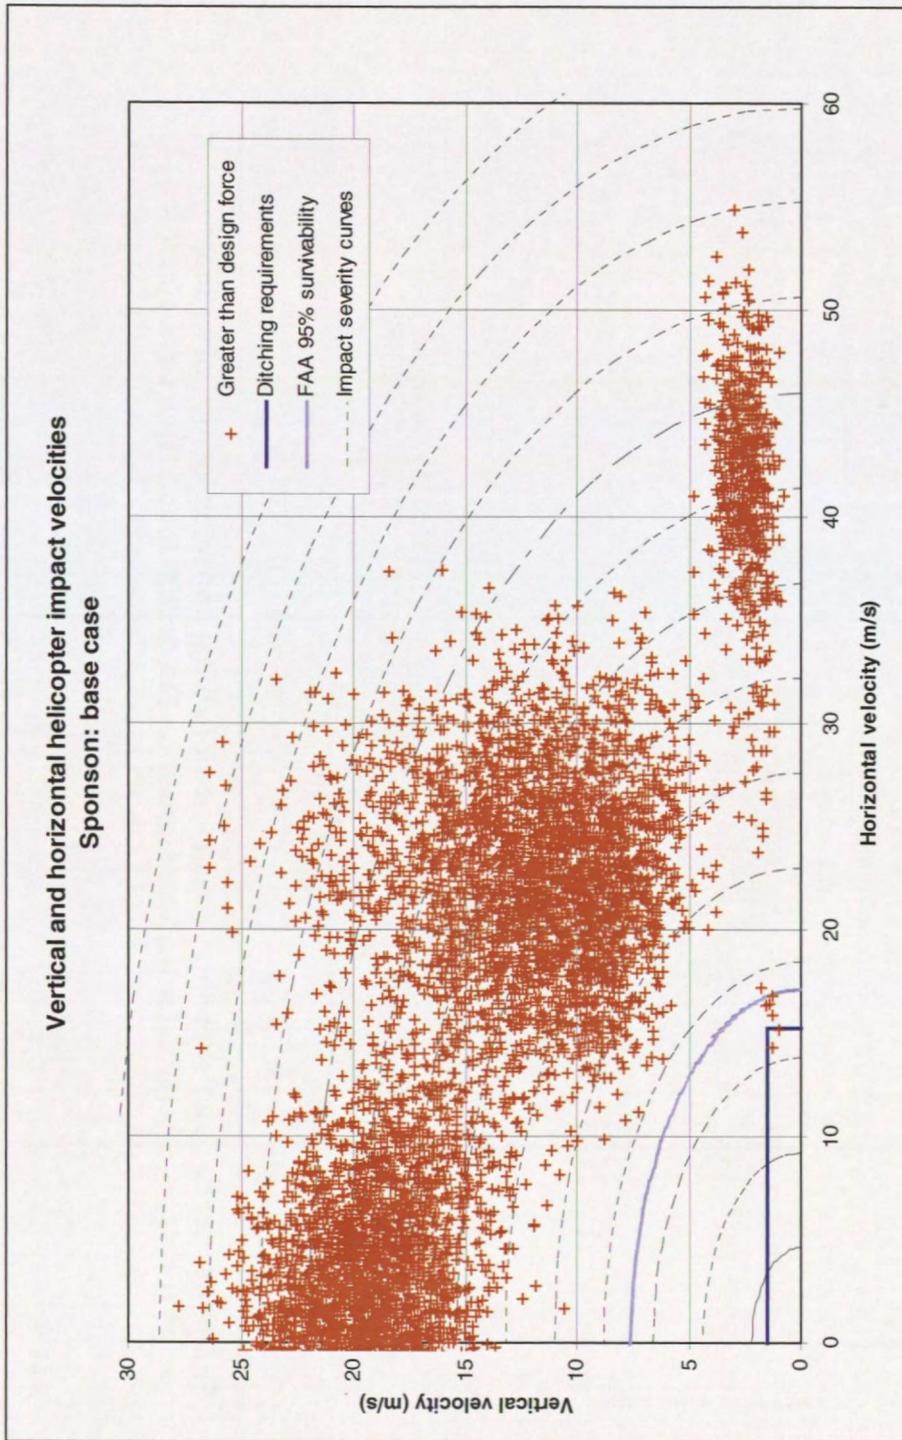
Figure 88: Scatter plot showing vertical and horizontal impact velocities of helicopter: loads on sponson greater than the design load: base case conditions.

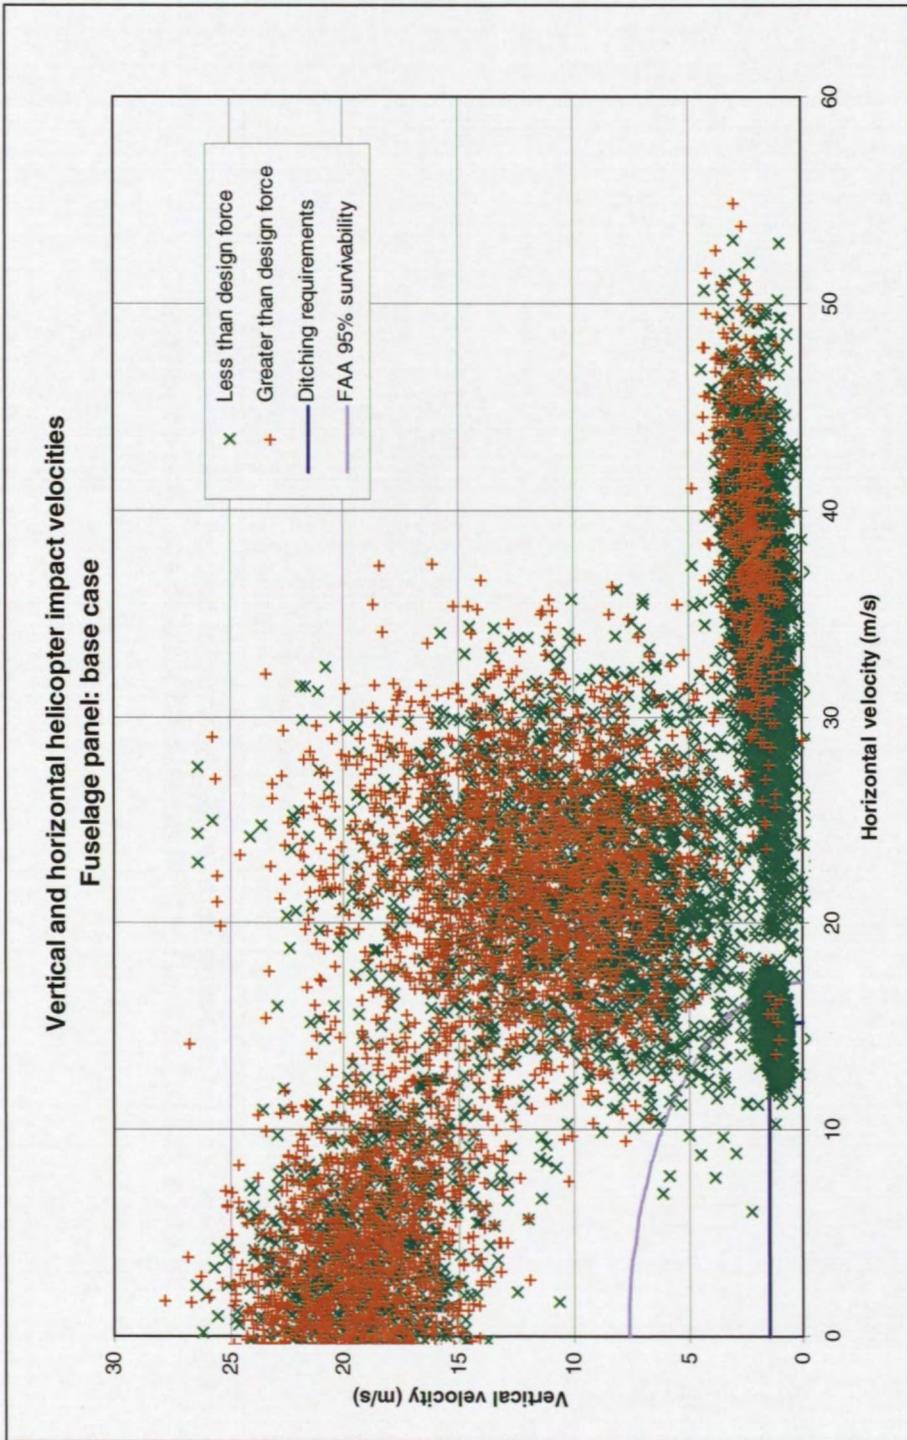
Figure 89: Scatter plot showing vertical and horizontal impact velocities of helicopter: loads on fuselage panel greater than and less than the design load: base case conditions.

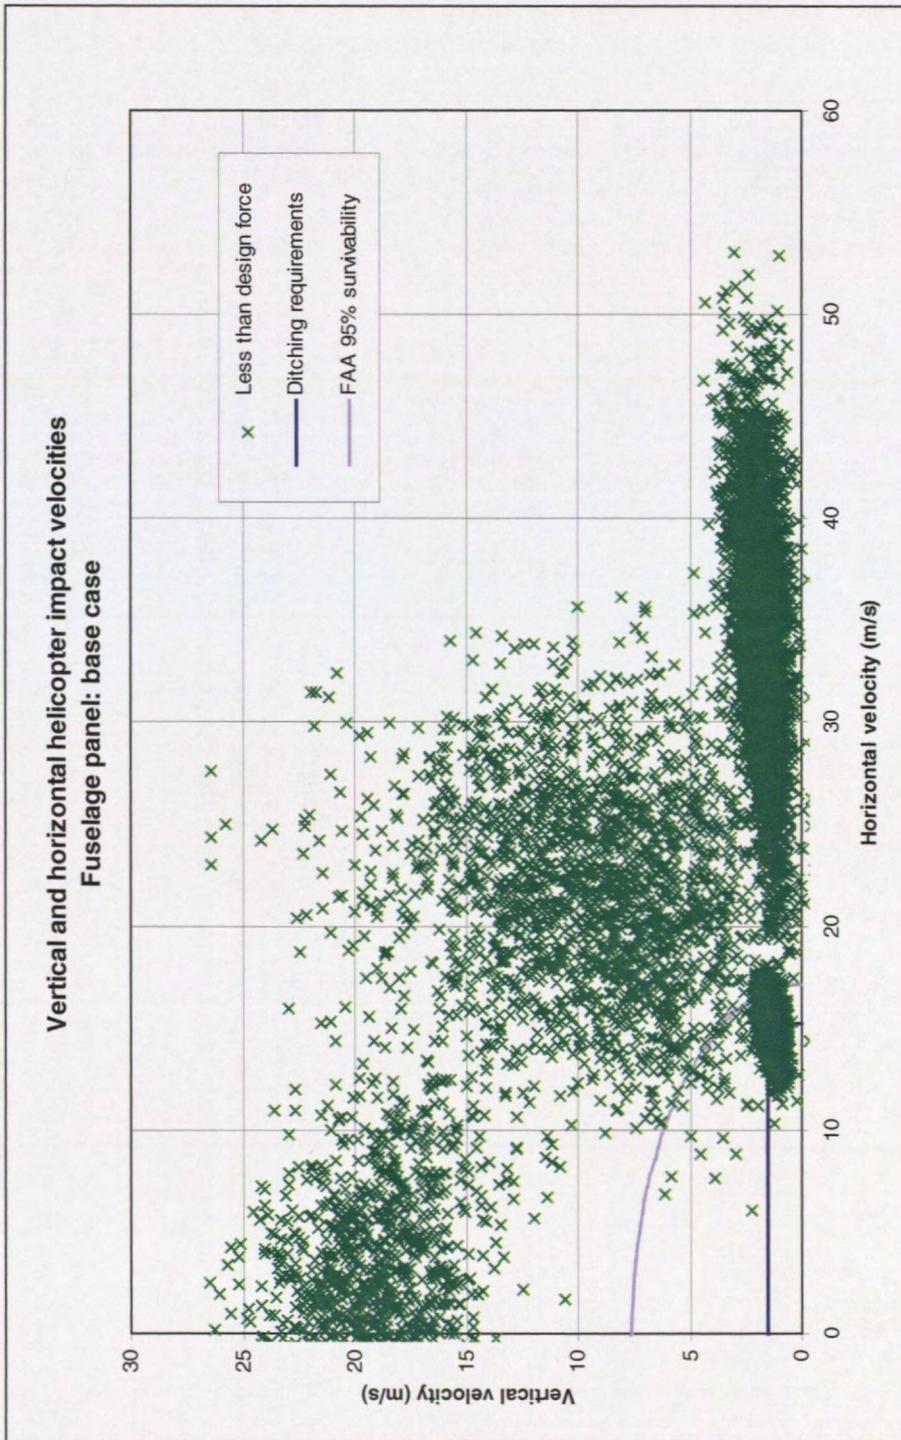
Figure 90: Scatter plot showing vertical and horizontal impact velocities of helicopter: loads on fuselage panel less than the design load: base case conditions.

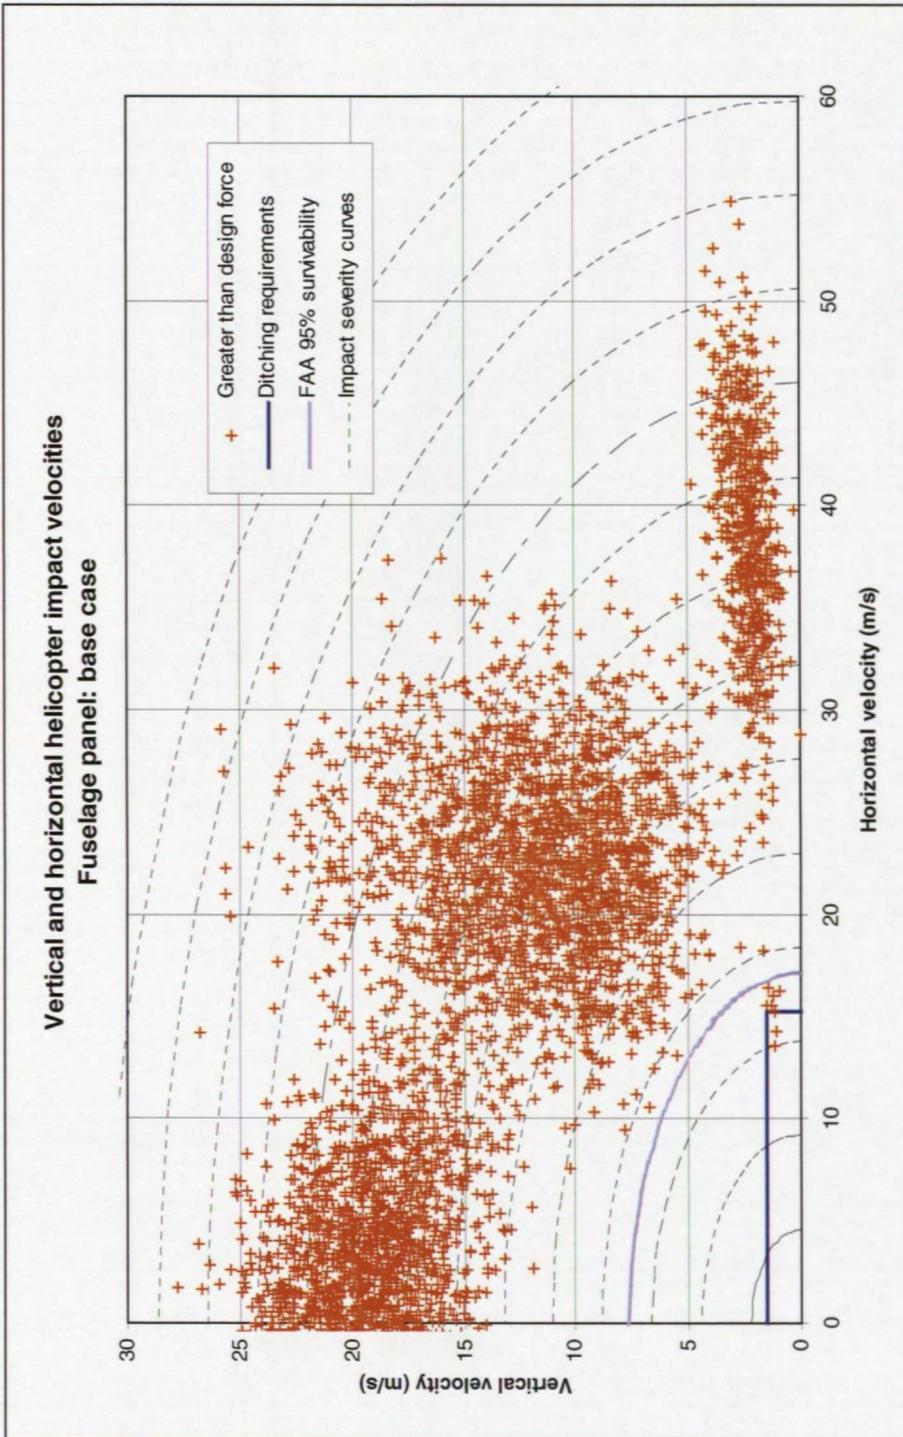
Figure 91: Scatter plot showing vertical and horizontal impact velocities of helicopter: loads on fuselage panel greater than the design load: base case conditions.

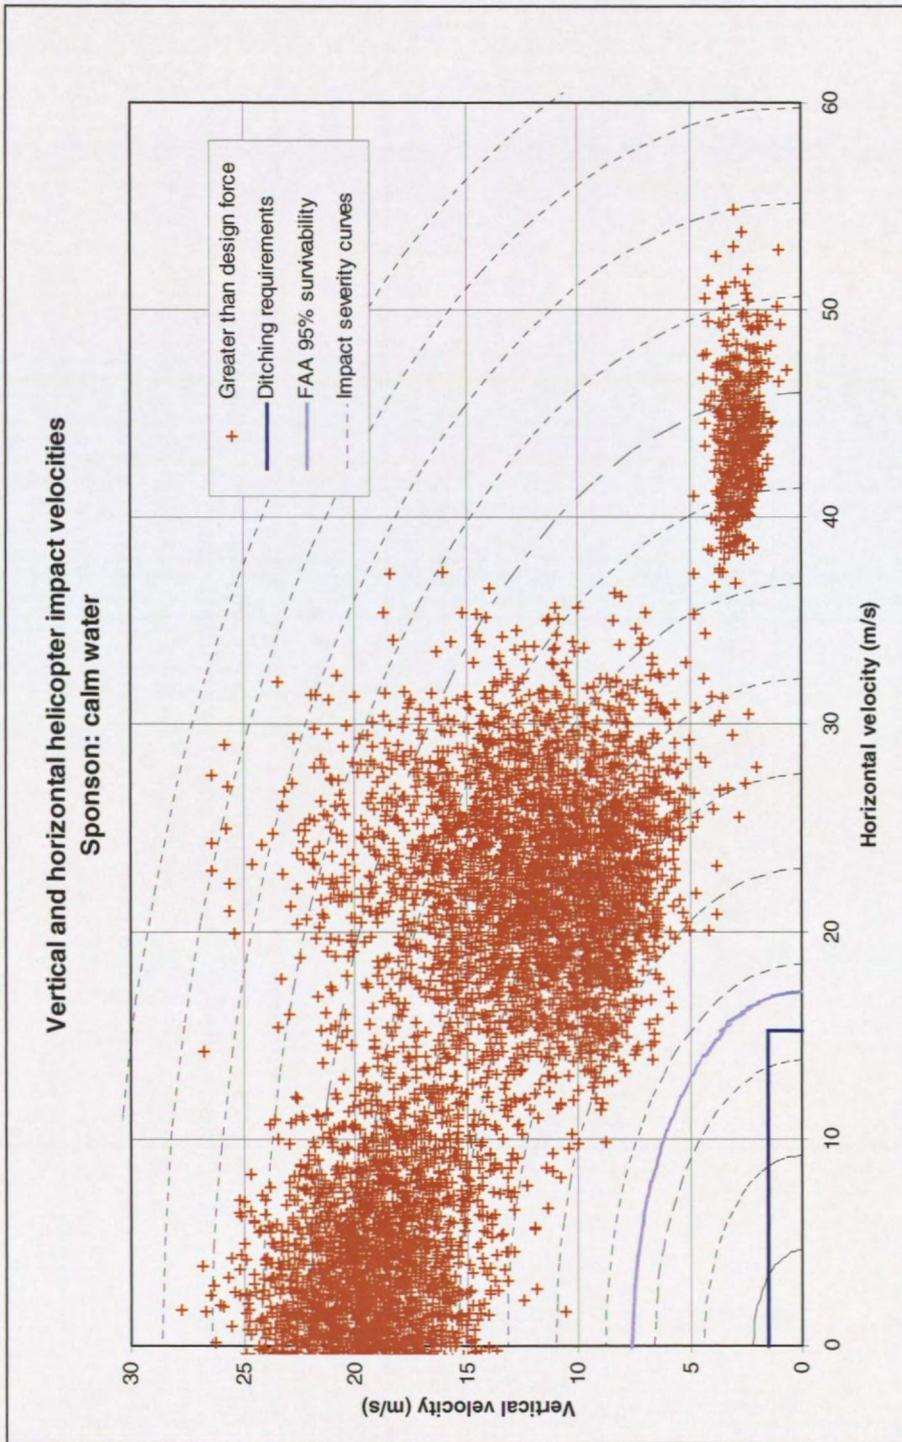
Figure 92: Scatter plot showing vertical and horizontal impact velocities of helicopter: loads on sponson greater than the design load: calm water conditions.

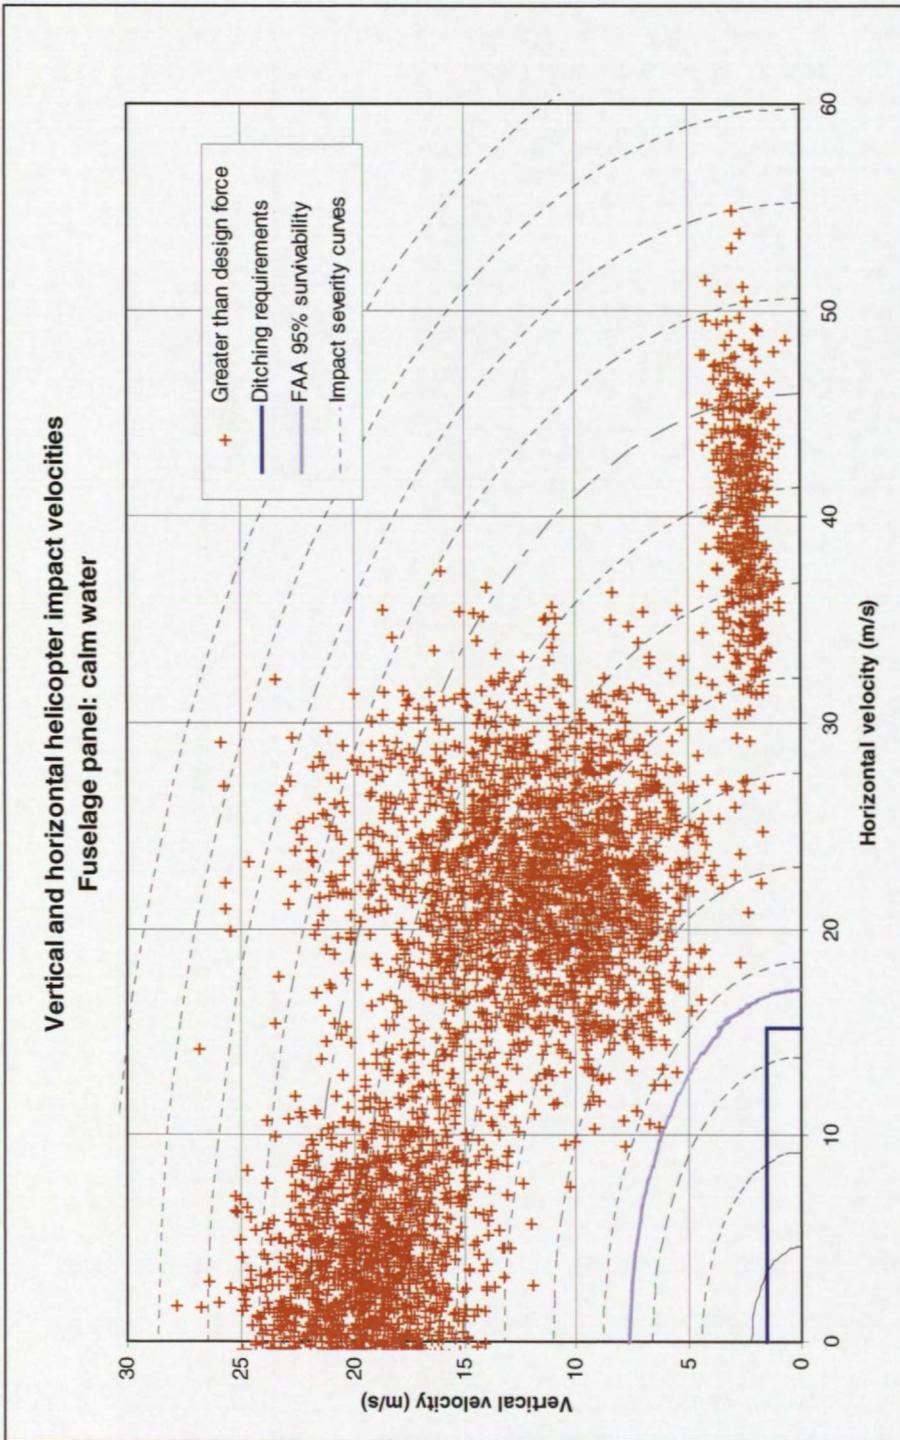
Figure 93: Scatter plot showing vertical and horizontal impact velocities of helicopter: loads on fuselage panel greater than the design load: calm water conditions.

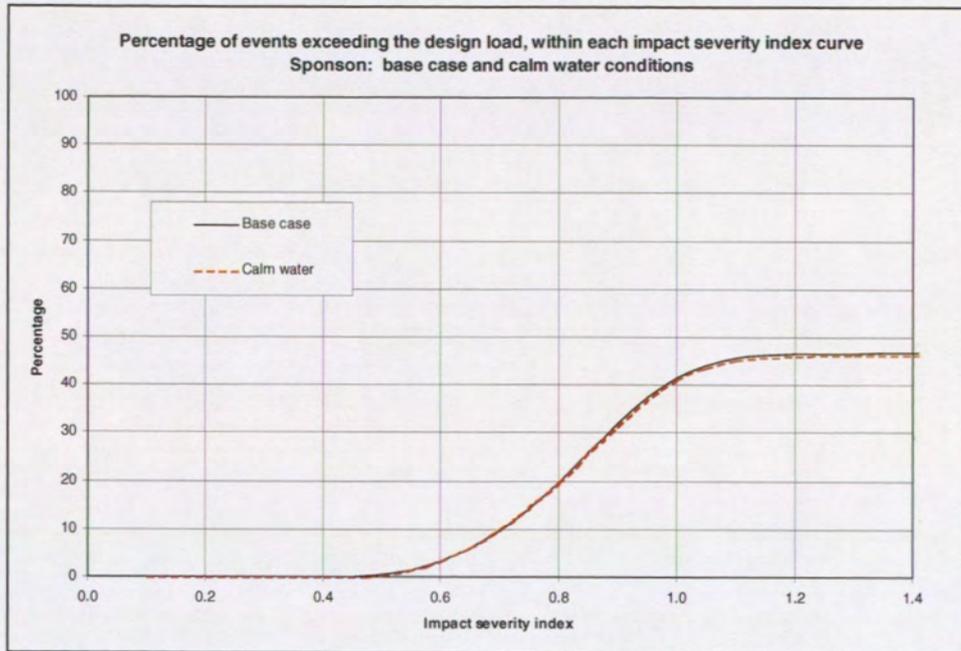
Figure 94: Percentage of impact events exceeding the design load within each impact severity index curve: sponson in base case & calm water conditions.

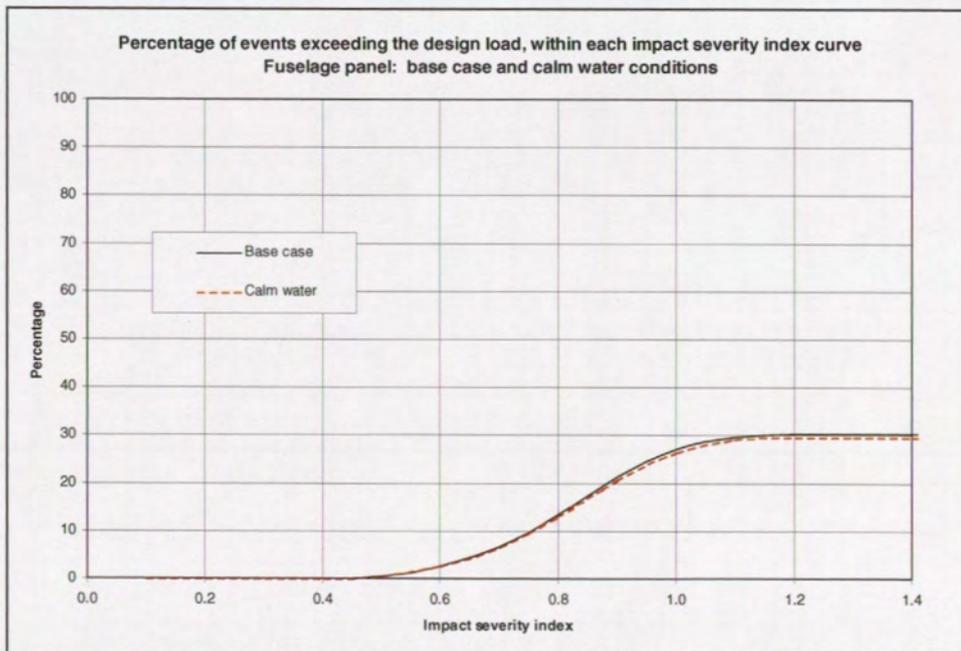
Figure 95: Percentage of impact events exceeding the design load within each impact severity index curve: fuselage panel in base case & calm water conditions.

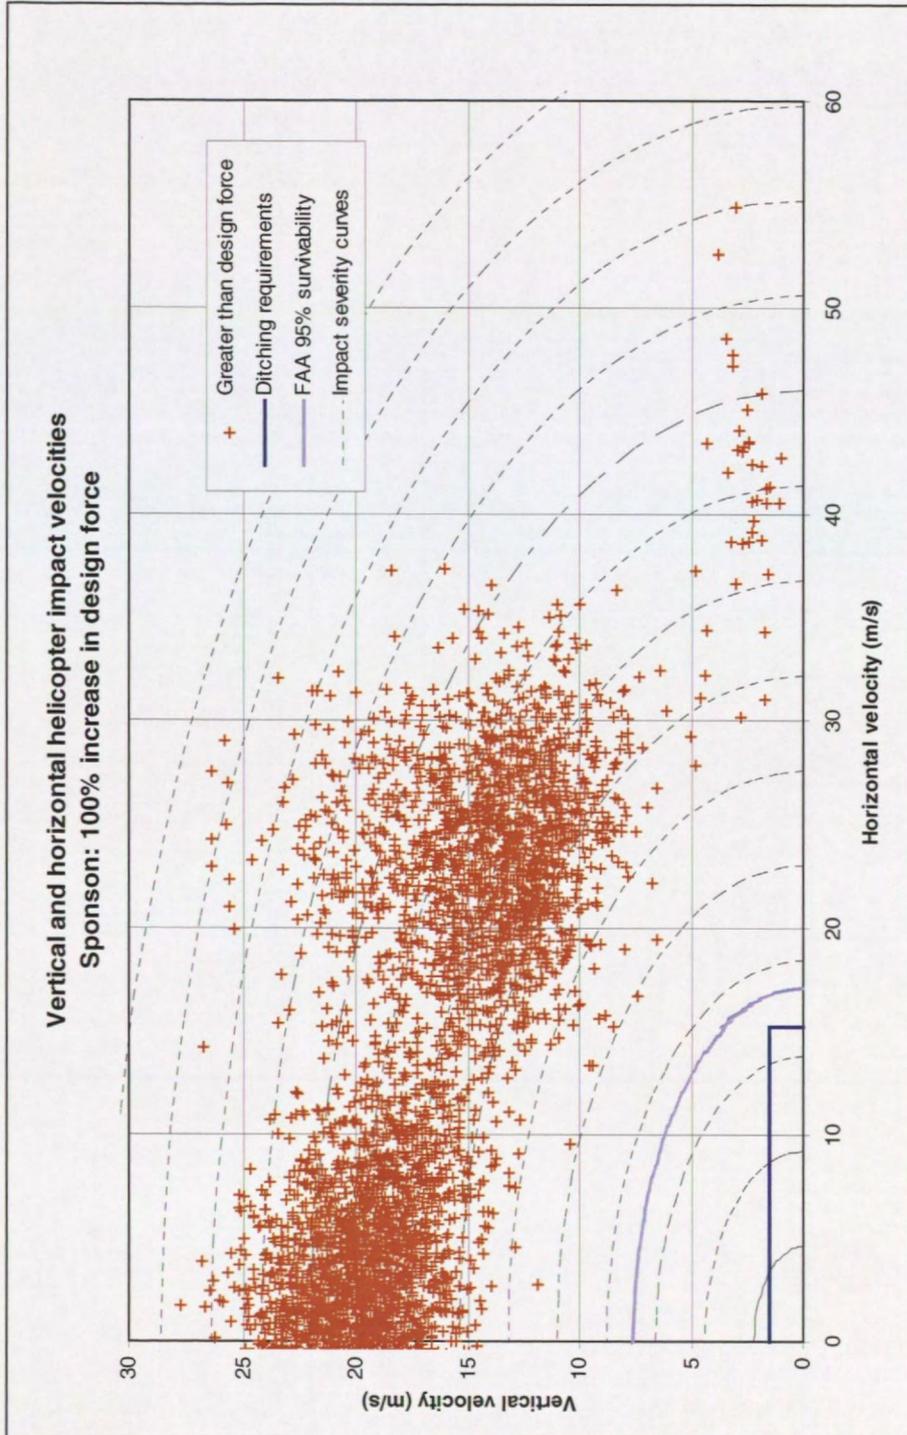
Figure 96: Scatter plot showing vertical and horizontal impact velocities of helicopter: loads on sponson greater than the design load: 100% increase in design load.

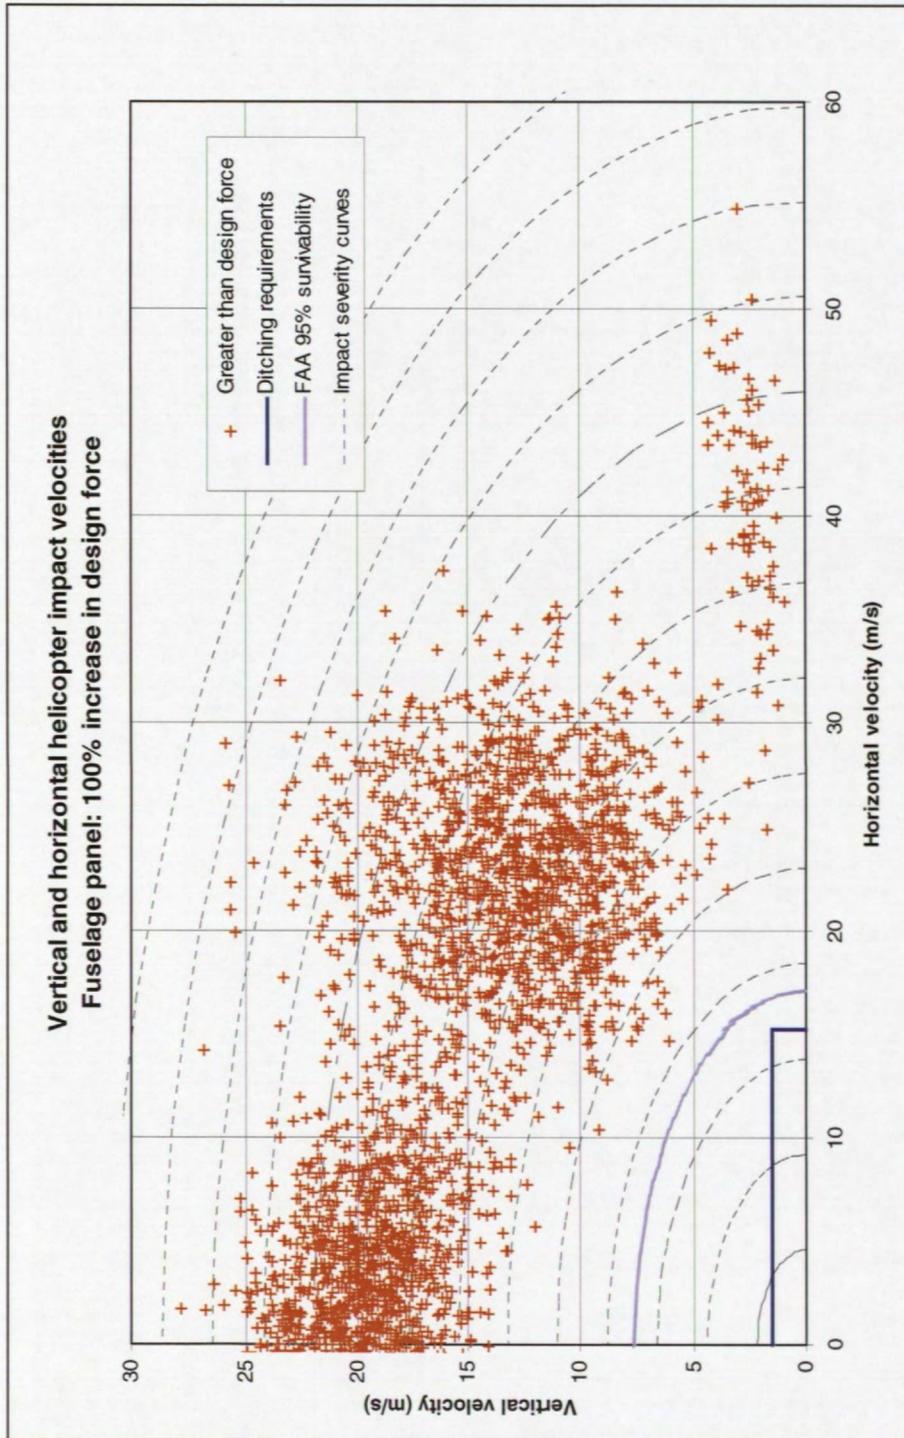
Figure 97: Scatter plot showing vertical and horizontal impact velocities of helicopter: loads on fuselage panel greater than the design load: 100% increase in design load.

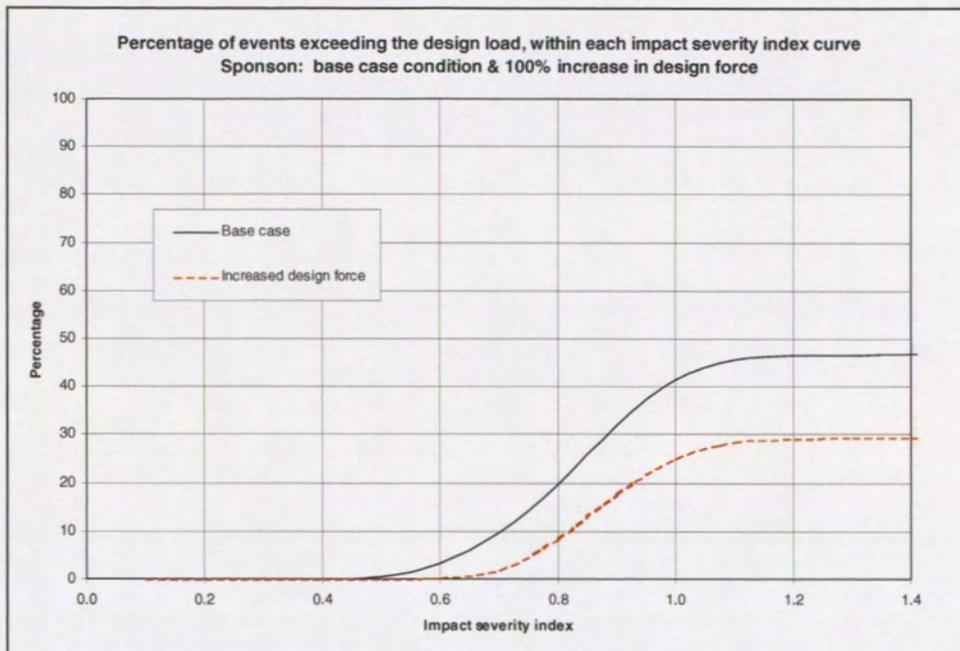
Figure 98: Percentage of impact events exceeding the design load within each impact severity index curve: sponson in base case conditions, and with 100% increase in the design load.
