CAA PAPER 2001/2

**CRASHWORTHINESS OF HELICOPTER
EMERGENCY FLOTATION SYSTEMS**

Study I (Main Study)

Study II (Supplementary Study)

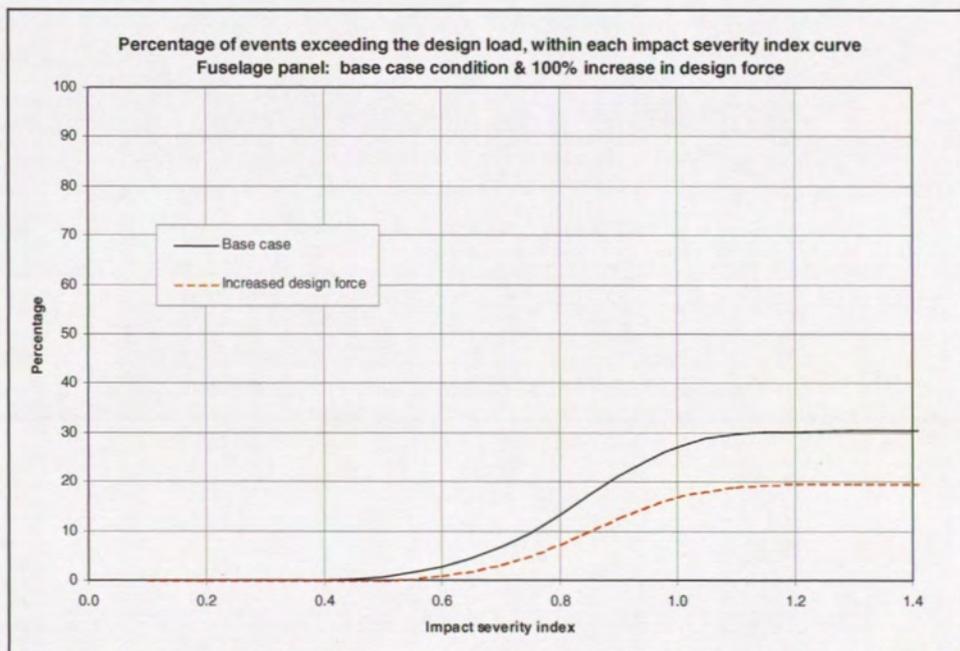
Figure 99: Percentage of impact events exceeding the design load within each impact severity index curve: fuselage panel in base case conditions, and with 100% increase in the design load.

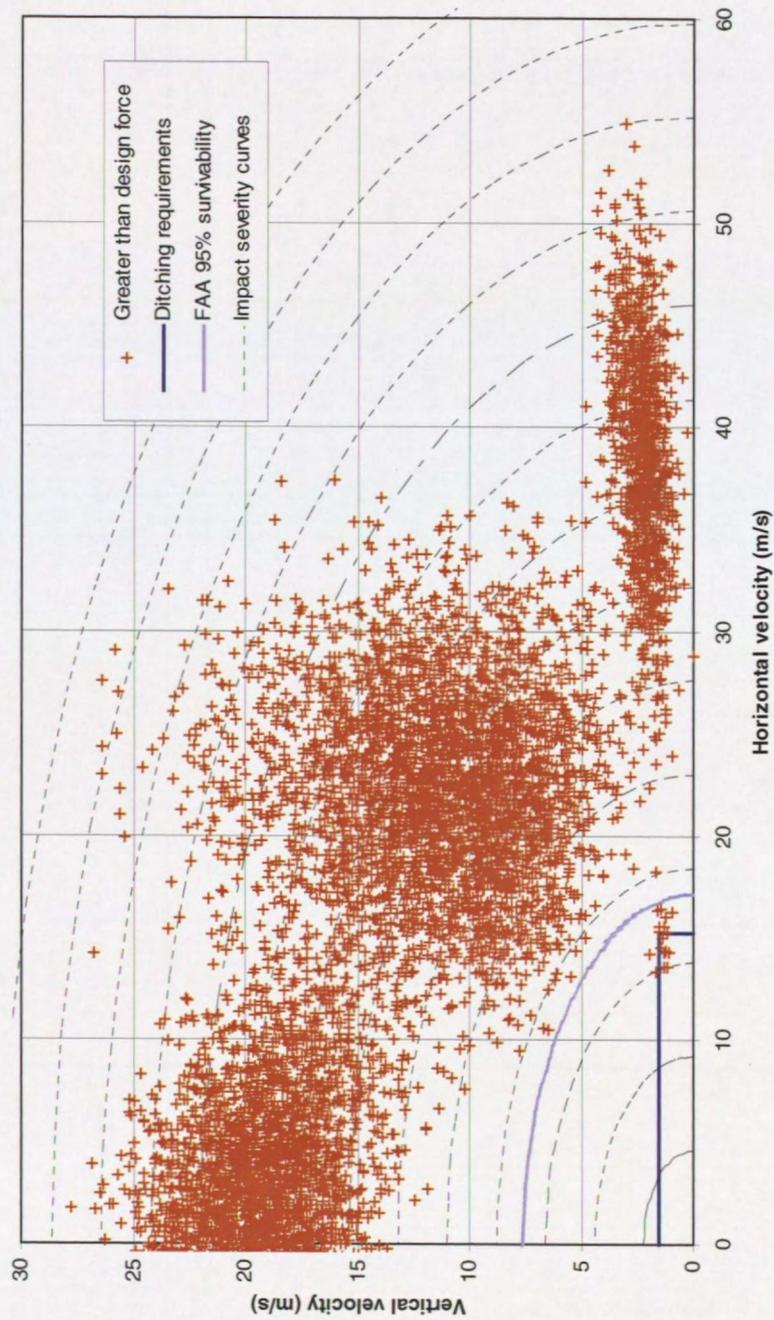
Figure 100: Scatter plot showing vertical and horizontal impact velocities of helicopter loads greater than the design load: two fuselage panels, no redundancy.

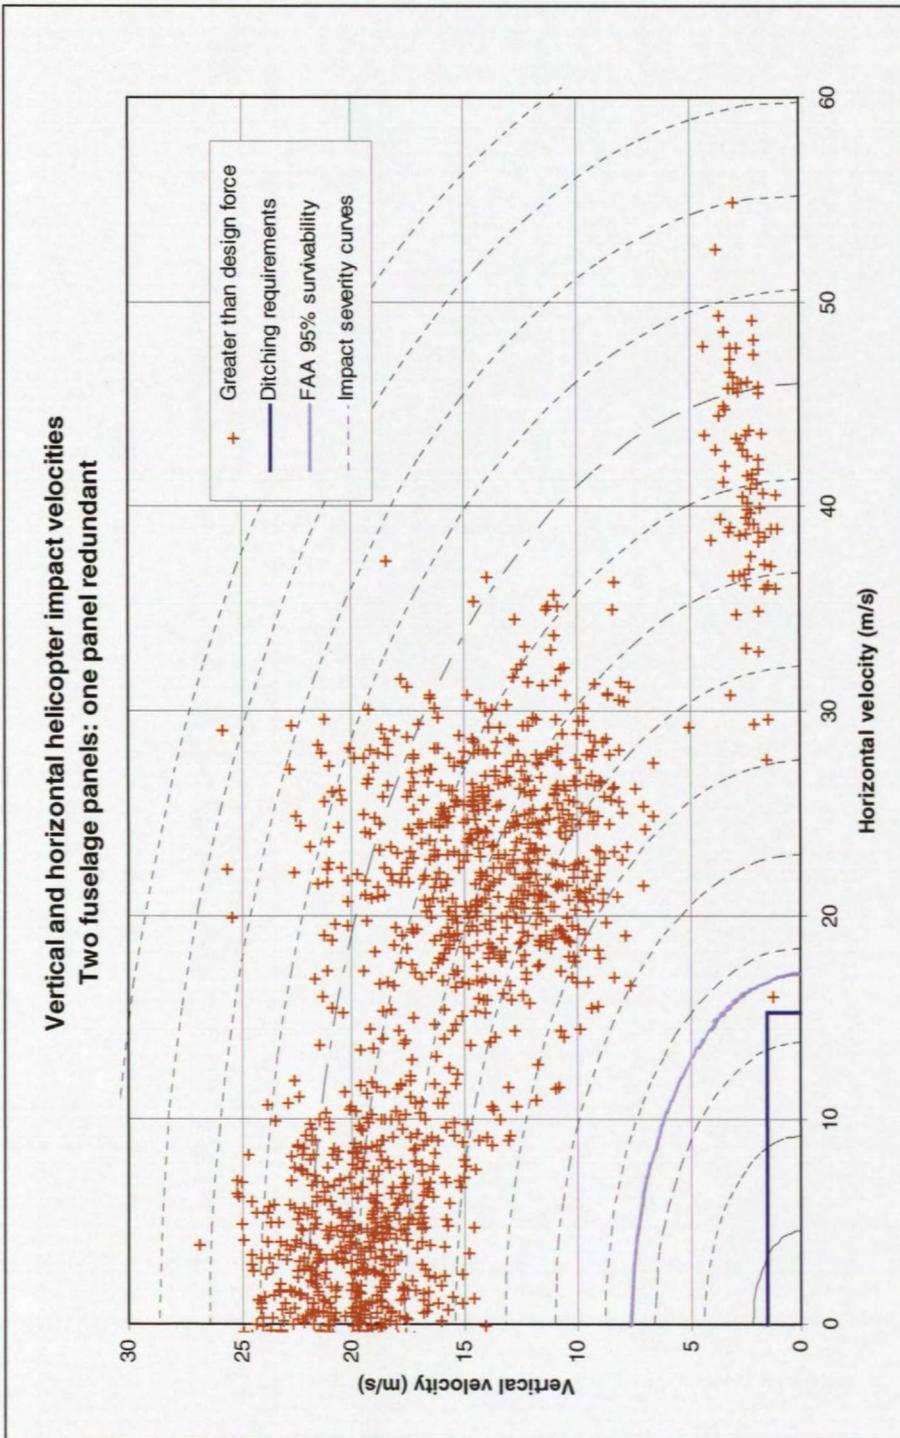
Figure 101: Scatter plot showing vertical and horizontal impact velocities of helicopter: loads greater than the design load: two fuselage panels, one panel redundant.

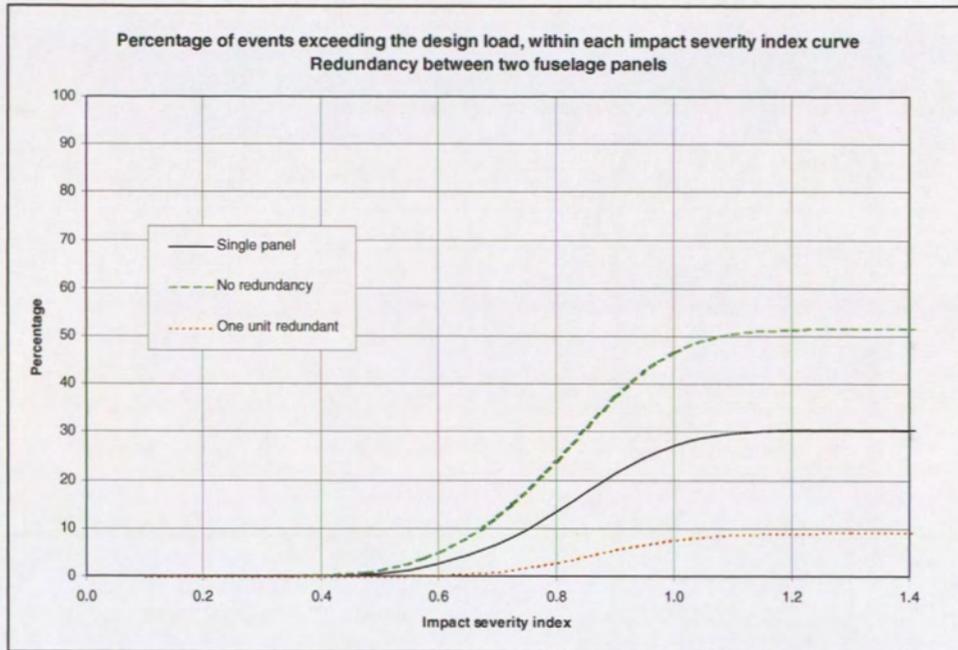
Figure 102: Percentage of impact events exceeding the design load within each impact severity index curve: redundancy between two fuselage panels.

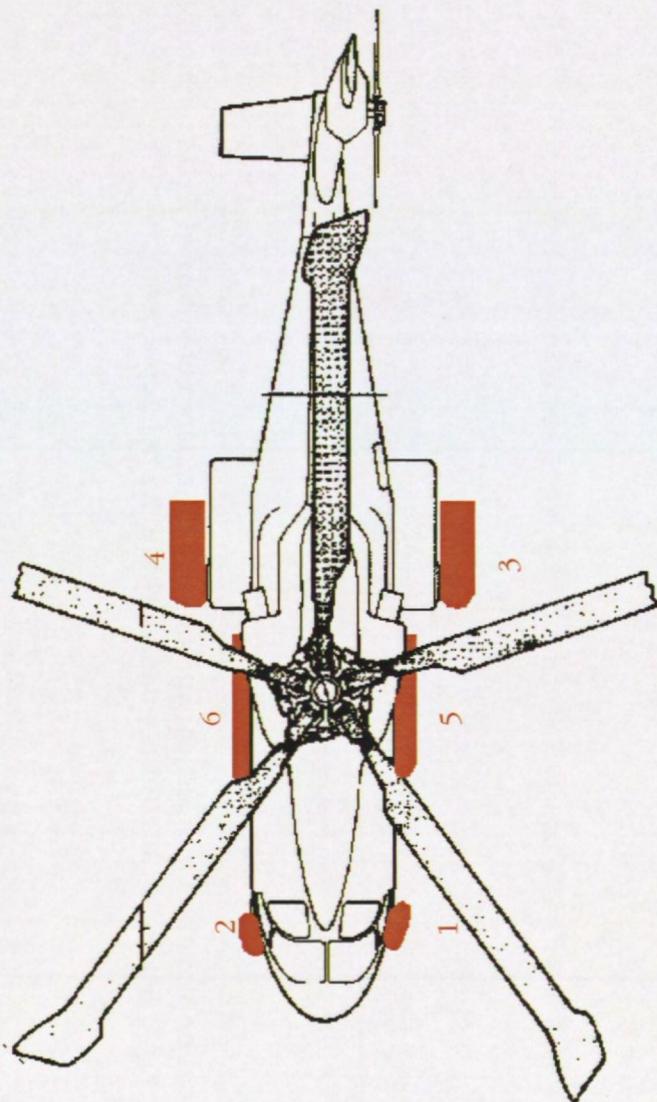
Figure 103: EH101 float numbering scheme.

Table 9.4 represents BMT's best subjective assessment of the consequences of panel failure, and Figure 103 shows the float numbering system used during this analysis. This table should be interpreted as follows:

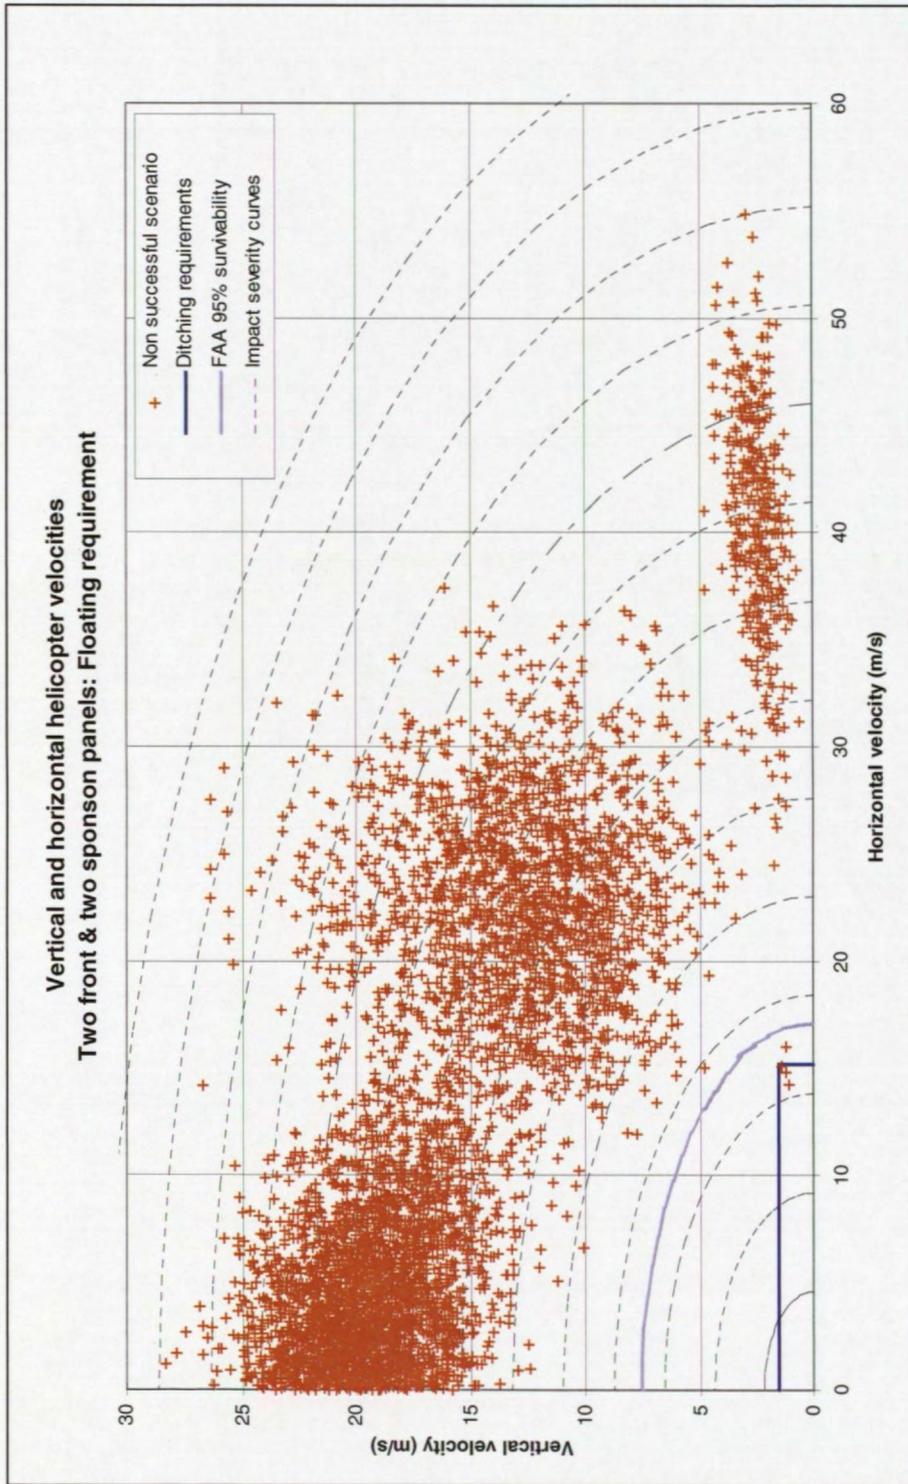
Figure 104: Scatter plot showing vertical and horizontal impact velocities of EH101 helicopter: 4-float configuration; cases where the helicopter sank.

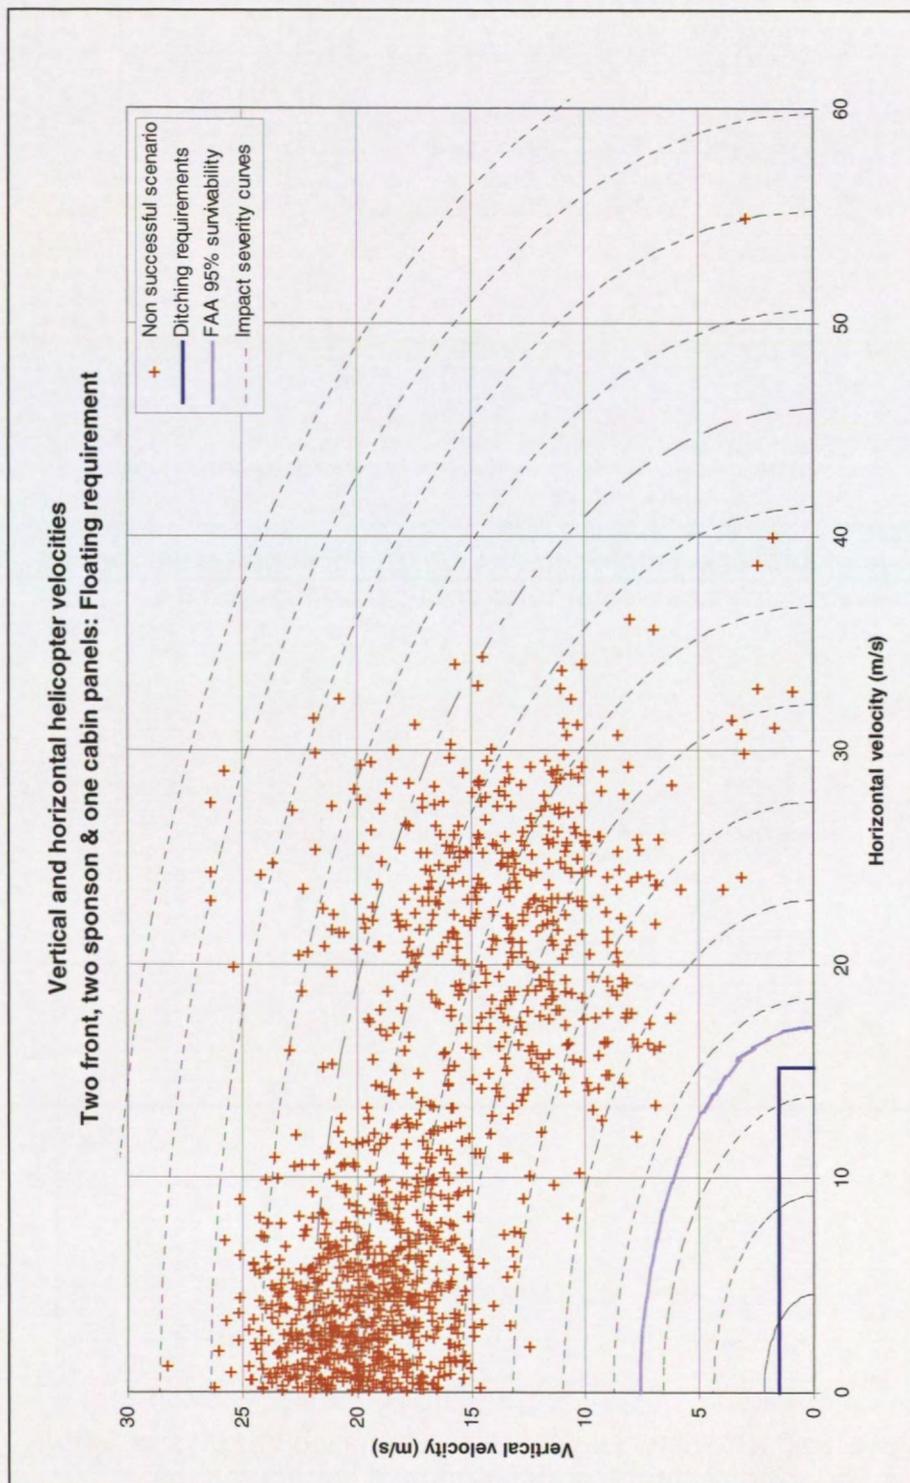
Figure 105: Scatter plot showing vertical and horizontal impact velocities of EH101 helicopter: 5-float configuration; cases where the helicopter sank.

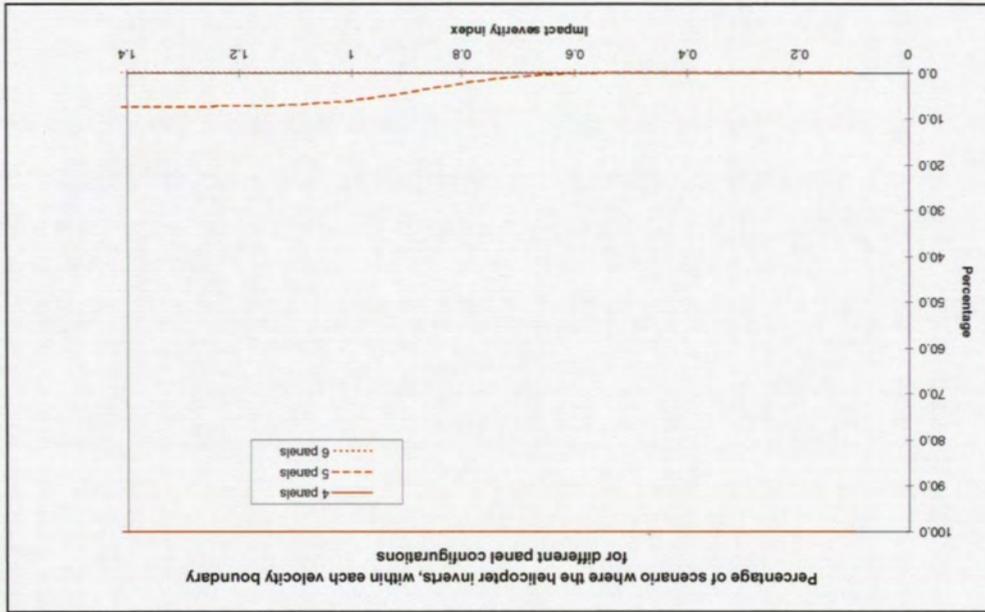
Figure 106: Percentage of impact events where the EH101 helicopter sinks, within each impact severity index curve, for different float configurations.

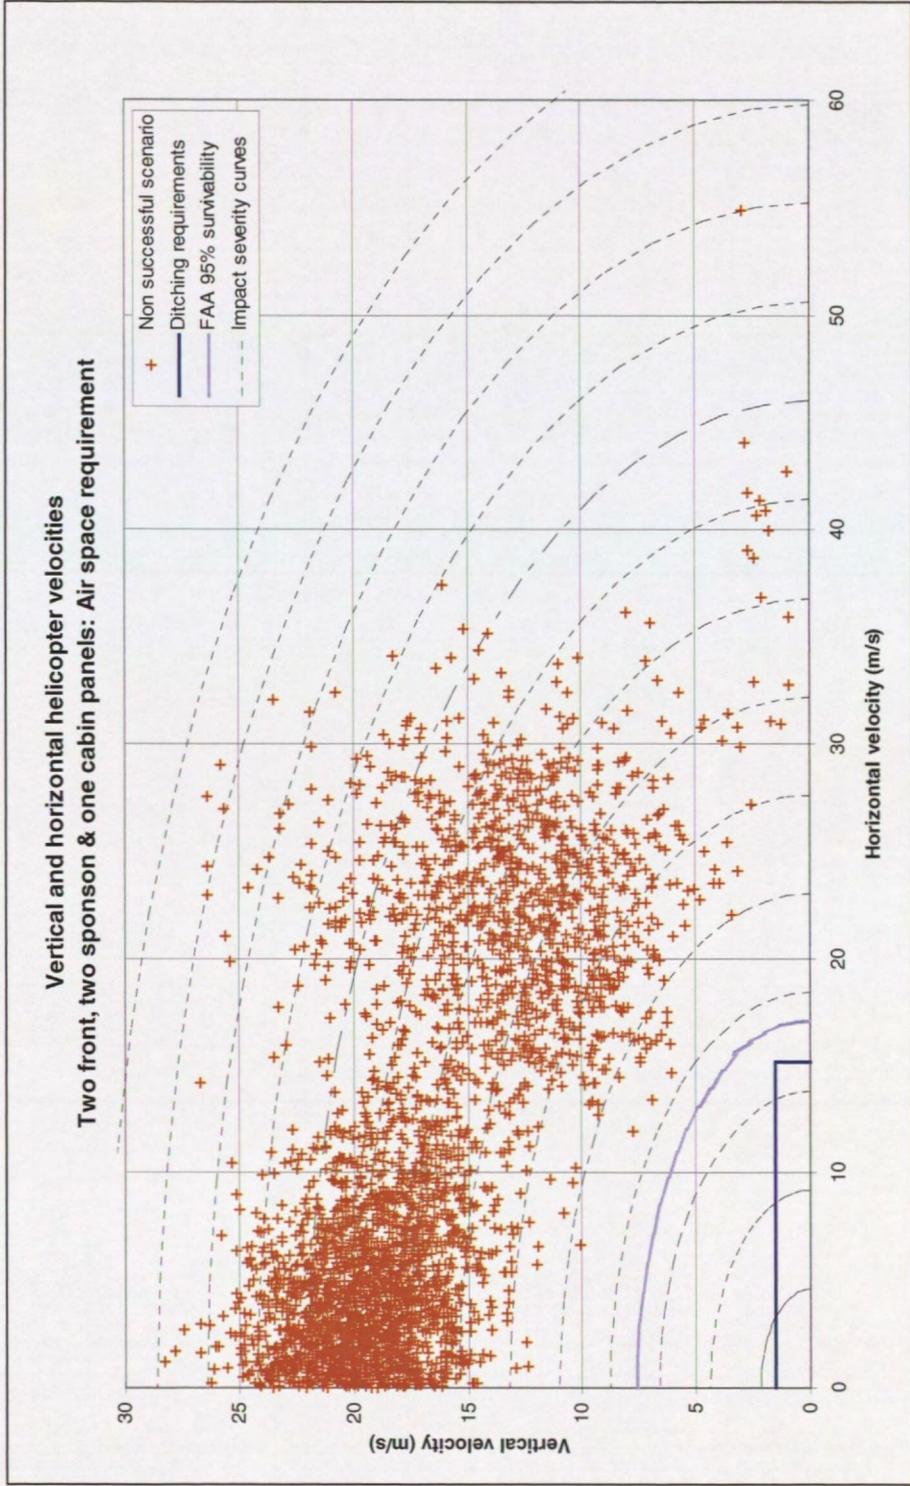
Figure 108: Scatter plot showing vertical and horizontal impact velocities of EH101 helicopter: 5-float configuration; cases with an unsatisfactory air space.

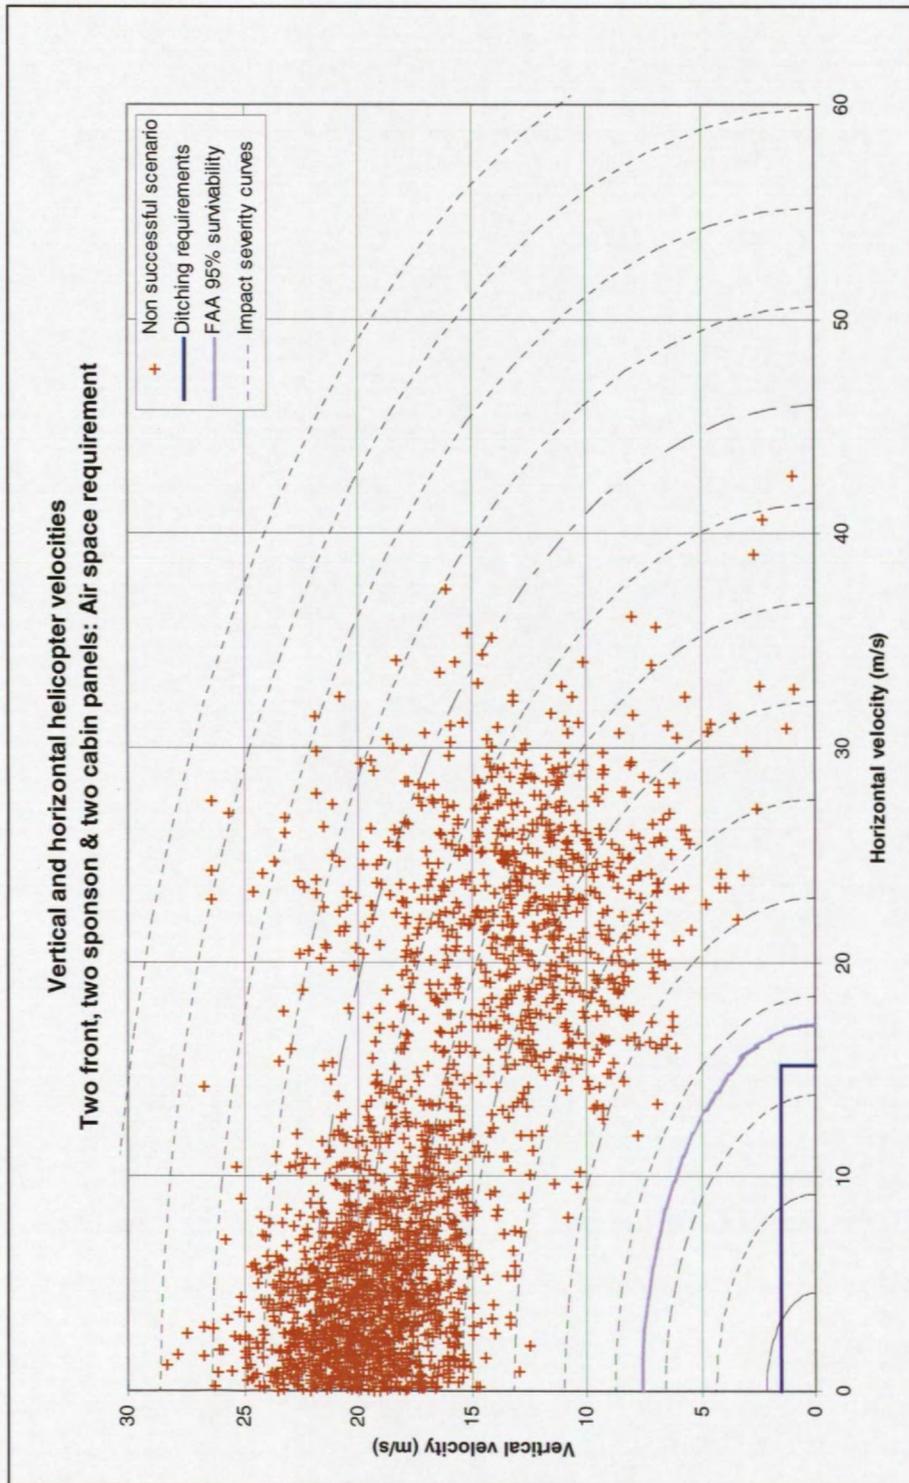
Figure 109: Scatter plot showing vertical and horizontal impact velocities of EH101 helicopter: 6-float configuration; cases with an unsatisfactory air space.

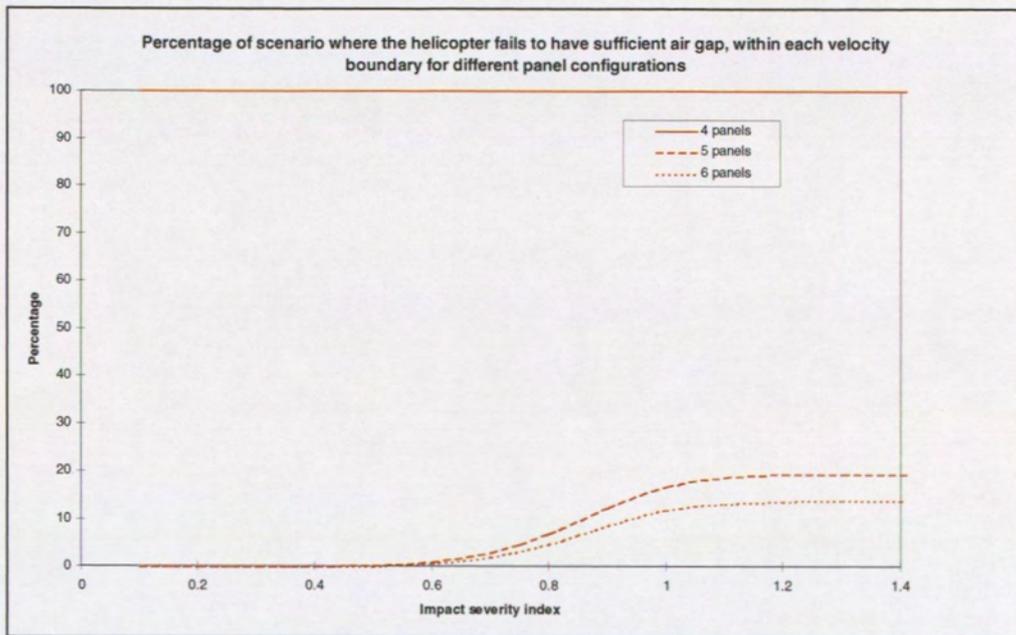
Figure 110: Percentage of impact events where the *EH101* helicopter provided an unsatisfactory air space, within each impact severity index curve, for different float configurations.

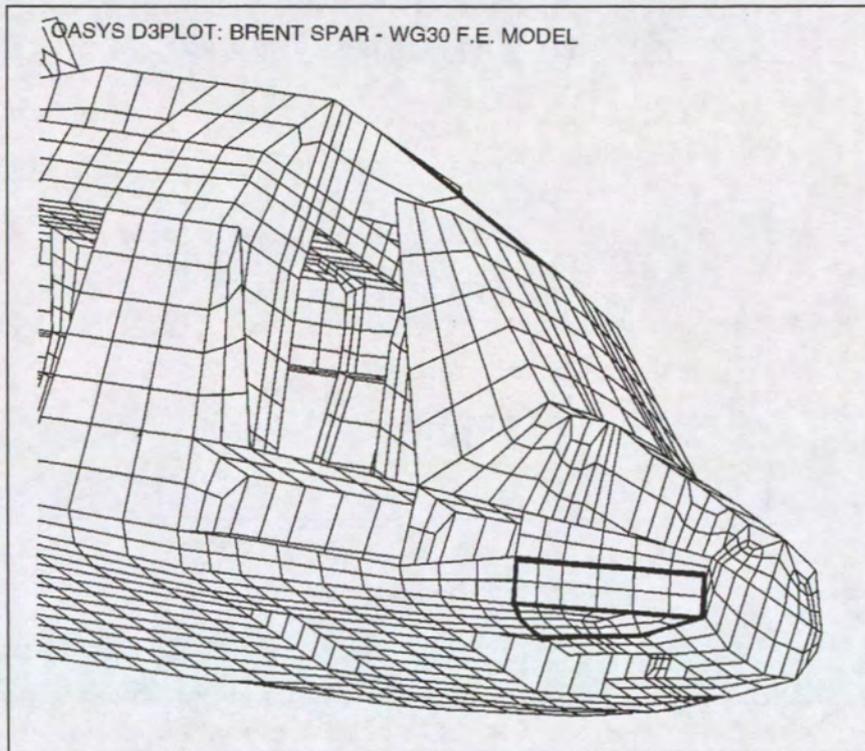
Figure 111: Forward part of WSA's finite element model, highlighting panels identified for investigation.

The helicopter involved in the *Brent Spar* accident suffered structural damage in a number of different areas [1]. WSA's investigations indicated severe water impact loading on the starboard side of the nose. The panels defined in Figure 111 and Figure 112 were therefore agreed to be of particular interest [36]. The attitude of the helicopter in these diagrams is shown at the instant of impact onto the water surface, with the same heel and trim angles as the helicopter involved in the *Brent Spar* accident.

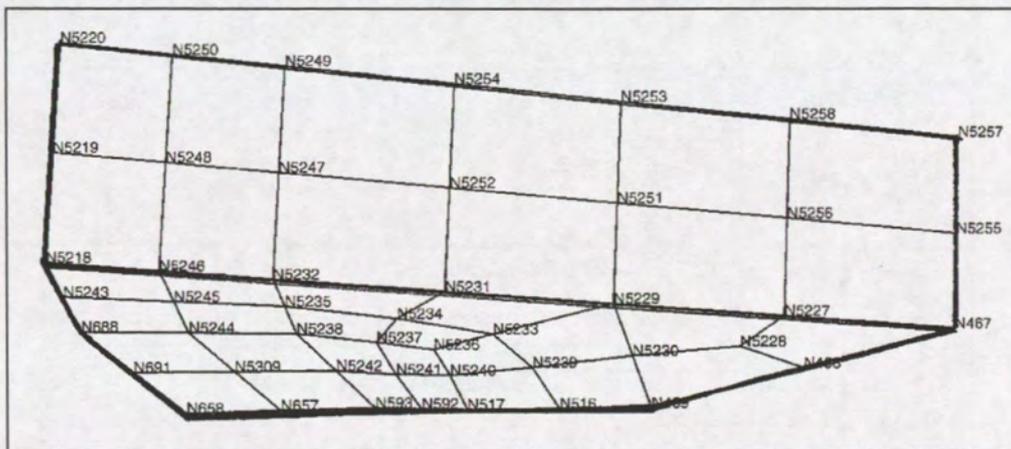
Figure 112: Enlargement of panels identified for investigation.

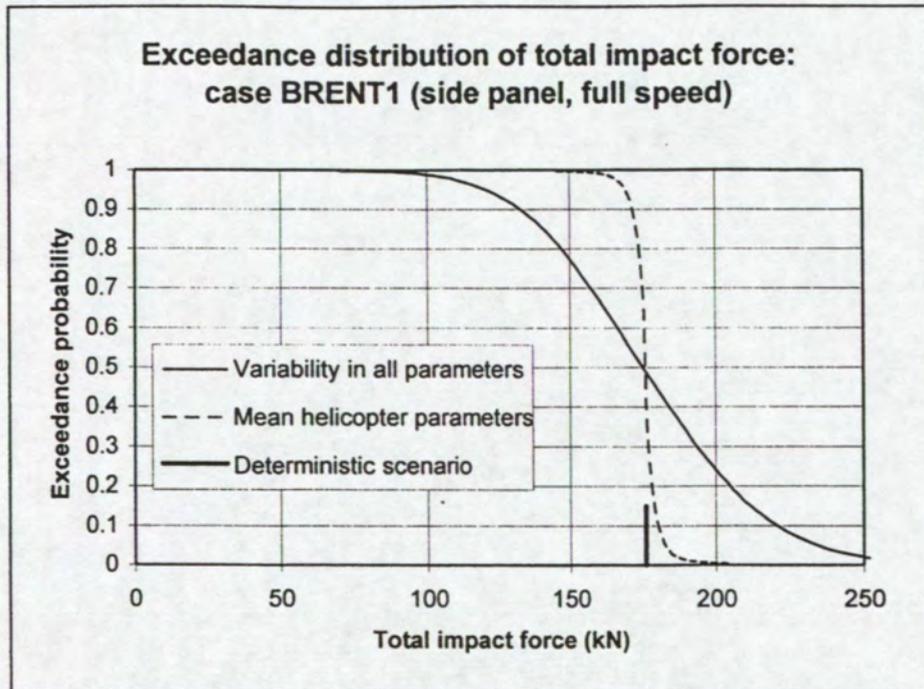
Figure 113: Exceedance distribution of the maximum total impact force: side panel in *Brent Spar* full-speed accident scenario.

The main results from the *Brent Spar* investigation are shown in Figures 113 to 116. These four figures show exceedance probability distributions for the maximum impact load on the side and base panels in full-speed and half-speed impacts. Three sets of results are shown on each figure:

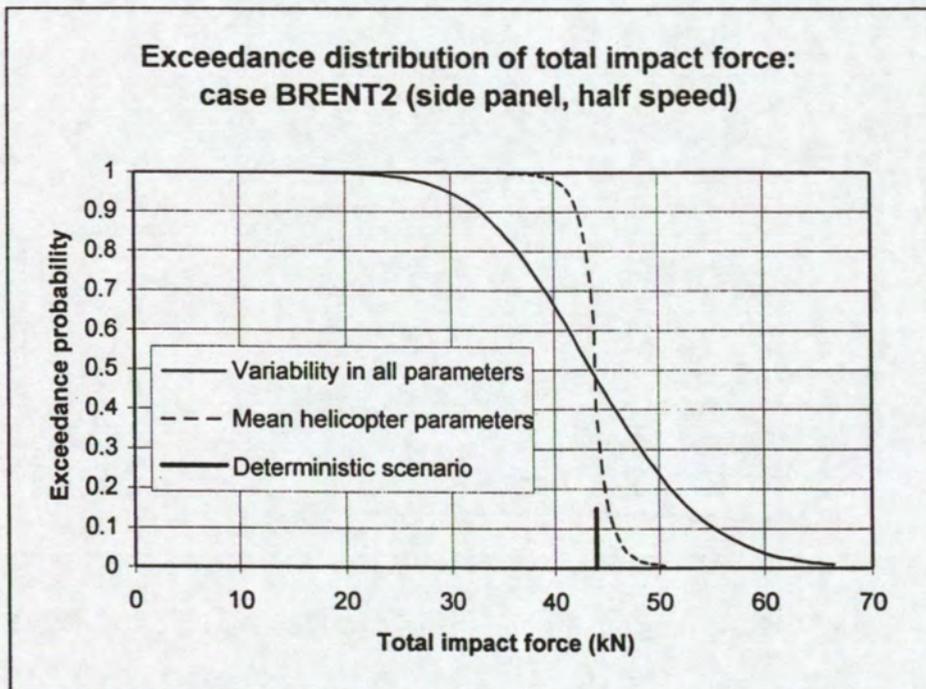
Figure 114: Exceedance distribution of the maximum total impact force: side panel in *Brent Spar* half-speed accident scenario.

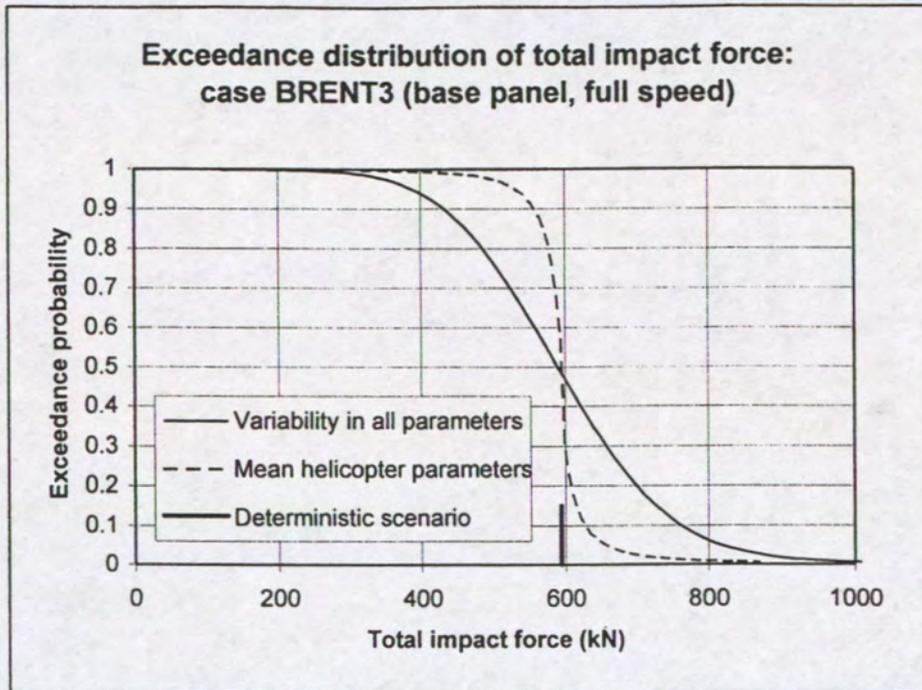
Figure 115: Exceedance distribution of the maximum total impact force: base panel in *Brent Spar* full-speed accident scenario.

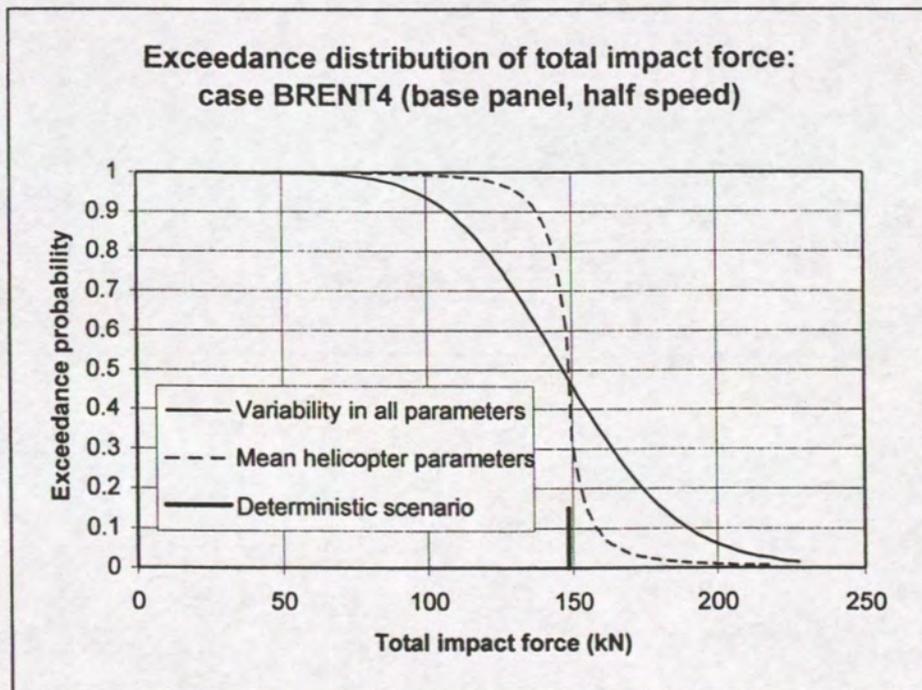
Figure 116: Exceedance distribution of the maximum total impact force: base panel in *Brent Spar* half-speed accident scenario.

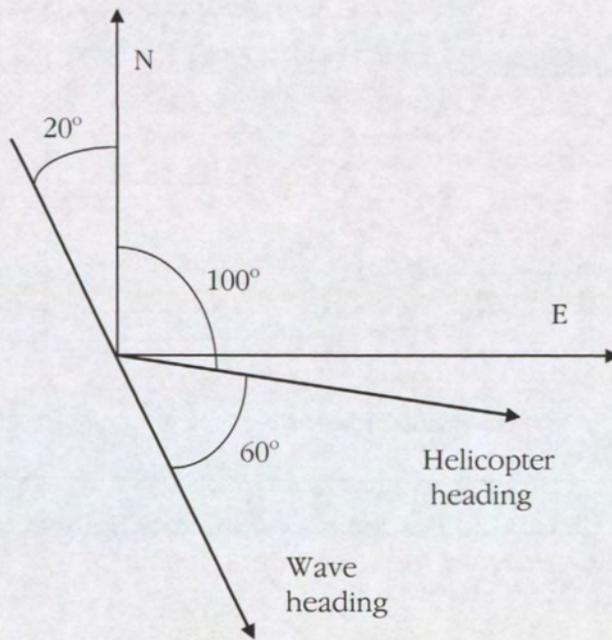
Figure 117: Mean wave heading and helicopter heading directions assumed during the *Cormorant Alpha* investigation.

Impact parameters representing the *Cormorant Alpha* scenario were also agreed with WSA, and are summarised in Table A2-2. The helicopter's assumed mean heading and wave direction at the instant of impact are illustrated in Figure 117. These parameters are based on conditions defined in references [38] and [39].

BMT had previously recommended [39] that a wave slope angle of 10 degrees, and a wave phase speed between 12 and 16 m/s should be assumed in WSA's deterministic model. The damage report suggested that the helicopter involved in the *Cormorant Alpha* accident had come down onto the rear flank of a wave travelling in approximately the same direction. The deterministic model therefore represents a wave surface, moving at an angle of 60° to the helicopter's own heading (see Figure 117), inclined towards it, and receding at the instant of impact.

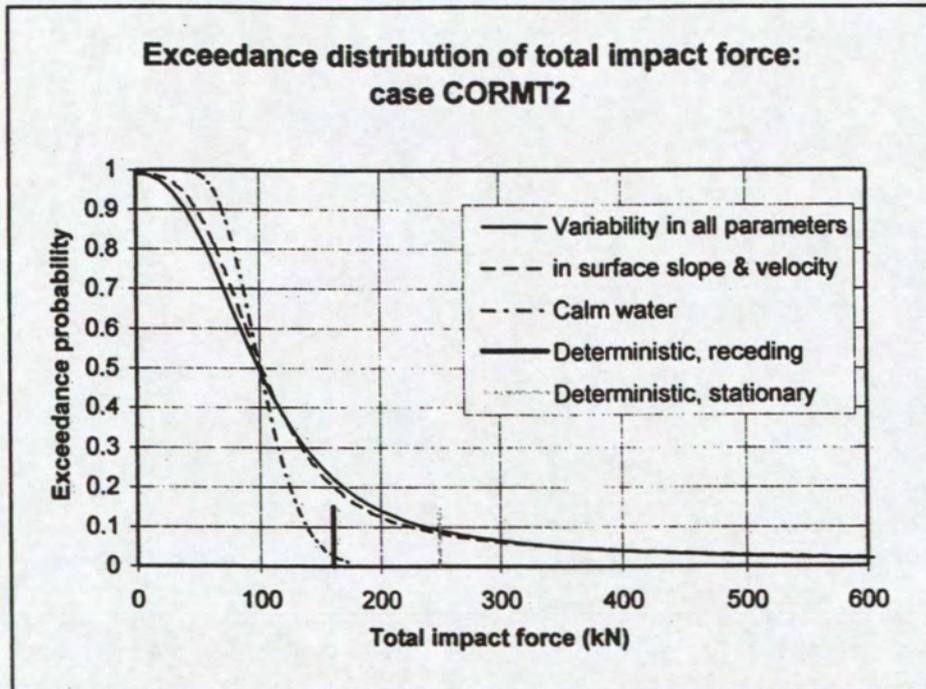
Figure 118: Exceedance distribution of the maximum total impact force: base panel in *Cormorant Alpha* accident scenario.

Figures 118 and 119 show exceedance distributions of the maximum total impact force on the base panel and side panel respectively, based on the *Cormorant Alpha* accident scenario described above. Five sets of results are shown on each figure:

The sea state, surface slope and velocity have a particularly marked effect on base panel loads, as shown in Figure 118. The load distribution obtained by varying the surface slope and velocity alone is close to that obtained when all parameters are allowed to vary. Furthermore the 'calm water' load distribution has markedly less spread than when the simulation was based on sea states representative of the *Cormorant Alpha* accident. Sea state was more significant in this respect than variations in the helicopter's speed, descent angle, attitude and heading. This result is again at variance with those obtained from the main sensitivity study (see Section 6.2 in the main part of this report and Figure 68), which apply to loads on a side-facing panel, and are not necessarily valid for loads on a base panel.

The dashed lines in Figures 118 and 119 show that impact forces on both the base panel and side panel are sensitive to variations in the water surface slope and velocity at the point of impact. The results from these simulations therefore had to be processed further in order to determine the maximum impact force associated with a deterministic impact scenario, where the wave surface slope and velocity are fixed at the instant of impact.

This particular deterministic scenario is represented by the symbol ● in Figures 120 and 121. The maximum total impact force on the base panel in this scenario is 160 kN, and the corresponding force on the side panel is 45 kN. These two ('deterministic, receding') values are shown as solid vertical bars in Figures 118 and 119.

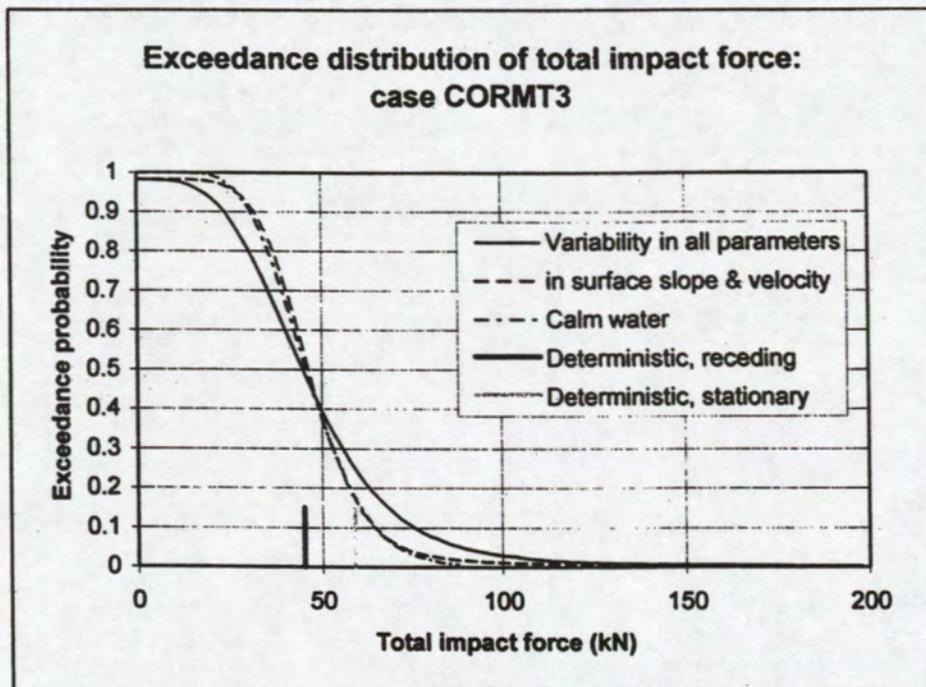
Figure 119: Exceedance distribution of the maximum total impact force: side panel in *Cormorant Alpha* accident scenario.

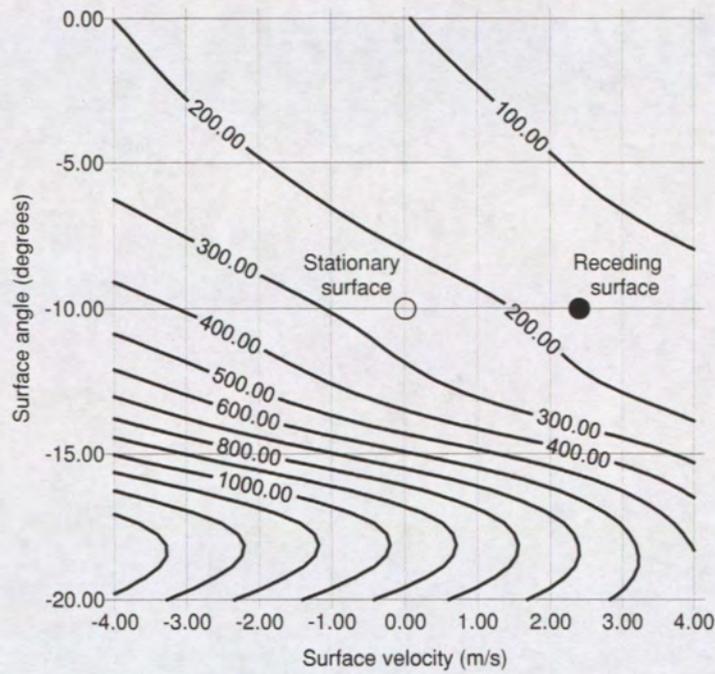
Figure 120: Contour plot of maximum total impact force against water surface angle and velocity, with other parameters fixed: *Cormorant Alpha* base panel.

The contour plots in Figures 120 and 121 show how the maximum total impact forces on the base panel and side panel vary with the water surface angle β_w and the normal water surface velocity u_w . These contour plots are based on results from Monte Carlo simulations with fixed mean helicopter and sea state parameters. As expected, the force generally increases when the water surface rises (i.e. as the surface velocity becomes more negative), and when it is inclined towards the helicopter (a negative surface angle). The contour plot for the base panel shows a large peak centred around a water surface angle of about -18 degrees, this being the angle at which the water surface is parallel to the panel itself.

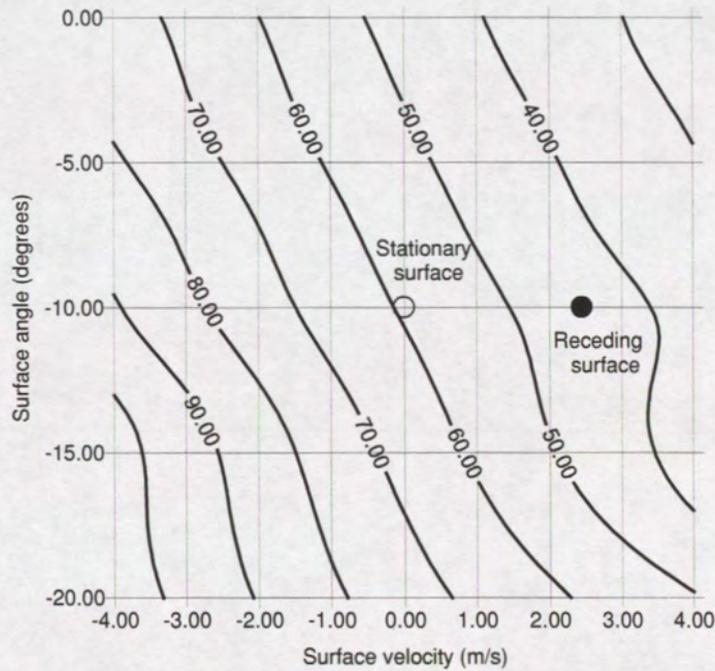
Figure 121: Contour plot of maximum total impact force against water surface angle and velocity, with other parameters fixed: *Cormorant Alpha* side panel.
